**Allentown Historical Architectural Review Board
FINAL Review Sheet**

HDC-2024-00018

Address: 1515 Linden Street

Proposal: Reconsider window replacement on bandshell at West Park

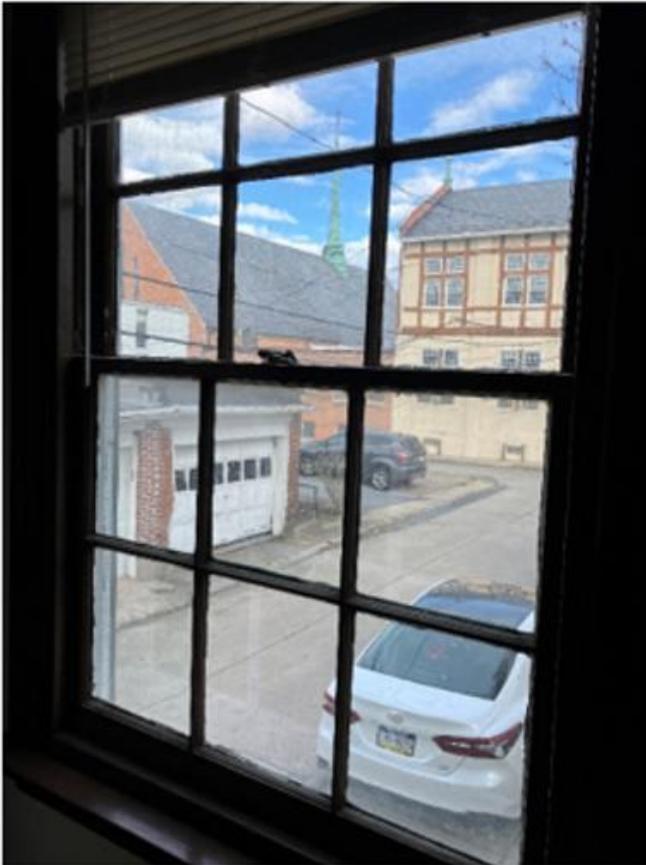
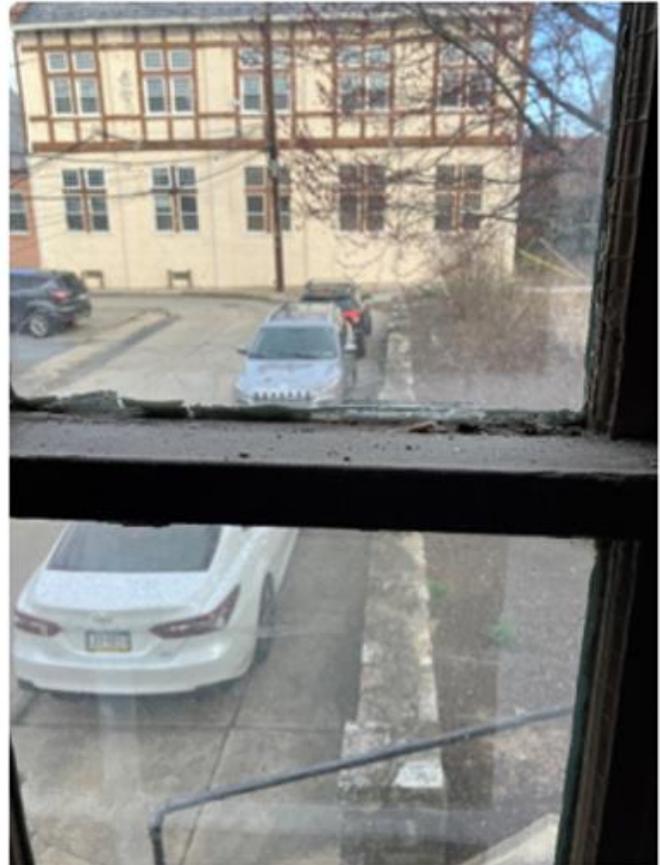
View: North side of the building towards N Baxter St, first floor; window doesn't work, paint is coming off.

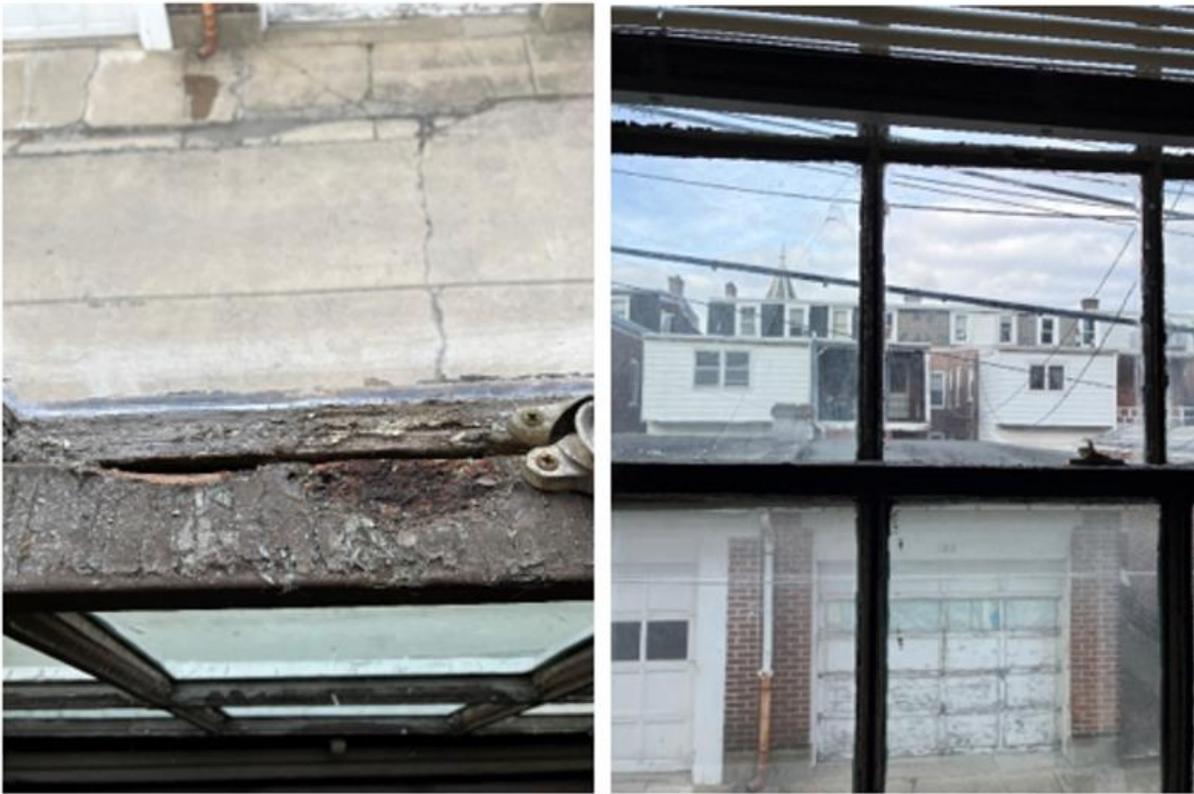
View: West side of the building in alley, first floor; window is damaged, doesn't work.

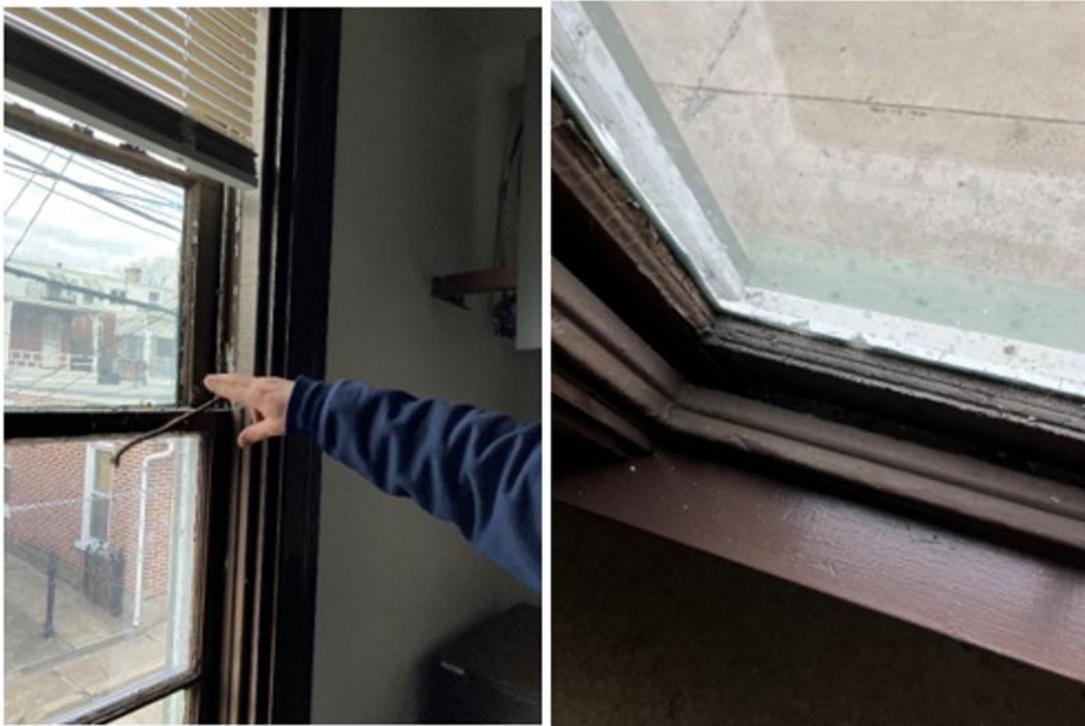
View: West side of building in alley, first floor; window doesn't work, gaps at the bottom, broken pulls.
