## APPENDIX 19

### *Park Pump Station Force Main Inspection Report*

Park Force Main Internal Inspection  
from ARVs 4, 5, and 6

December 22, 2021

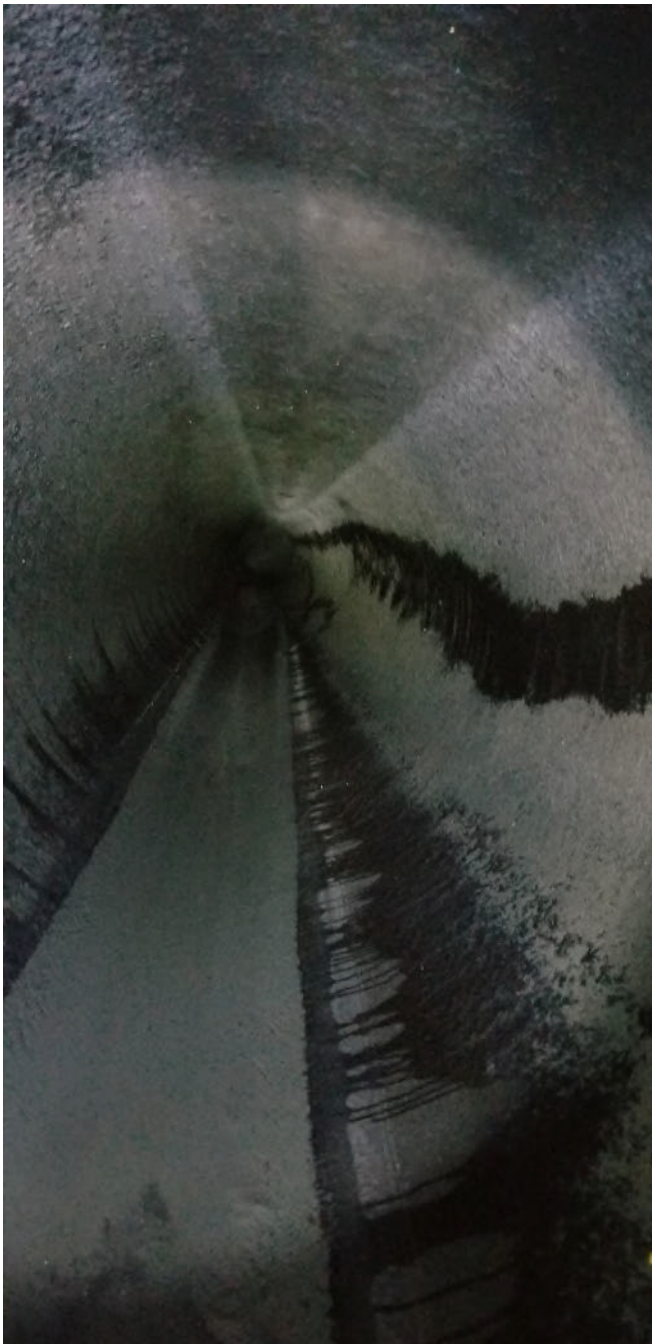
Manned entry inspection was conducted to approximately 40' upstream of ARV 4 just passed the 69° bend at Station 2672. The coating is firmly bonding to the mortar. Hammer sounding indicates the cylinder-mortar bond is still good.

*Figure 5 - ARV 4 toward ARV 3 - 40' Upstream - Pipe Image*

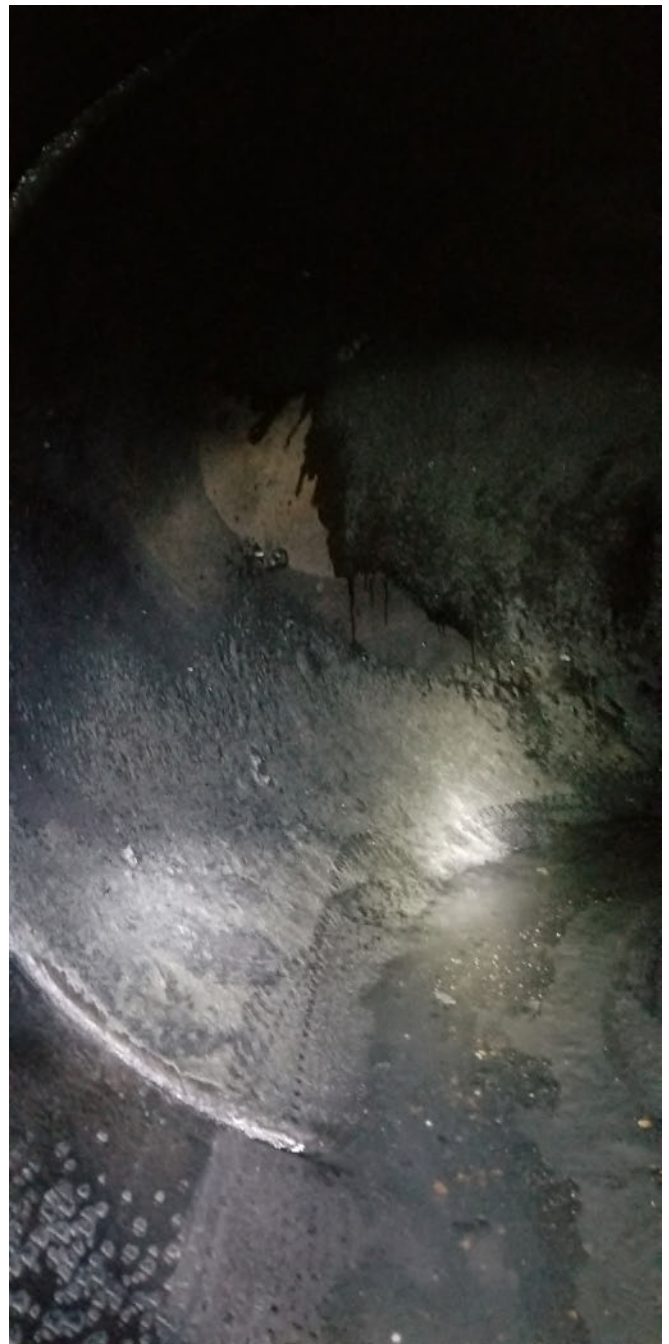
*Figure 4 - ARV 4 toward ARV 5 - Bend at Station 2672*

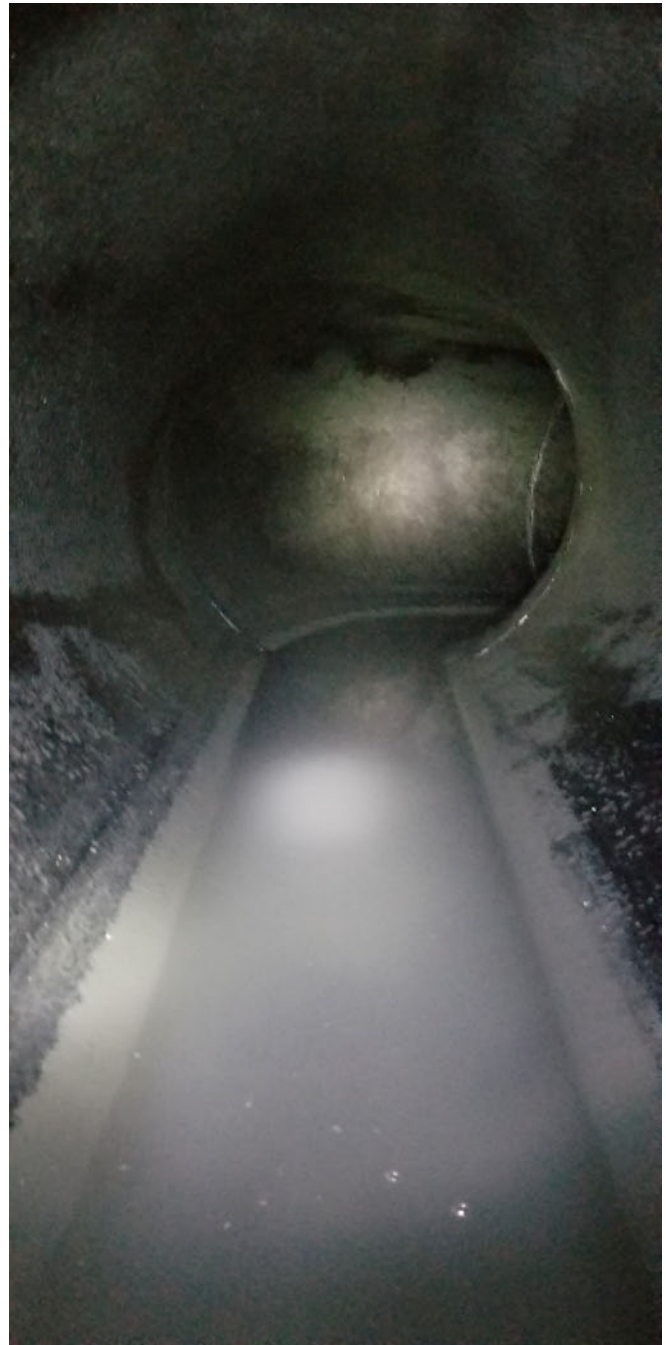
Manned entry inspection was conducted to approximately 40' upstream of ARV 4. The coating is firmly bonding to the mortar. Hammer sounding indicates the cylinder-mortar bond is still good.

*Figure 6 - ARV 4 toward ARV 5 - 10' downstream looking at bend at Station 2724*

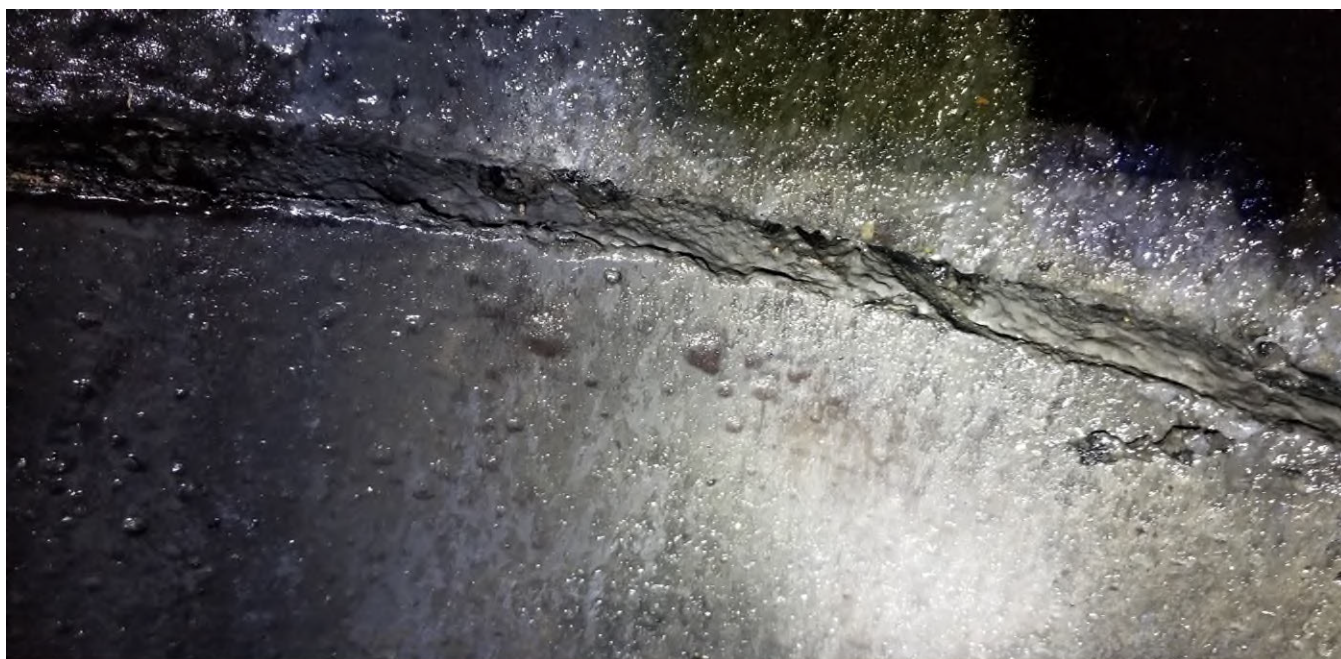
This segment has unmudded joints approximately ½" wide and 2" deep.

*Figure 7 - ARV 5 toward ARV 4 - Unmudded joint*

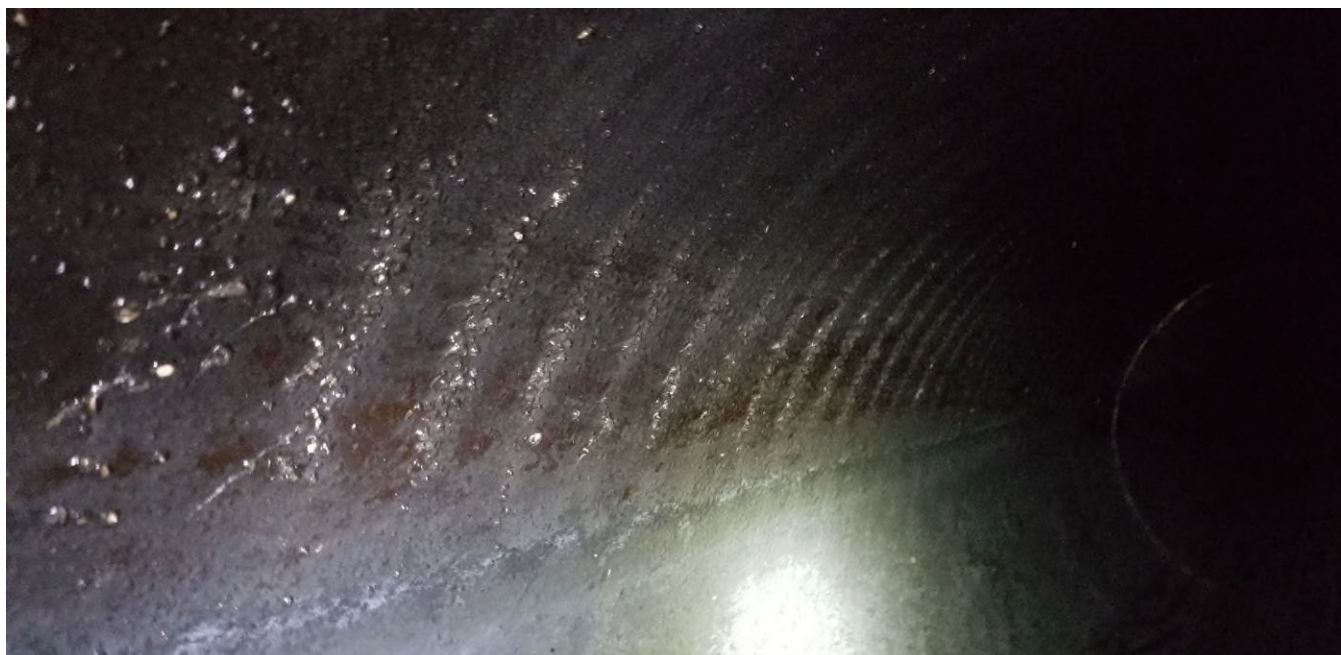
Manned entry inspection was conducted to approximately 40' upstream of ARV 5. The coating is disbonding from the mortar, first in circular patterns mimicking the coating spray pattern, then about 10' into the segment becoming systemic above the pump off water line 8-4 clock. The coating appears to be coal tar type coating and is very thin and brittle where it is flaking off. The H2S attack under the coating is wide-spread but very shallow with minimal impact to date on the thickness of the mortar, which on this pipe diameter for L301 pipe is 2.25" thick. Where the mortar is exposed, it is still bright white and relatively hard, with the softer gypsum layer being very minor. CCTV images are poor but indicate the blistering of the coating proceed upstream. Hammer sounding indicates the cylinder-mortar bond is still good.

*Figure 8 - ARV 5 toward ARV 4 - 8' Upstream - Disbonding of coating along spray pattern*

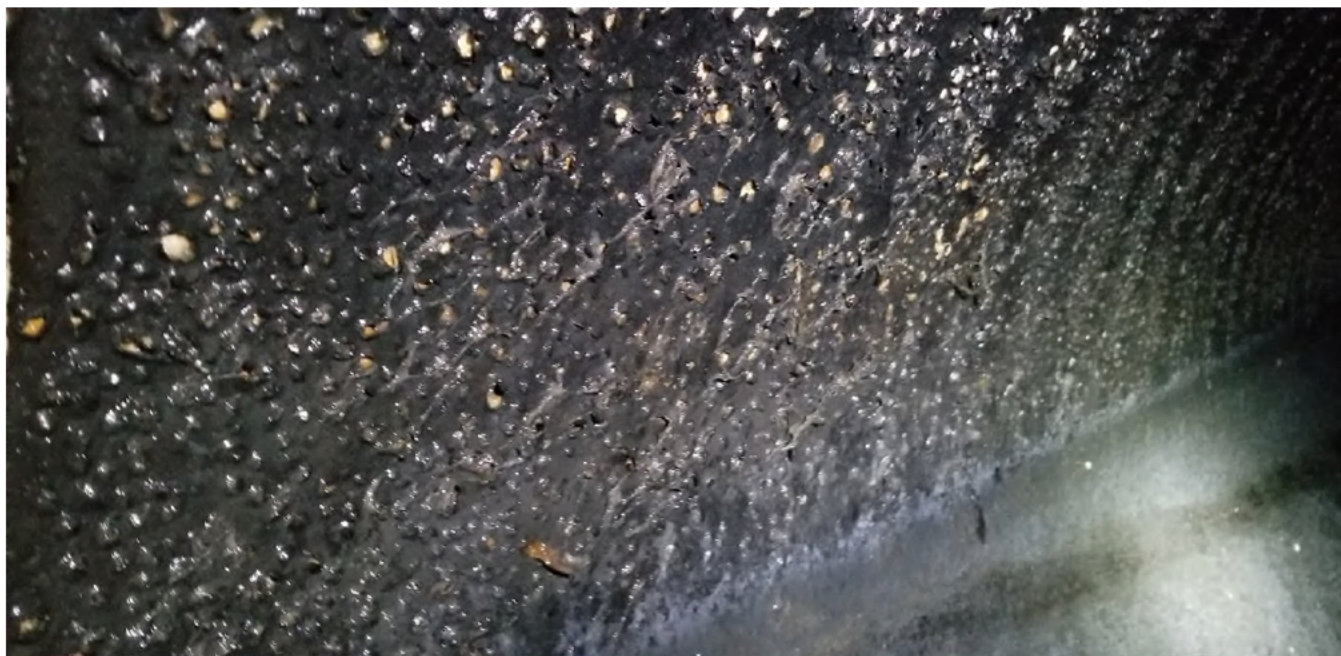
*Figure 9 - ARV 5 toward ARV 4 - 20' Upstream - Systemic disbonding of coating*

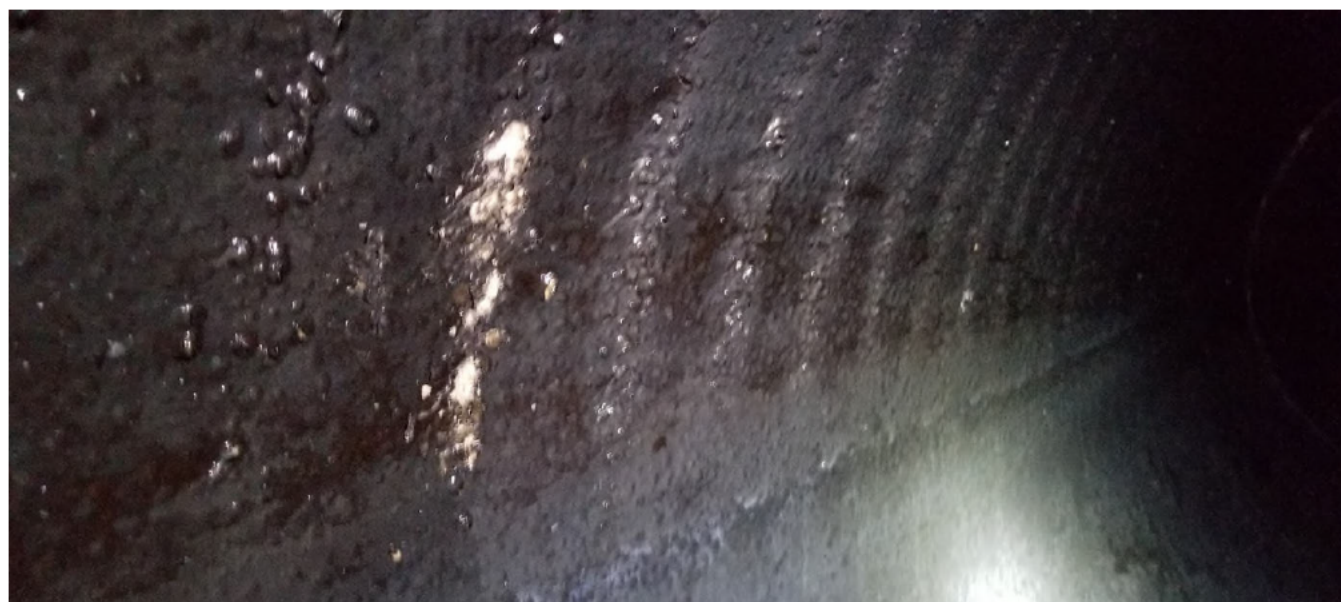
*Figure 10 - ARV 5 toward ARV 4 - 8' Upstream - Soft mortar revealed under the disbonded coating (typ)*

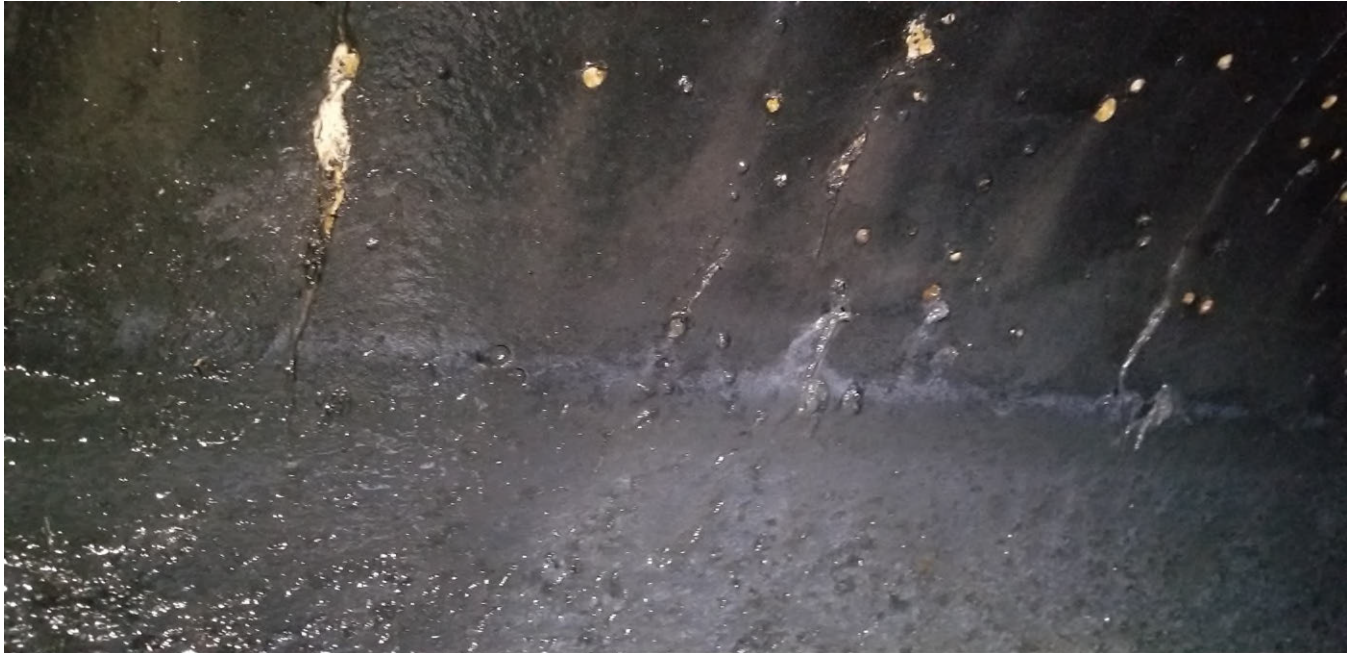
*Figure 11 - ARV 5 toward ARV 4 - 20' Upstream - Cracking of coating and exposure of underlying mortar*

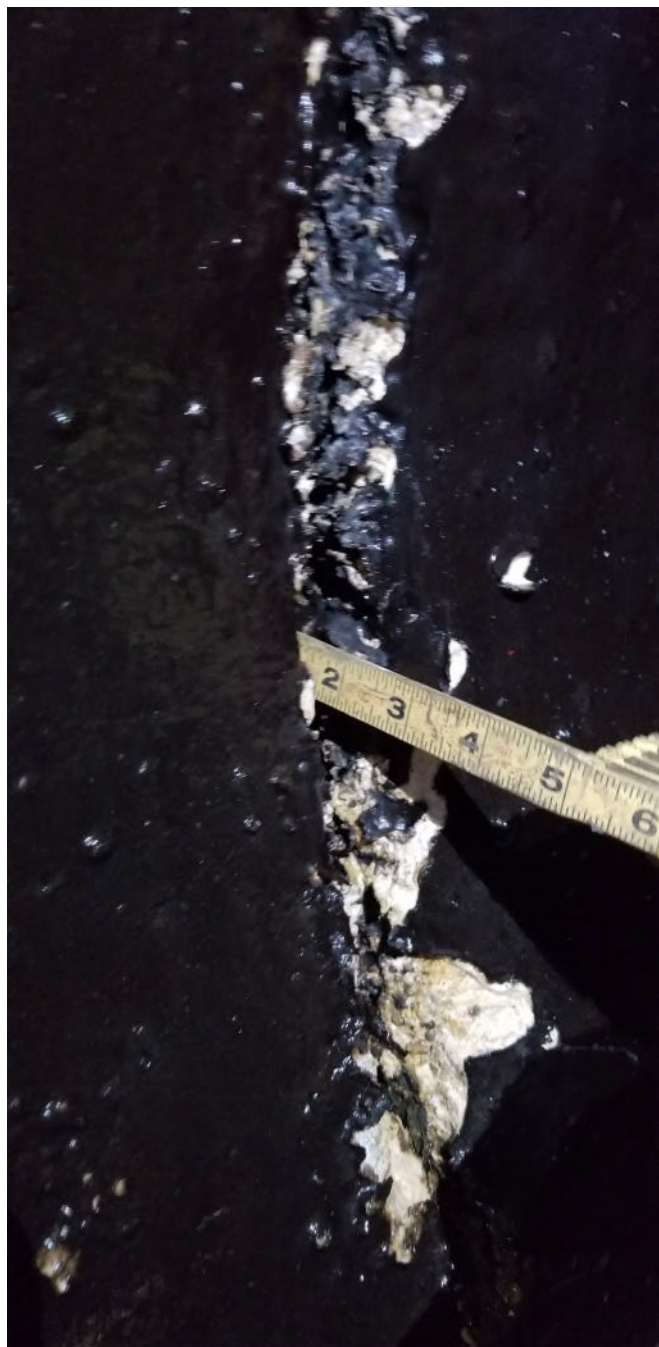
This segment has unmudded joints approximately ½" wide and 2" deep.

*Figure 13 - ARV 5 toward ARV 6 - Joint*

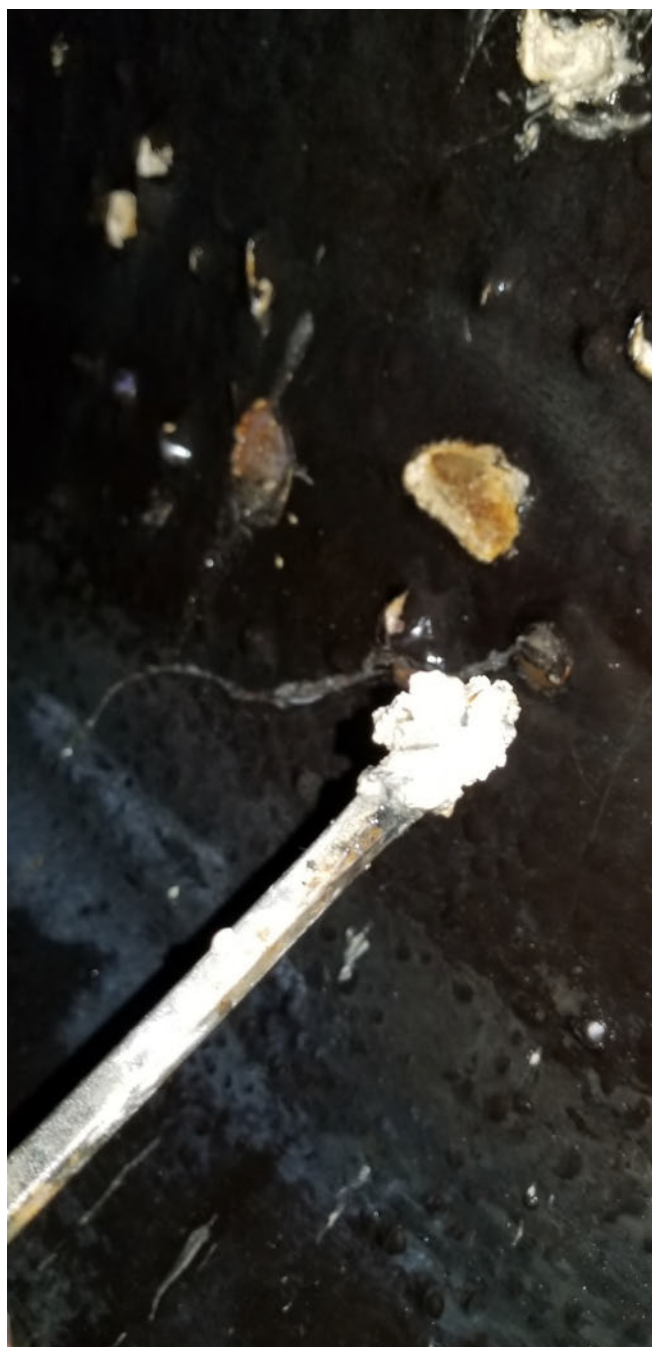
Manned entry inspection was conducted to approximately 80' downstream of ARV 5. The coating is disbonding or completely removed from the mortar, first in bands between the 2-5 and 7-10 clock positions, then extending from 8-4 clock positions. Mortar loss in these locations is 3/8" to ¼" deep. The coating appears to be coal tar type coating and is very thin and brittle where it is flaking off. The H2S attack under the coating is wide-spread. Blisters originate from the wire pattern, likely a result of pipe stress from ovality as a result of vertical pipe loading pushing the pipe laterally into the pipe bedding envelope. While unclear from CCTV inspection, correlating photographs from manned entry inspection, the mortar attack from 9-3 clock positions appears to occur the entire distance toward ARV 6. Where the mortar is exposed, it is still bright white and relatively hard, with the softer gypsum layer being very minor. Hammer sounding indicates the cylinder-mortar bond is still good except in haunch area where soundings were slightly duller.

*Figure 12 - ARV 5 toward ARV 6 - Gypsum from H<sub>2</sub>S attacked mortar*

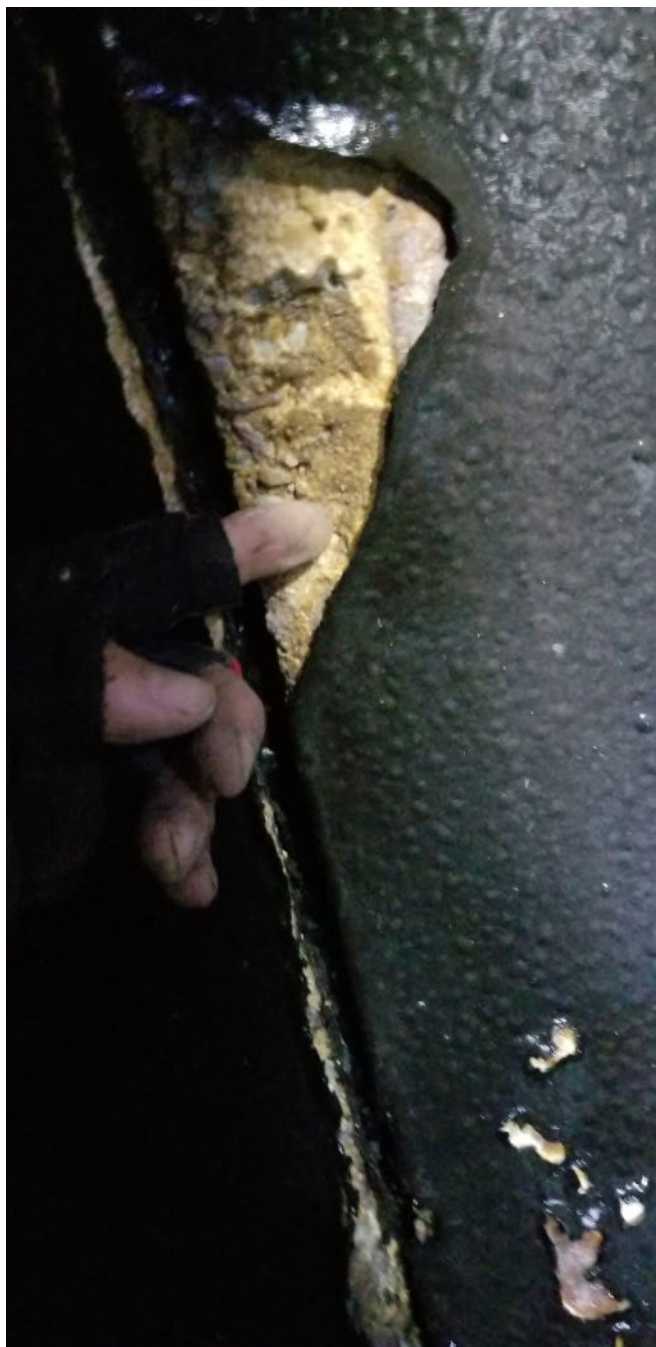
*Figure 15 - ARV 5 toward ARV 6 - Coating disbondment at joint*

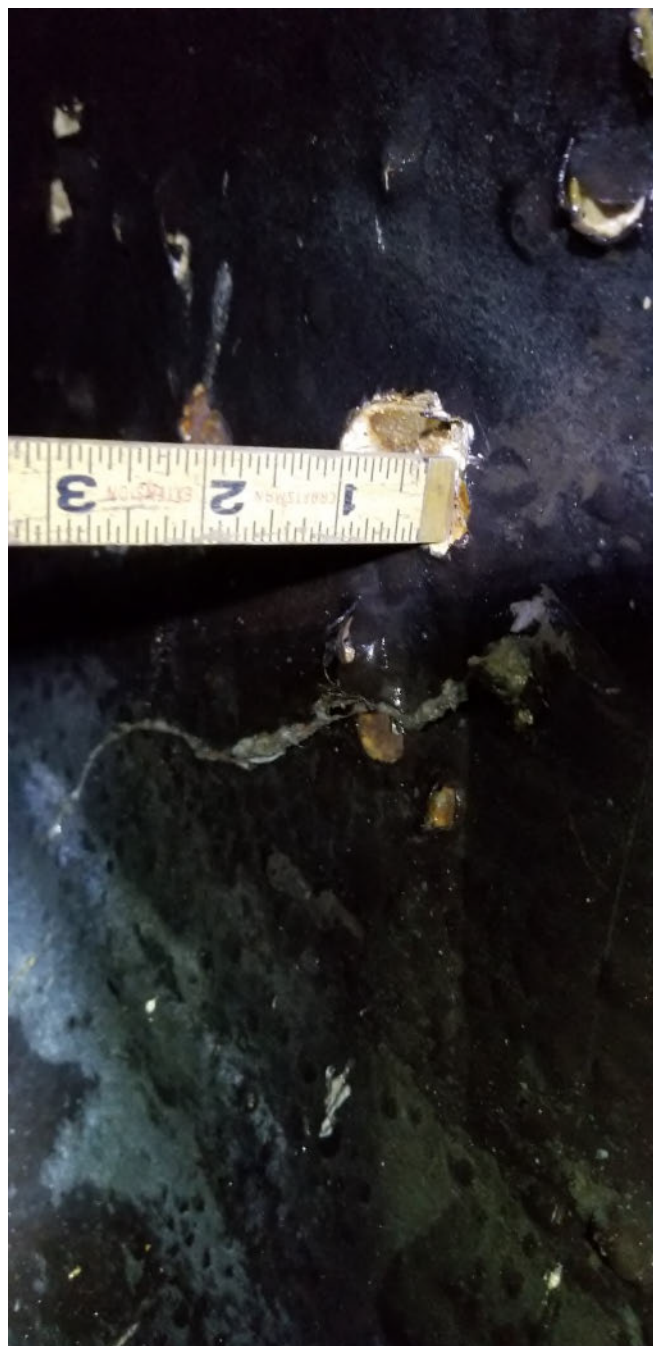
*Figure 14 - ARV 5 toward ARV 6 - H<sub>2</sub>S attack at coating blister*

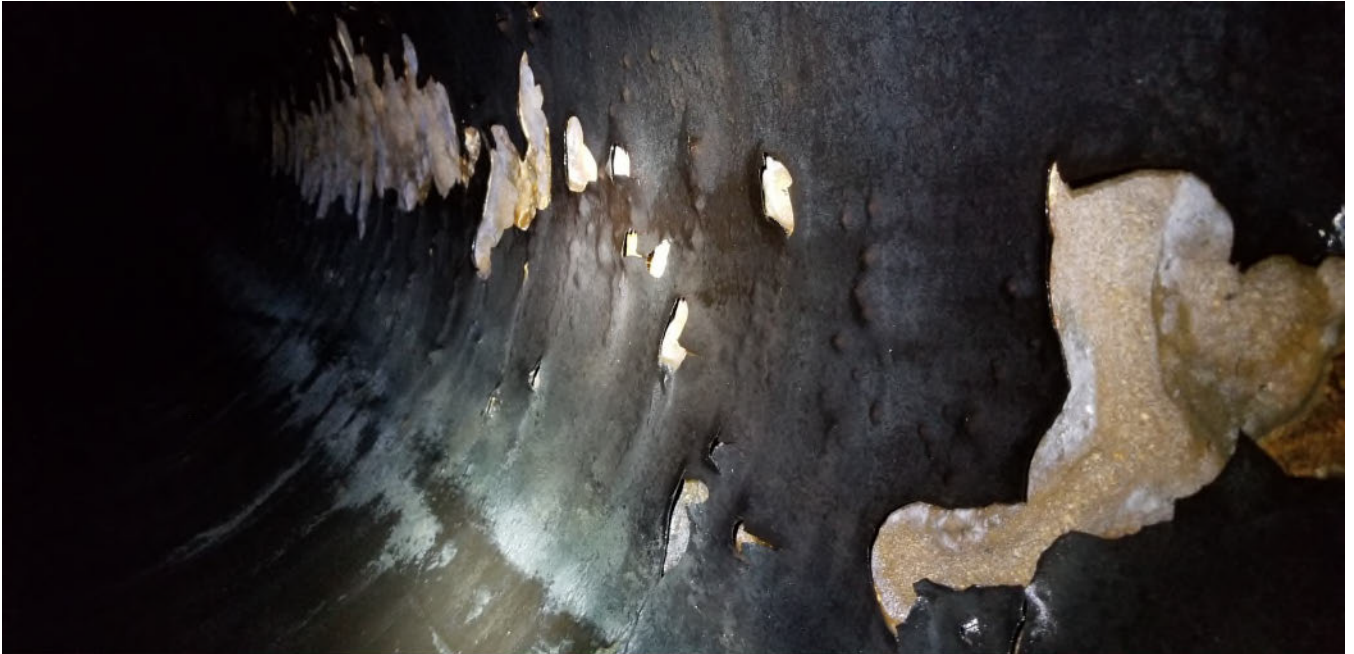
*Figure 17 - ARV 5 toward 6 - Coating disbondment along springline with 1/2" mortar loss under blisters*

On the downstream side of ARV 5, the H<sub>2</sub>S attack is markedly worse, with the entire top half of some sticks of pipe have all of their coating and ¼" to ½" of mortar loss from the 2.25" interior mortar coating. ARV 5 represents the high flat portion of the PFM, so these findings make sense.

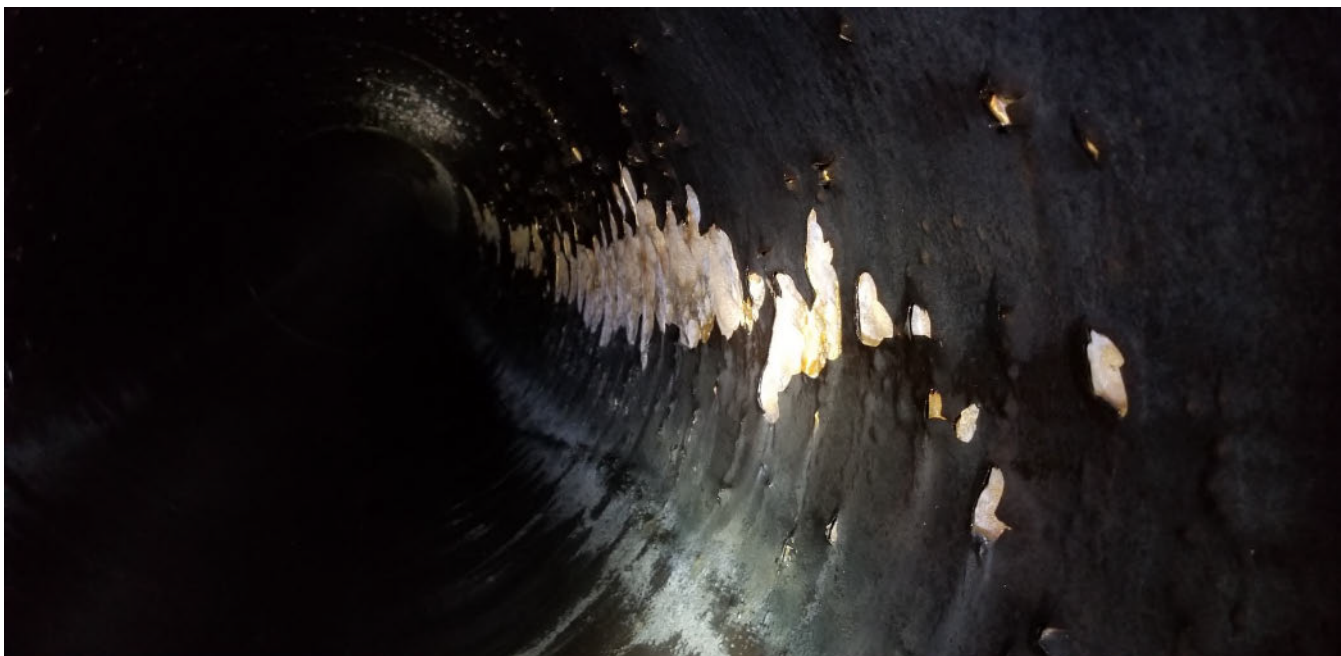
*Figure 16- ARV 5 toward 6 - Coating disbondment along springline following wire pattern*

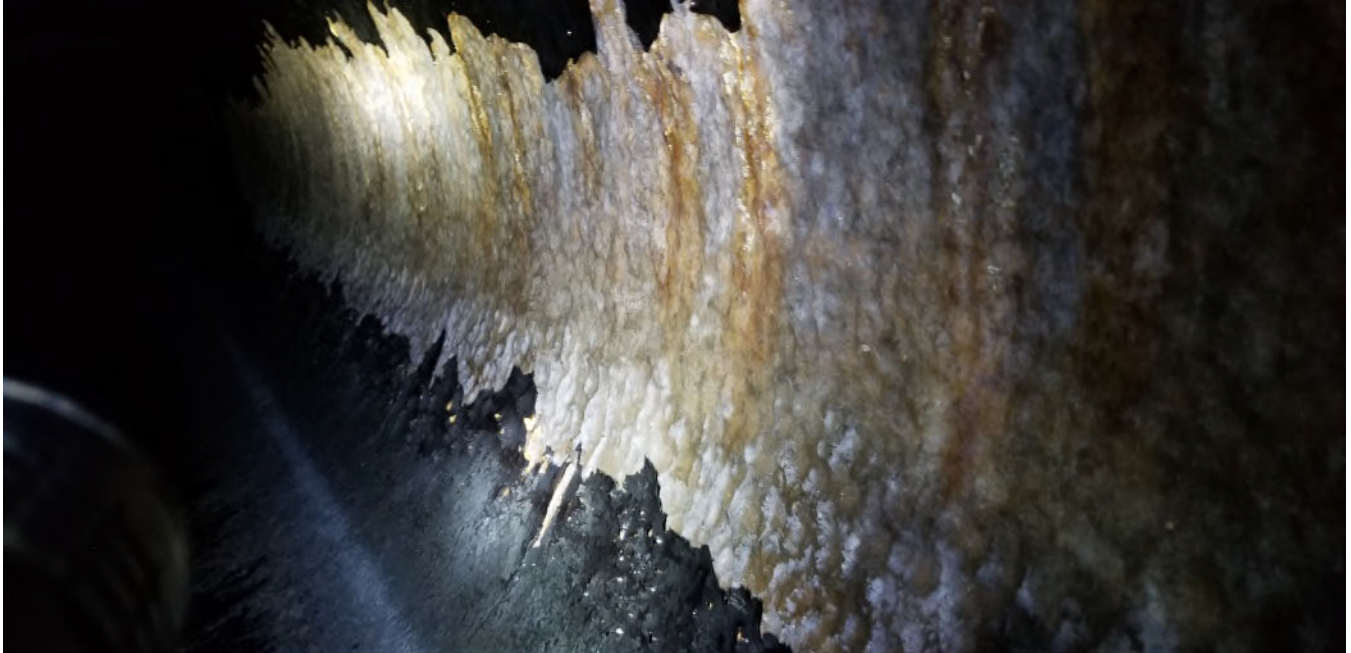
*Figure 18- ARV 5 toward 6 - Coating disbondment and ½" mortar loss along springline, rust pattern from steel shell beginning to seep through mortar following wire pattern*

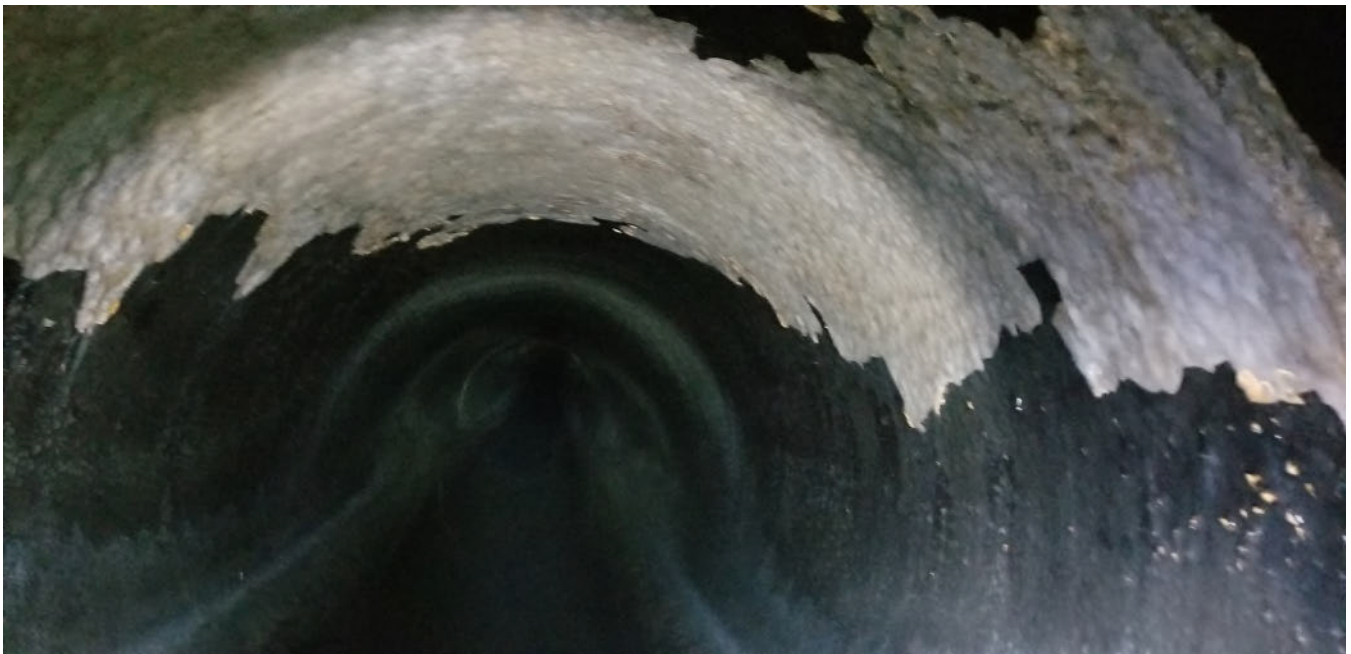
*Figure 19- ARV 5 toward 6 - Coating disbondment and 3/8" mortar loss springline to springline*

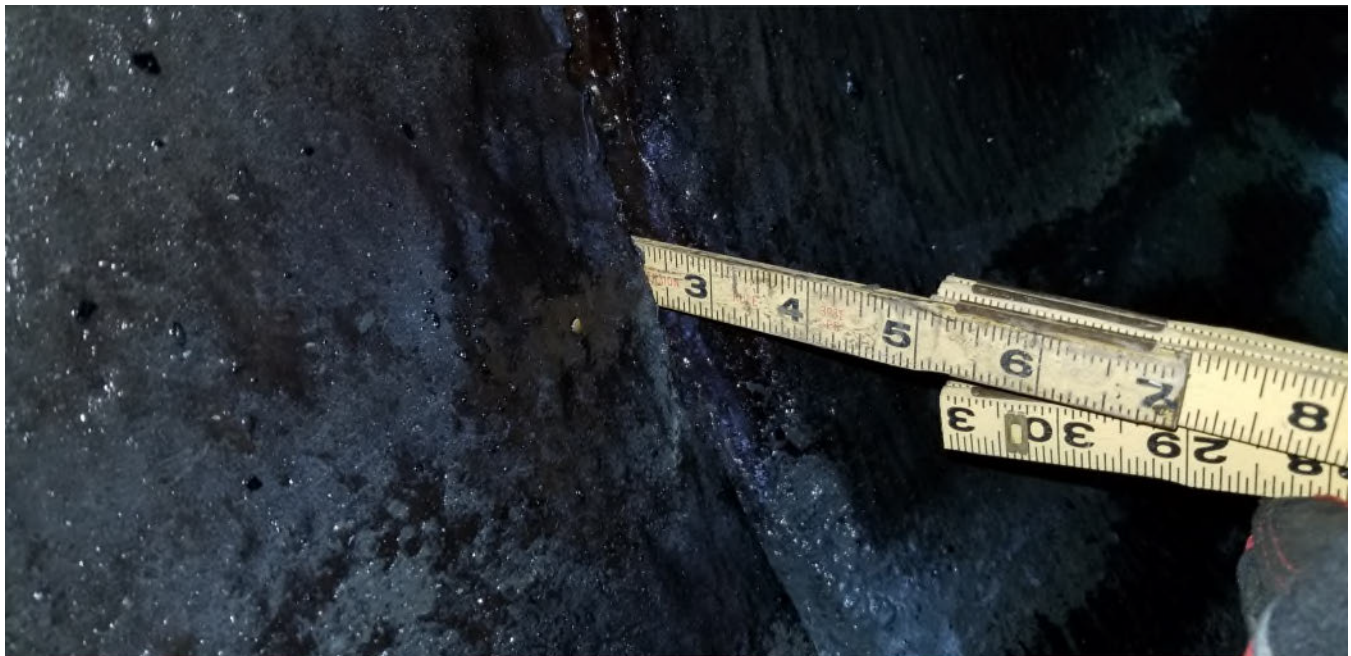
This segment has unmudded joints approximately  $\frac{1}{2}$ " wide and 2.5" deep.

*Figure 20 - ARV 6 toward ARV 5 - Joint*

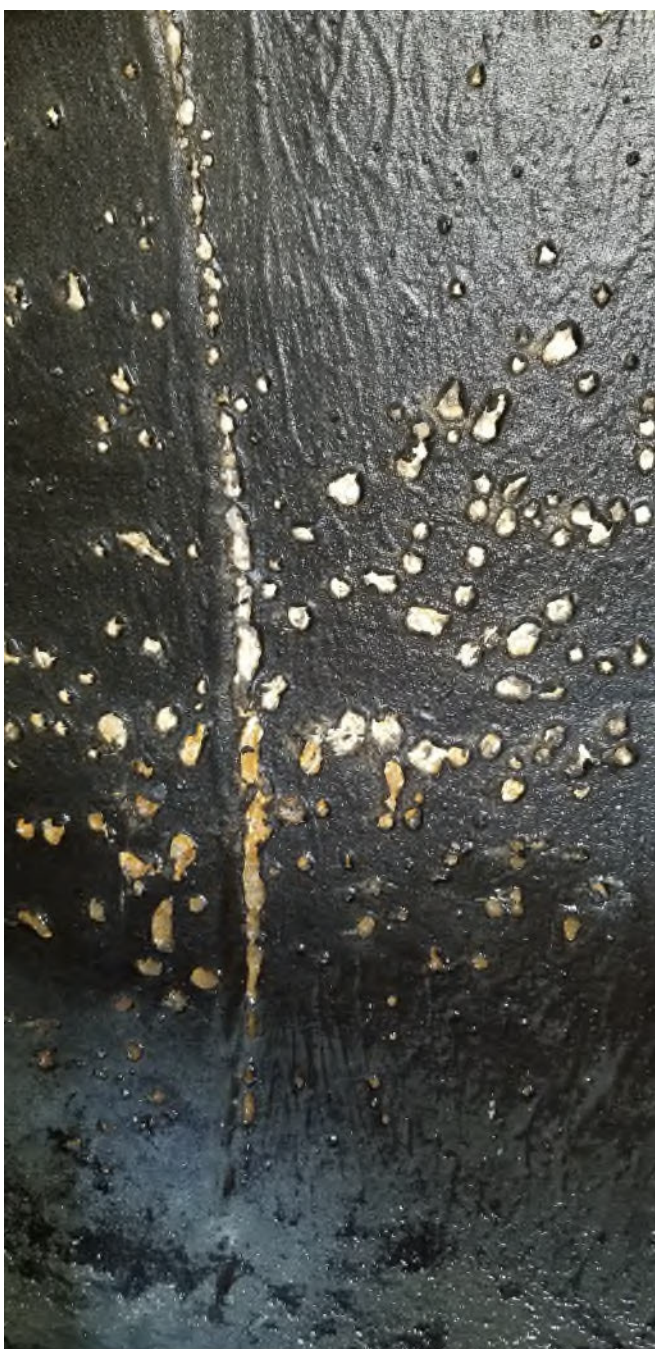
Man entry inspection was conducted to approximately 40' upstream of ARV 6. The coating is blistered and disbonding from the mortar above the pump off water line, first in bands between the 2-4 and 8-10 clock positions, then extending from 8-4 clock positions. Within the length inspected via man entry, there is  $\sim\frac{1}{4}$ " mortar loss under the blistered coating. The CCTV further upstream is hazy but blistering and H<sub>2</sub>S attack looks similar to what was seen ARV 5 toward ARV 6, though the mortar loss is measurable but less than  $\frac{1}{2}$ ". The coating is thin and brittle where it is flaking off. The H<sub>2</sub>S attack under the coating is wide-spread. Hammer sounding indicates the cylinder-mortar bond is still good .

*Figure 22 - ARV 6 toward ARV 5 - Coating Blisters and Disbondment*

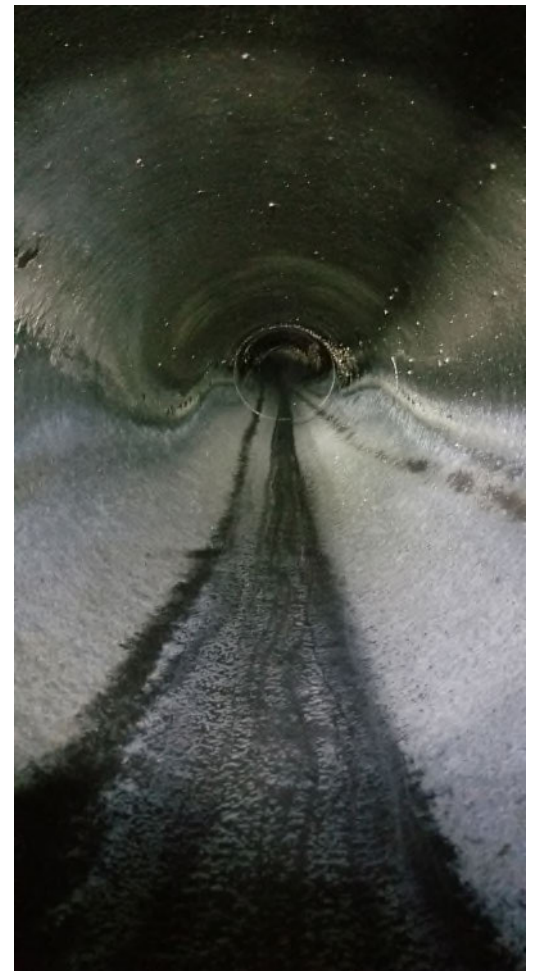
*Figure 23 - ARV 6 toward ARV 7 - Pipe*

Man entry inspection was conducted to approximately 30' downstream of ARV 6. The coating is blistered and disbonding from the mortar above the pump off water line between the extending from 8-4 clock positions. The mortar behind the blisters is soft. Hammer sounding indicates the cylinder-mortar bond is still good .

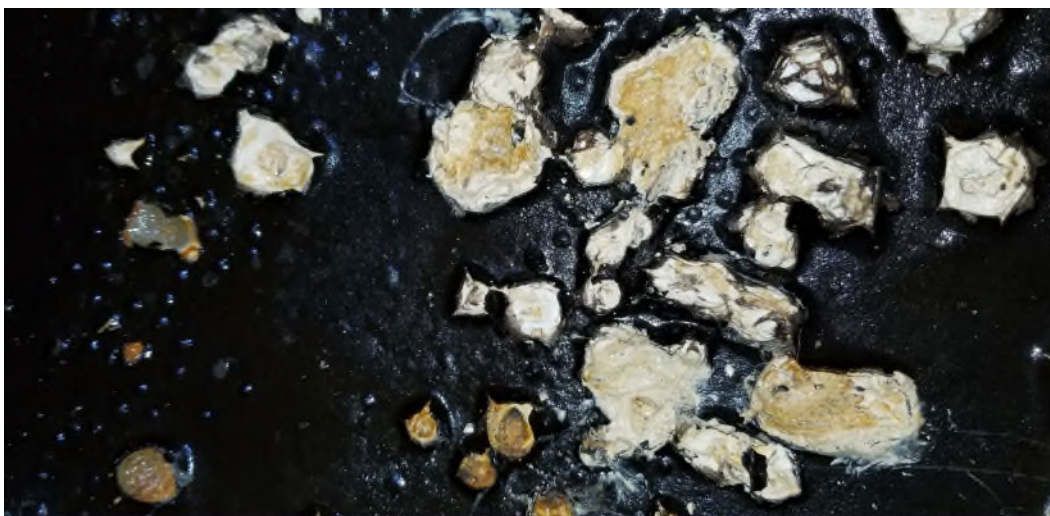
*Figure 24 - ARV 6 toward ARV 7 - Blisters in Coating*

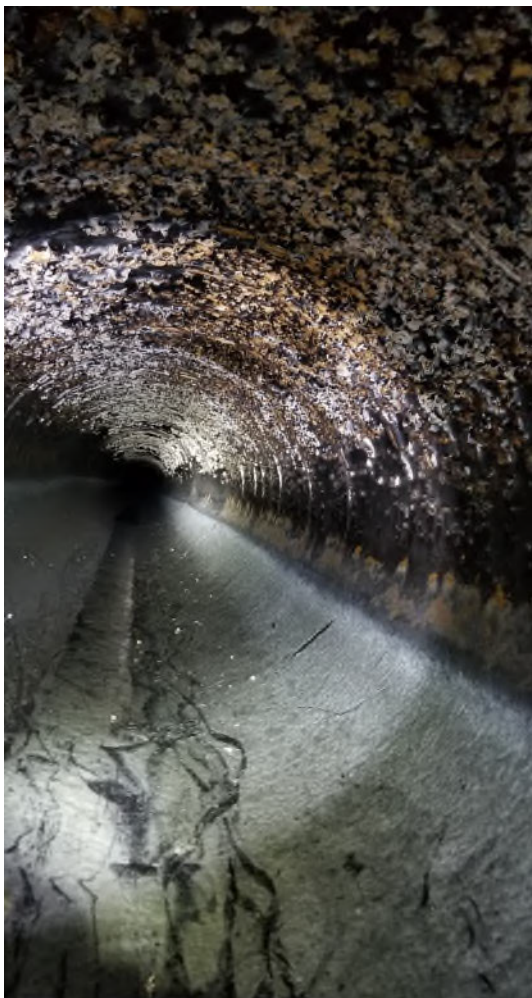
Manned entry inspection was conducted to approximately 80' upstream of ARV 8. The coating and pipe below the water line is sound. Above the waterline, the black coal tar coating is blistered the entire length inspected. Upon probing with mason's hammer, the cement liner under the coating pock marked and generally soft to a depth of 3/8" to 1/2" deep. There are no places where the coating and mortar are completely stripped away. The H2S attack under the coating is wide-spread. Where the mortar is exposed, it is still yellow but relatively hard. Hammer sounding indicates the cylinder-mortar bond is still weakening at various clock positions depending on the station of the pipe.

*Figure 26 - ARV 8 toward ARV 7 - Blisters in Coating*

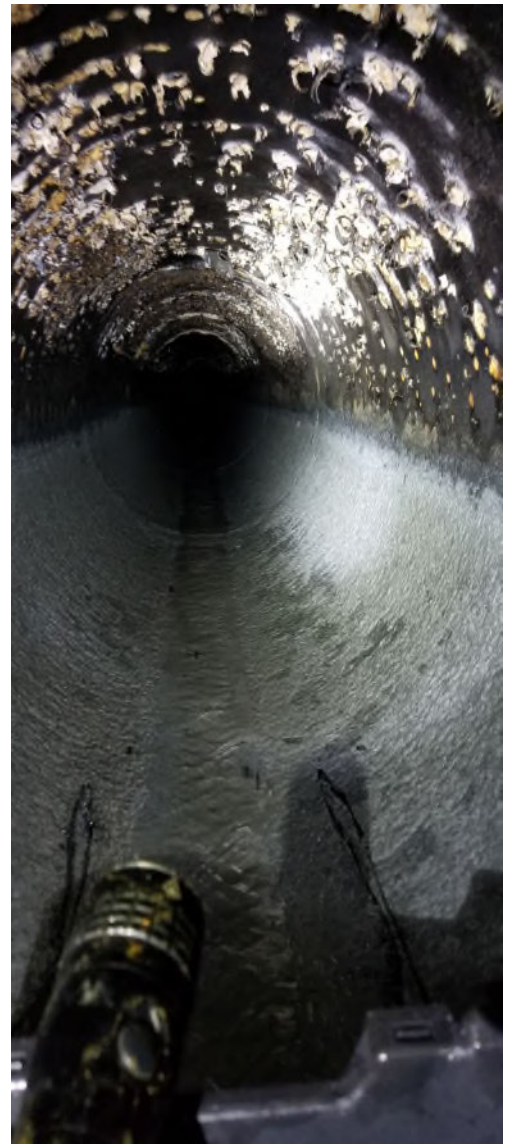
*Figure 25 - ARV 8 toward ARV 7 - Blisters in Coating*

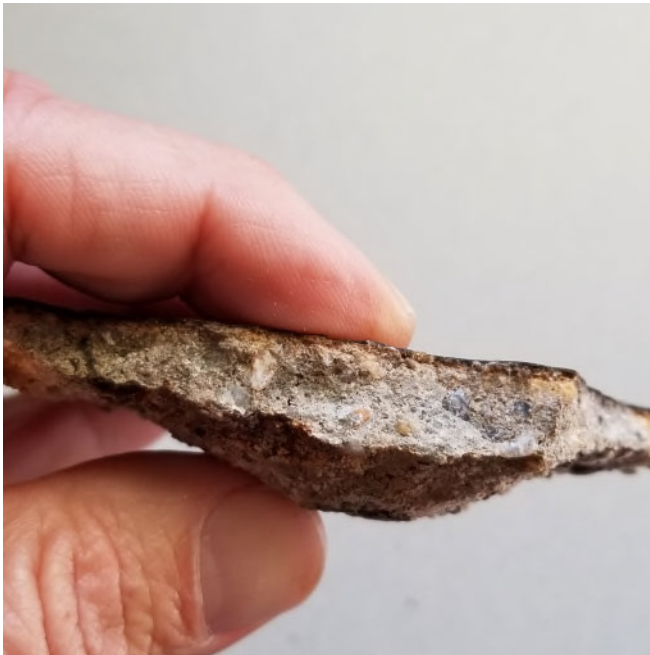
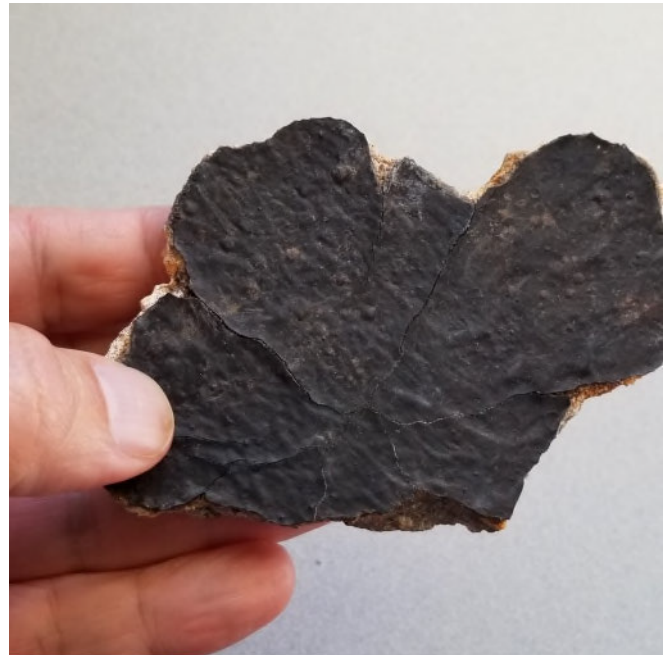
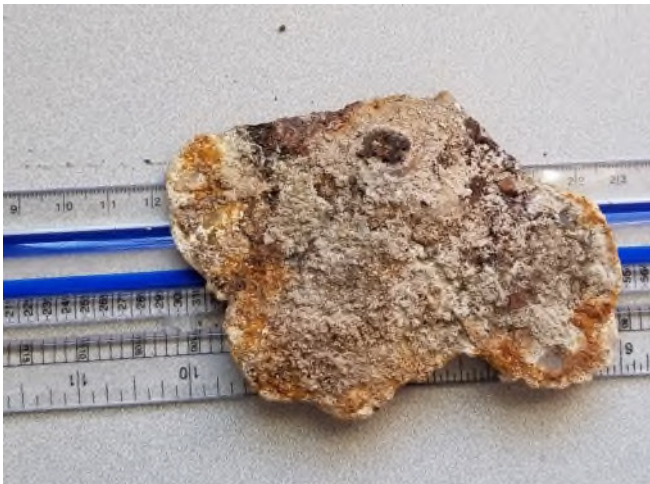
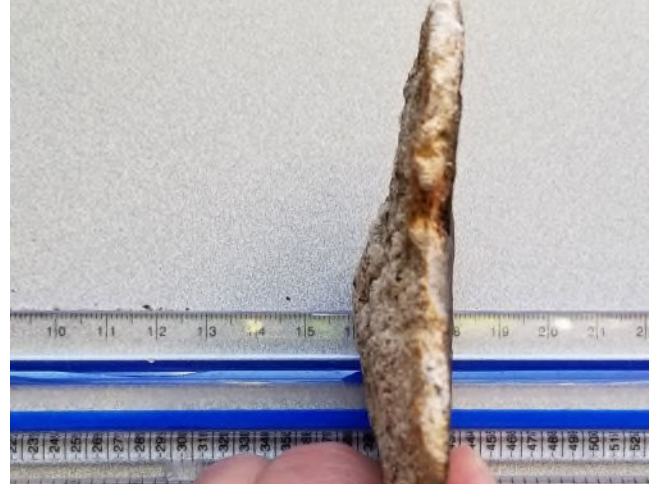
Shards of the PCCP pipe liner were found in the bottom of the pipe. These shards of mortar have the coal tar coating fully bonded but slight yellowing of the mortar on the backside of the share, indicating the shard disbonded from a combination of stress cracks and sulfide attack.

Figure 27 - Shard of PCCP Inner Liner Mortar and Coal Tar Coating near ARV 8

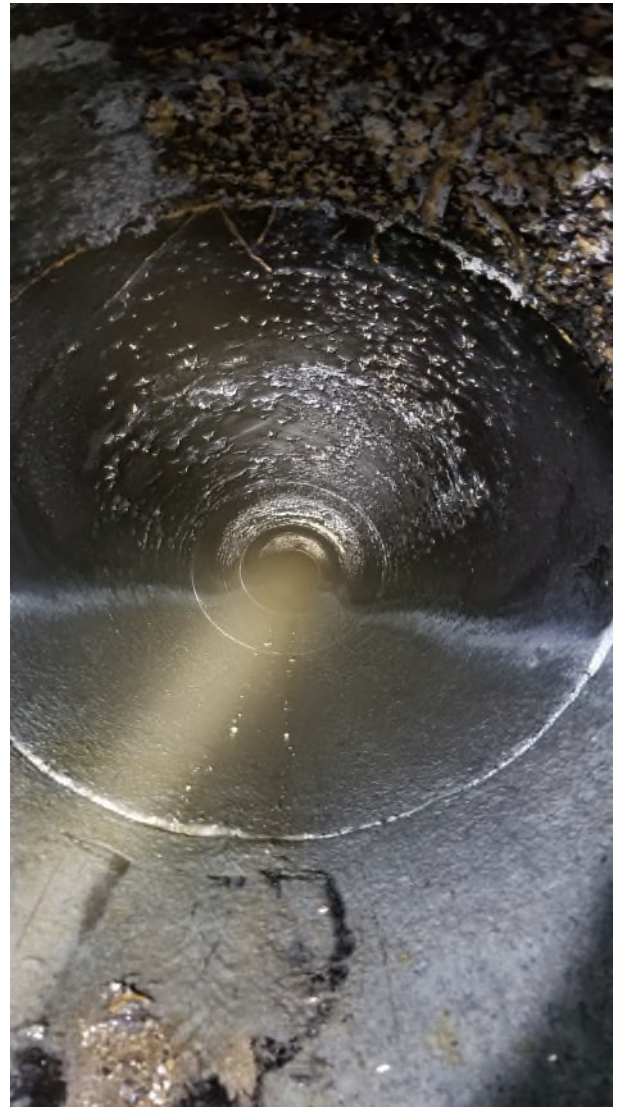
The coating and pipe below the water line is sound. Above the waterline, the black coal tar coating is blistered the entire length visible.

*Figure 28 - ARV 8 toward ARV 9 - Blisters in Coating*

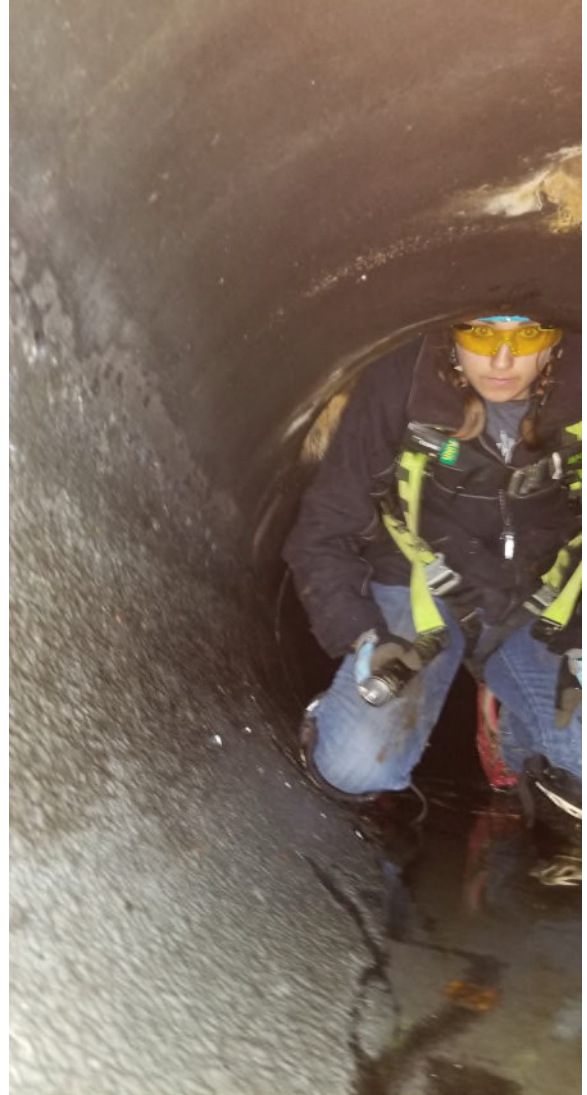
Manned entry inspection was conducted to approximately 70' upstream of ARV 9 to just passed the 50° fitting at Station 79+32. The coating and pipe at this location are in good shape with minimal/do degradation of the coating or the underlying pipe cement mortar coating. Hammer sounding indicates the cylinder-mortar bond is weakening at some places at the pipe haunch.

*Figure 29 - ARV 9 - ARV 8 Pipe Condition at ARV 9*
