## APPENDIX 19

### *Park Pump Station Force Main Inspection Report*

Park Force Main Internal Inspection  
from ARVs 4, 5, and 6

December 22, 2021

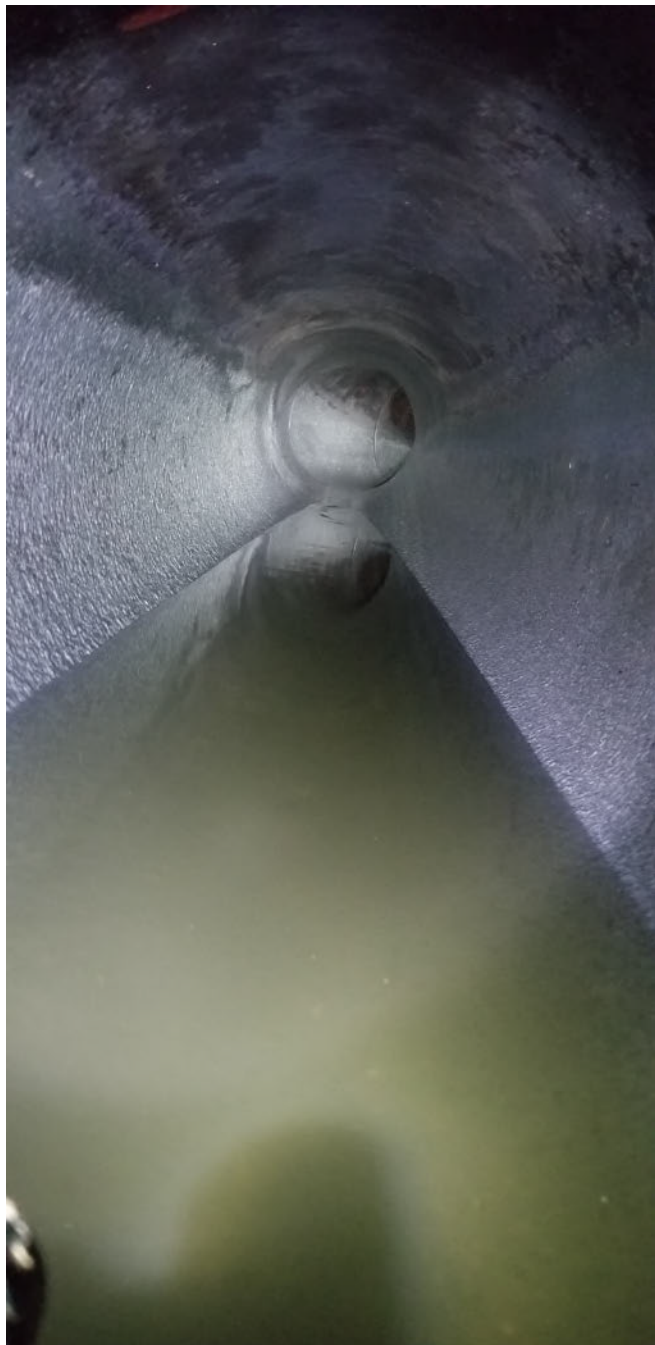
*Figure 31 - ARV 9 -ARV 8*

Manned entry inspection was conducted to approximately 70' upstream of ARV 9 to just passed the 50° fitting at Station 79+32. The coating and pipe at this location are in good shape with minimal/do degradation of the coating or the underlying pipe cement mortar coating. Hammer sounding indicates the cylinder-mortar bond is weakening at some places at the pipe haunch.

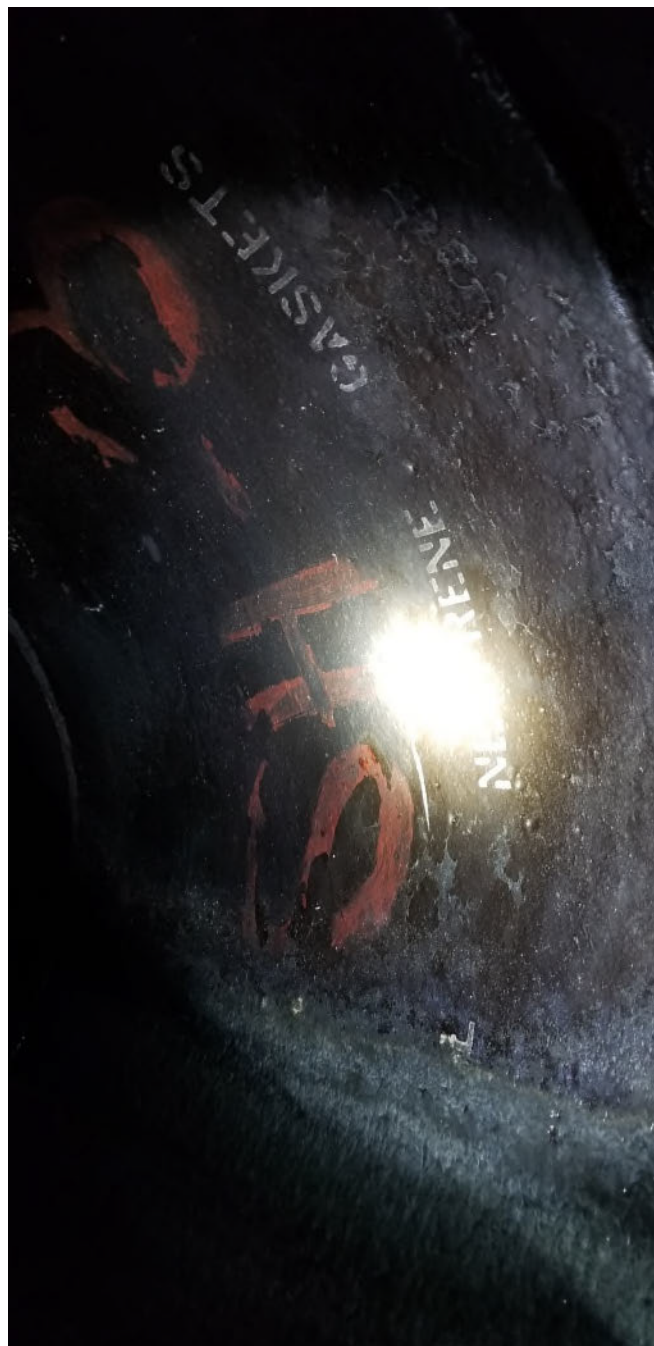
*Figure 30 - ARV 9 - ARV 8 Pipe Wall*

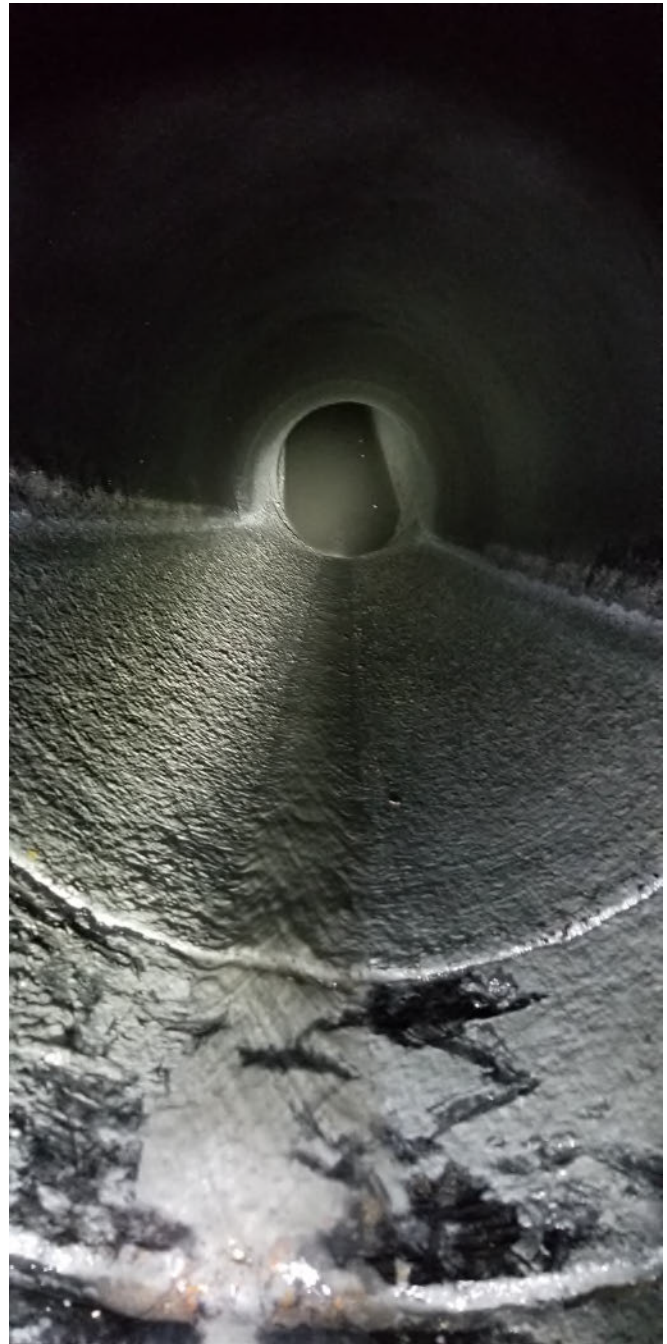
*Figure 32 - ARV 9 - Access Chamber 2*

The coating and pipe below the water line is sound. Above the waterline, the black coal tar coating and mortar are sound and without significant defects visible.

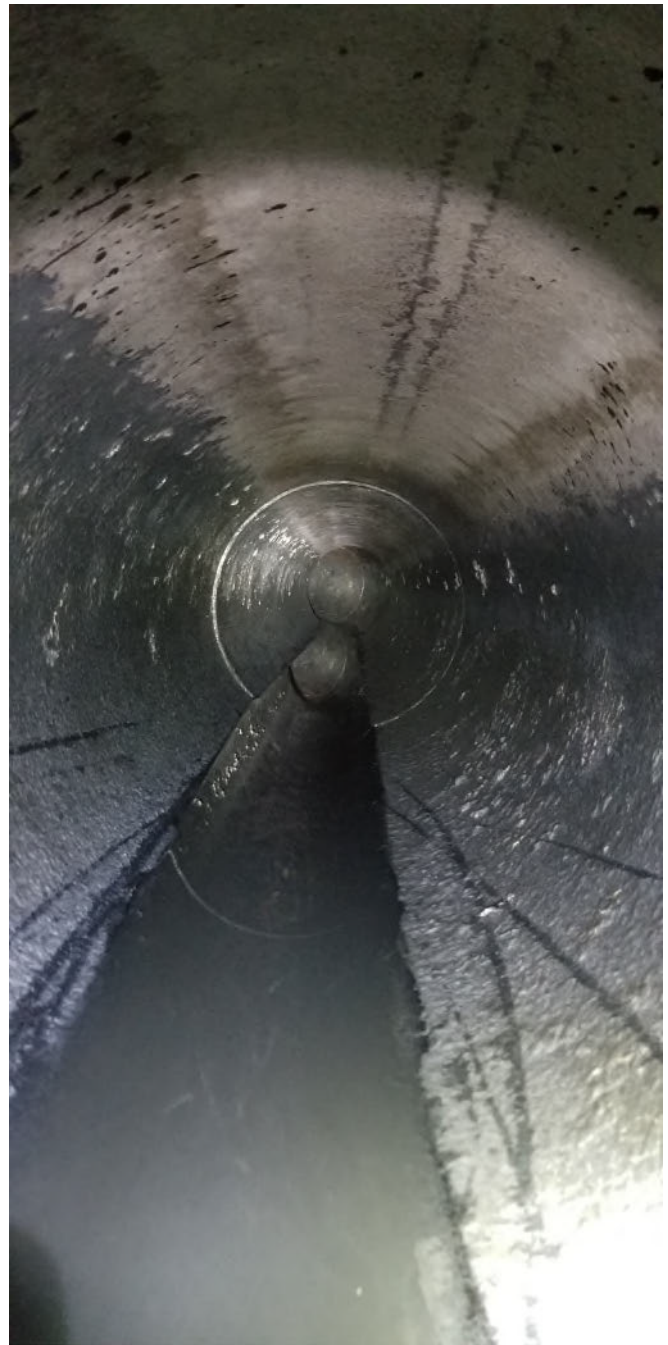
Manned entry inspection was conducted to approximately 50' upstream of AC2 to just passed the 33° fitting at Station 90+65. The coating and pipe at this location are in good shape with minimal/no degradation of the coating or the underlying pipe cement mortar coating. Hammer sounding indicates the cylinder-mortar bond is sound.

*Figure 33 - AC 2 - ARV 9 looking at 33 fitting at Station 90+65*

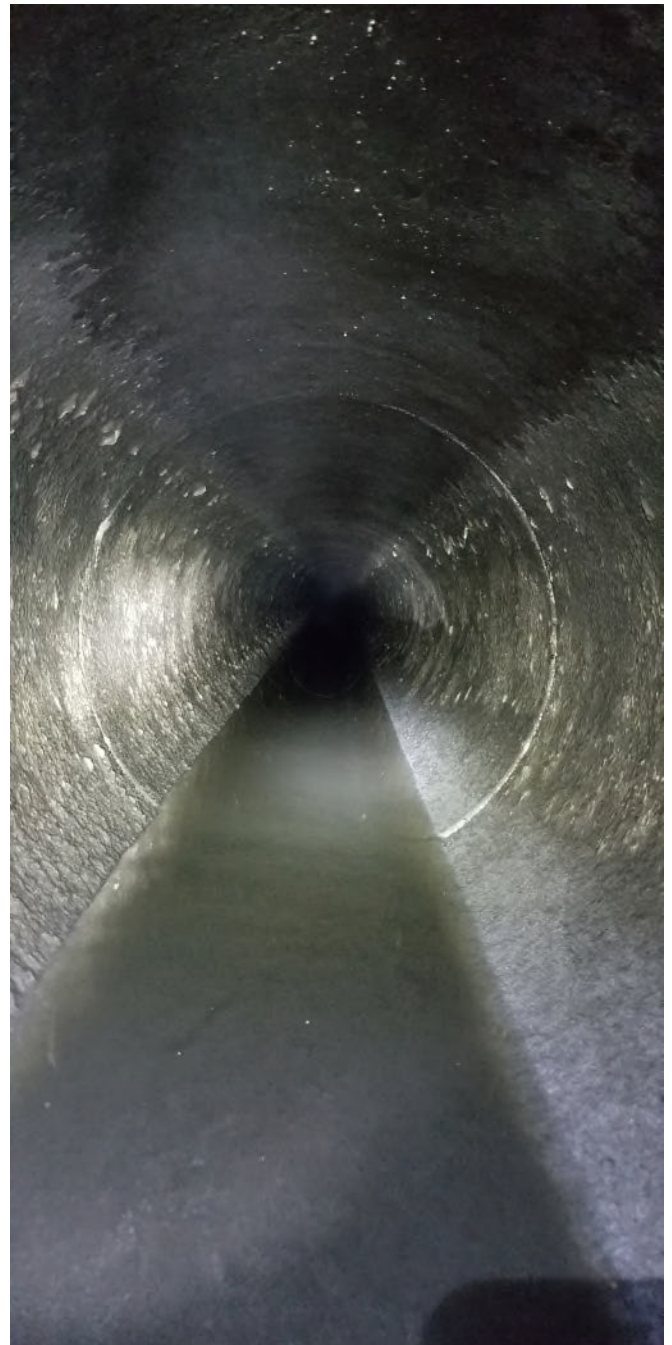
*Figure 34 - AC2 - PRV 10*

Manned entry inspection was conducted to approximately 40' downstream of AC2. The coating and pipe at this location are in good shape with minimal/no degradation of the coating or the underlying pipe cement mortar coating. Hammer sounding indicates the cylinder-mortar bond is sound.
