HDC-2022-000XX (Temporary HDC-2022-00022)

Address: 1118 W. Chew Street

HARB Meeting Date: May 02, 2022

**Project Description:**

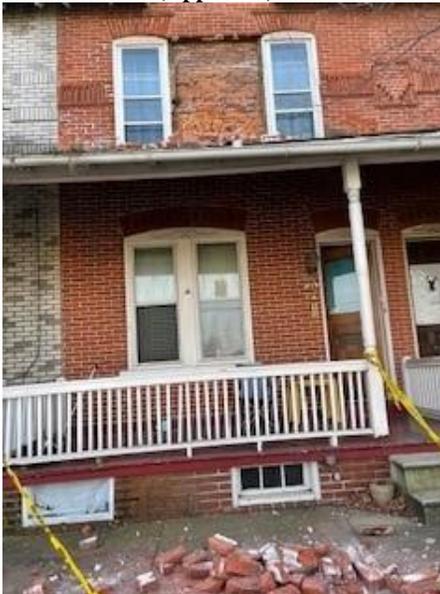
**Damaged Primary Facade  
(Applicant)**

As Provided by Applicant: Replace exterior brick facade that fell down during the winter. A temporary support of wood was placed after the brick initially fell, ok'ed by Building Standards and Safety. Replacement of exterior brick facade at front, 2<sup>nd</sup> story between 2 windows.

Restoration of the damaged area with new bricks, matching the original bricks and overall appearance, is appropriate and consistent with the Guidelines. New face brick (the exterior “layer” or wythe) should match the existing bricks in color, profile, dimension (size), texture, and physical structural properties. They should be laid in running bond to match the rest of the facade. The most appropriate restoration is to replicate the original decorative brick course between the windows (seen in the 2019 photo above). The pattern can be copied from the existing courses on either side of the windows.

The size of the mortar joints, the tooling of the joint, and type and color of the mortar should match the rest of the facade. It is important that the new mortar’s strength and permeability is compatible with the surrounding mortar and historic bricks, so that moisture will evaporate properly and avoid future damage. The Applicant is encouraged to reference pages 54-55 of the Guidelines.

1. Replacement and repointing in kind of the portion of the brick facade at the second story between the front two windows, where brick is missing.
2. The replacement brick shall replicate the decorative layout feature between the two 2<sup>nd</sup>-floor windows.
3. The cause of the deterioration shall be properly addressed in the proposed work.
4. Subsequent structural repairs shall be carried out by a licensed professional engineer.
