## APPENDIX 19

### *Park Pump Station Force Main Inspection Report*

Park Force Main Internal Inspection  
from ARVs 4, 5, and 6

December 22, 2021

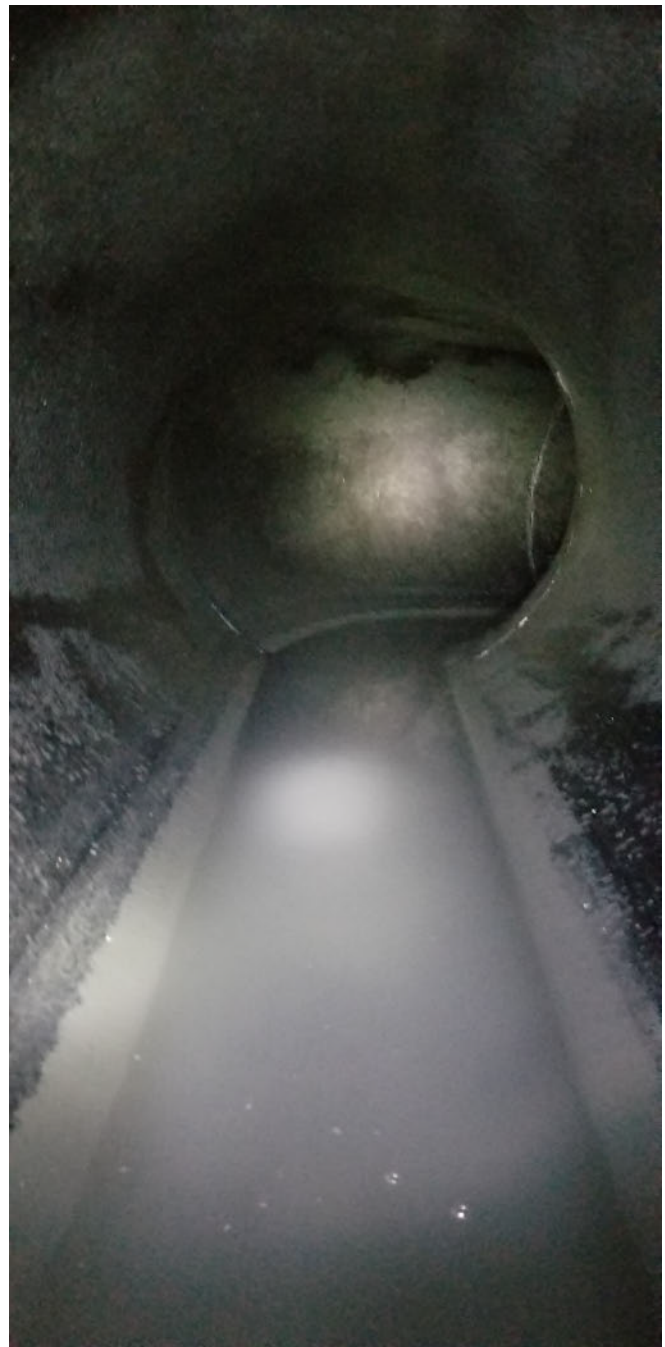
Manned entry inspection was conducted to approximately 40' upstream of ARV 4. The coating is firmly bonding to the mortar. Hammer sounding indicates the cylinder-mortar bond is still good.

*Figure 6 - ARV 4 toward ARV 5 - 10' downstream looking at bend at Station 2724*

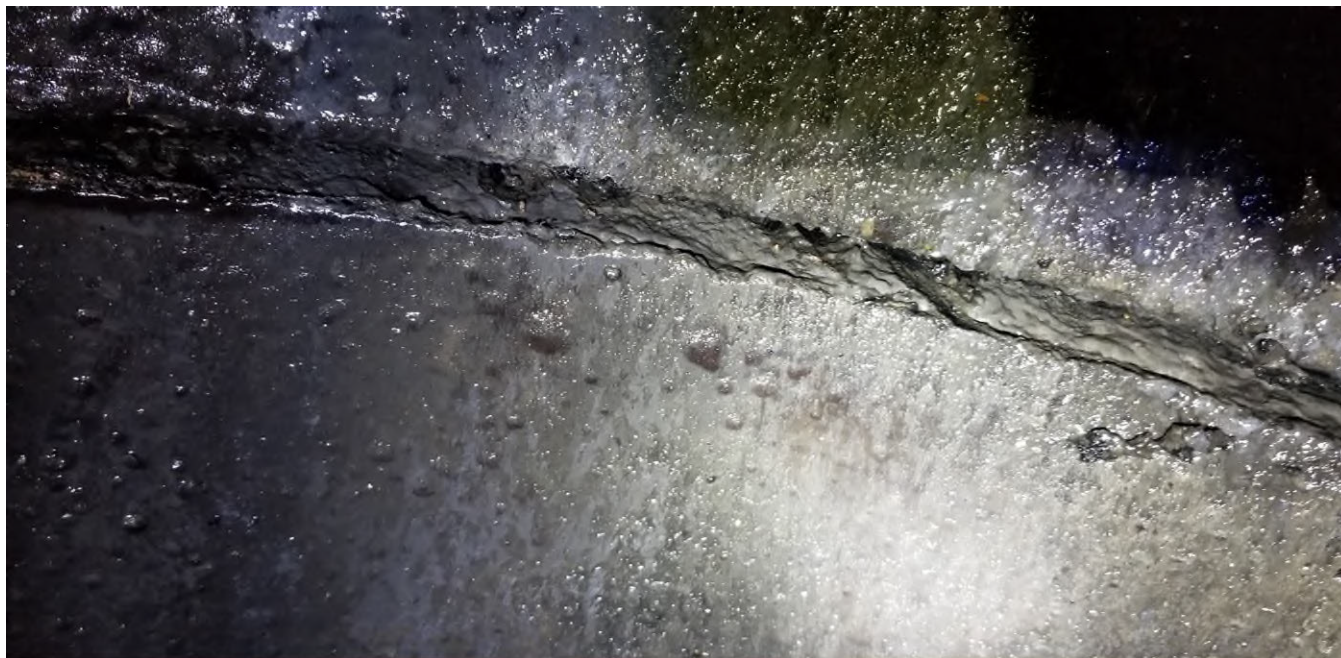
This segment has unmudded joints approximately ½" wide and 2" deep.

*Figure 7 - ARV 5 toward ARV 4 - Unmudded joint*

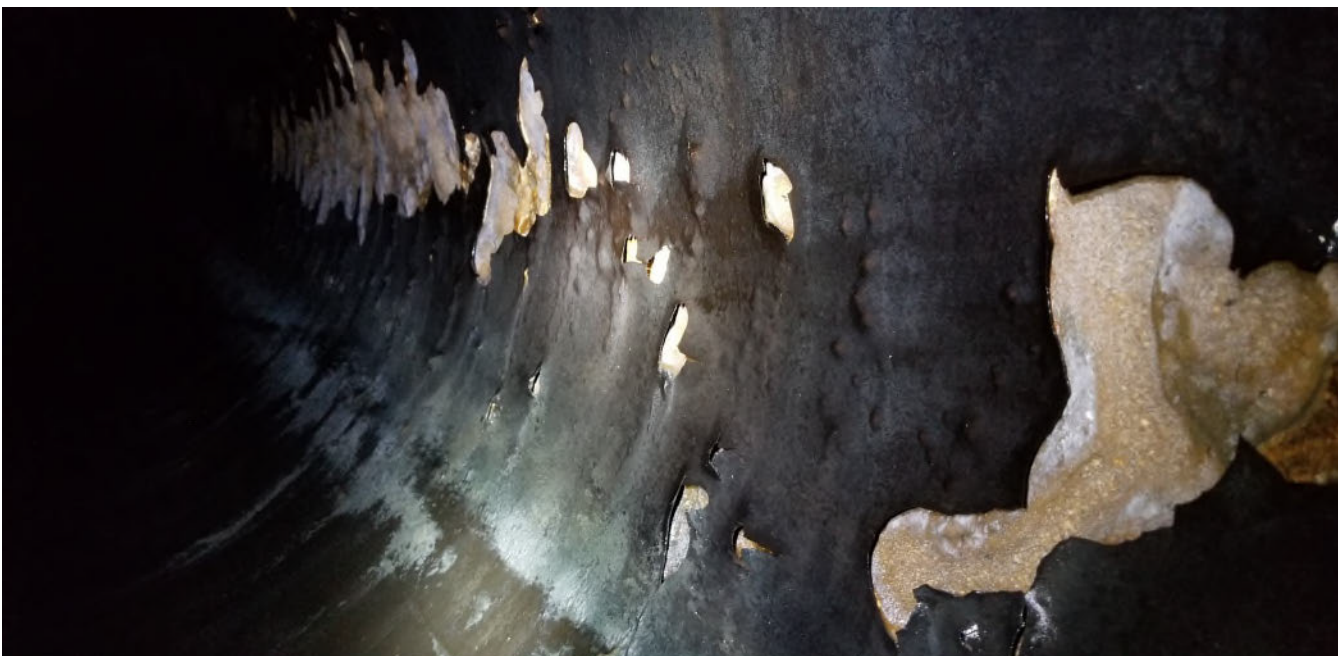
*Figure 17 - ARV 5 toward 6 - Coating disbondment along springline with 1/2" mortar loss under blisters*

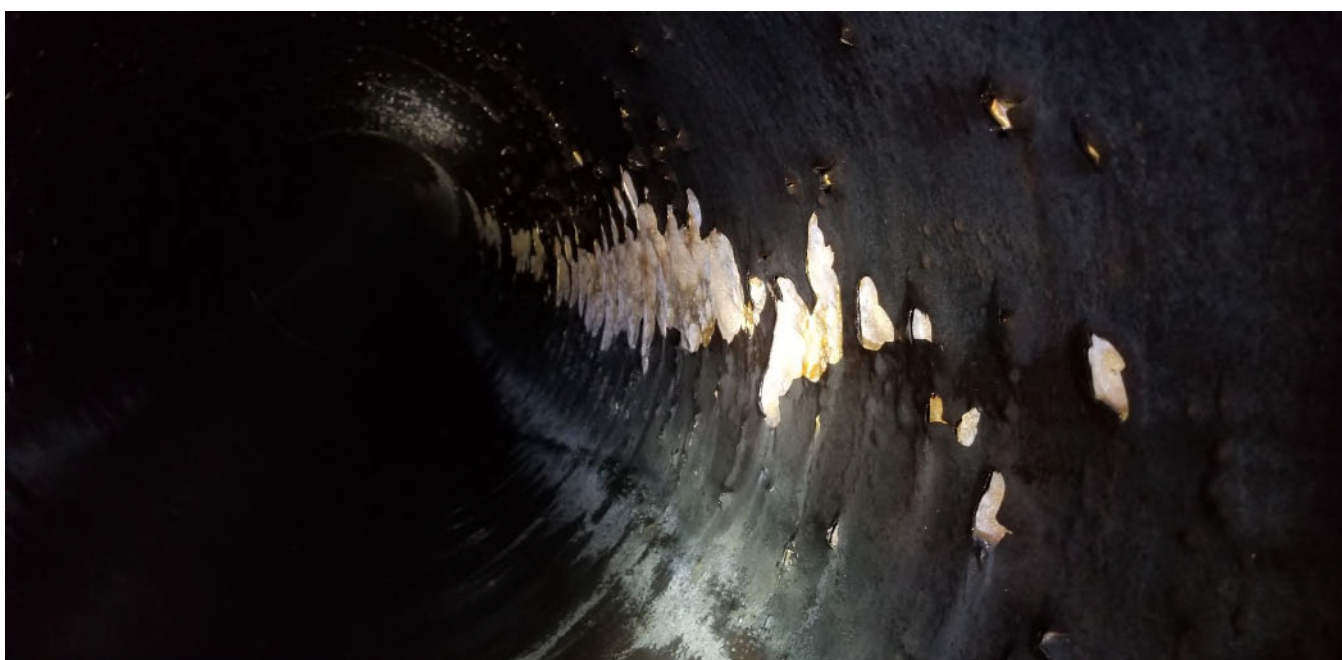
*Figure 16- ARV 5 toward 6 - Coating disbondment along springline following wire pattern*

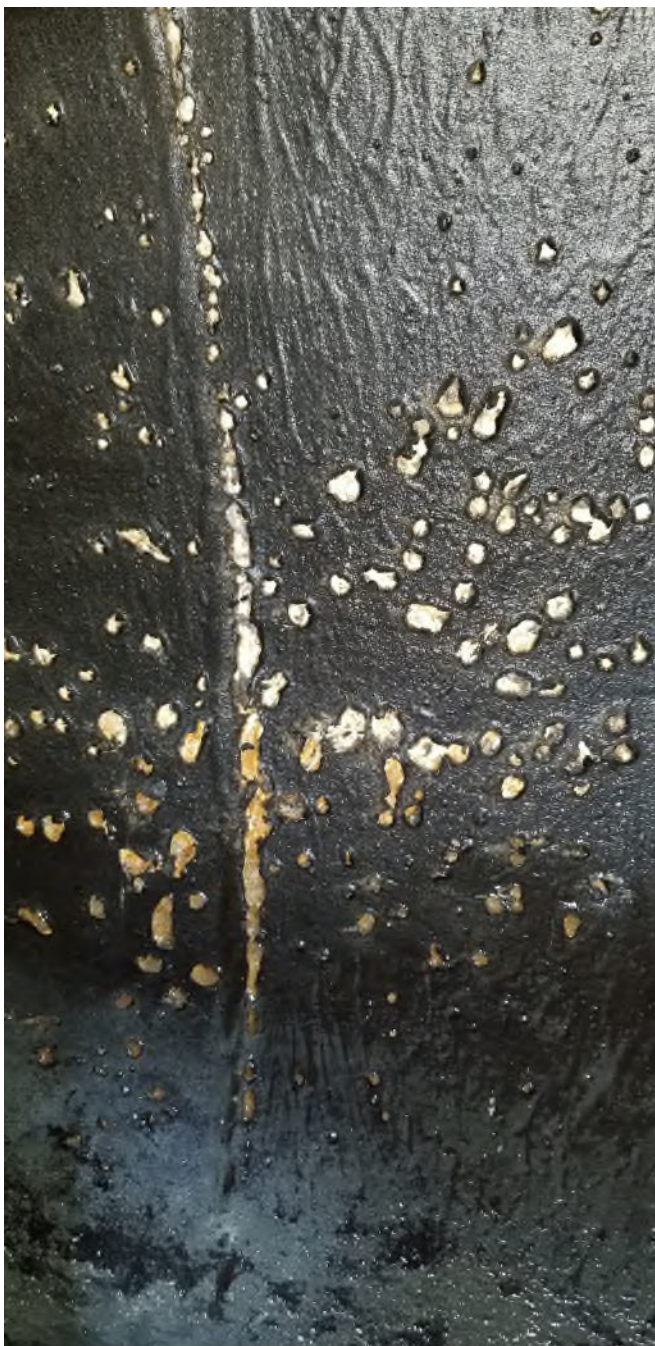
Man entry inspection was conducted to approximately 40' upstream of ARV 6. The coating is blistered and disbonding from the mortar above the pump off water line, first in bands between the 2-4 and 8-10 clock positions, then extending from 8-4 clock positions. Within the length inspected via man entry, there is  $\sim\frac{1}{4}$ " mortar loss under the blistered coating. The CCTV further upstream is hazy but blistering and H<sub>2</sub>S attack looks similar to what was seen ARV 5 toward ARV 6, though the mortar loss is measurable but less than  $\frac{1}{2}$ ". The coating is thin and brittle where it is flaking off. The H<sub>2</sub>S attack under the coating is wide-spread. Hammer sounding indicates the cylinder-mortar bond is still good .

*Figure 22 - ARV 6 toward ARV 5 - Coating Blisters and Disbondment*

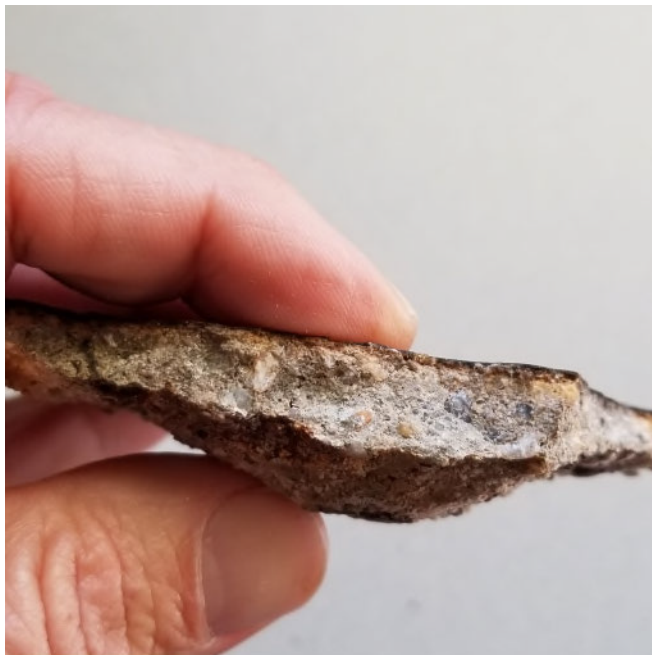
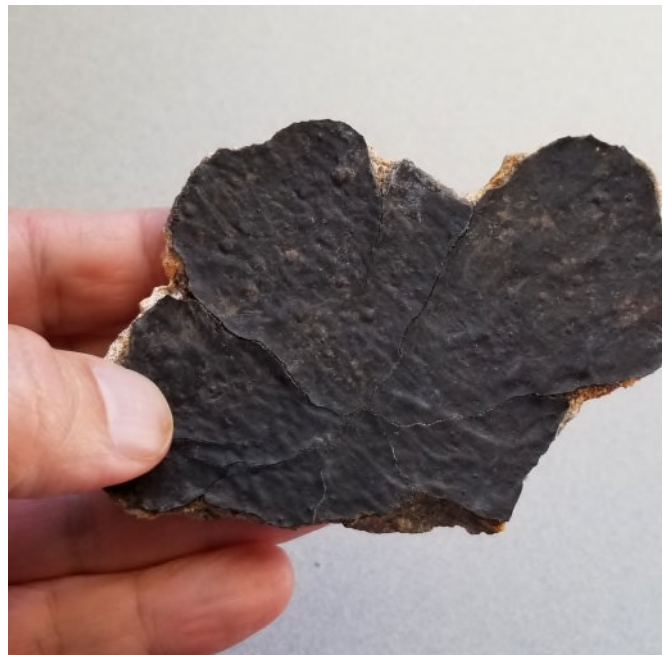
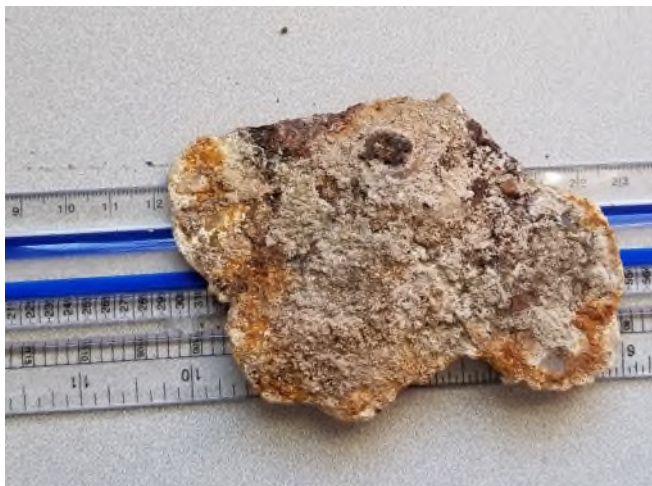
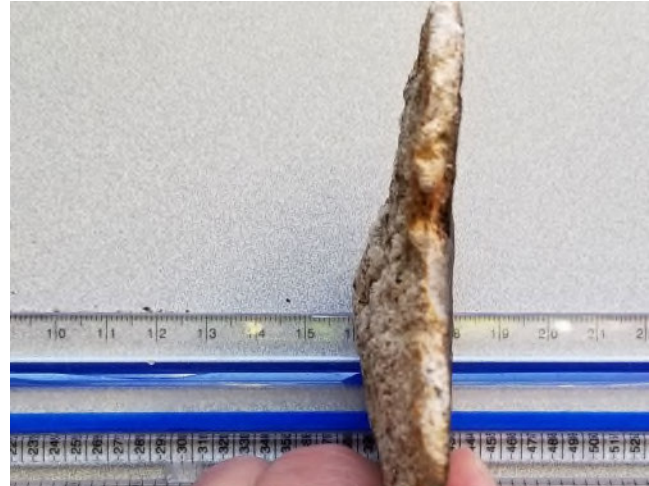
Shards of the PCCP pipe liner were found in the bottom of the pipe. These shards of mortar have the coal tar coating fully bonded but slight yellowing of the mortar on the backside of the share, indicating the shard disbonded from a combination of stress cracks and sulfide attack.

*Figure 27 - Shard of PCCP Inner Liner Mortar and Coal Tar Coating near ARV 8*

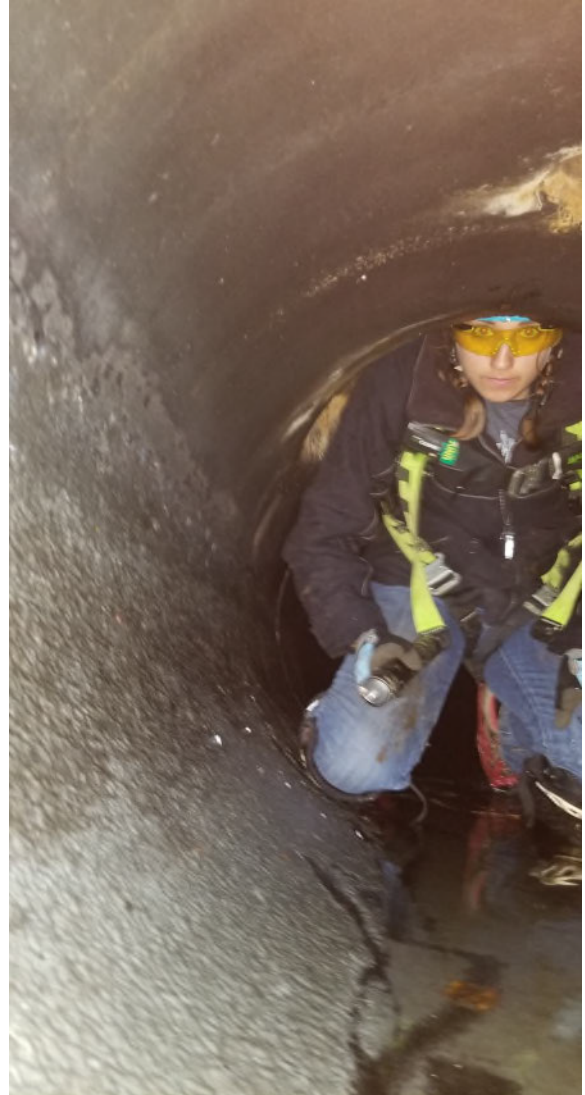
Manned entry inspection was conducted to approximately 70' upstream of ARV 9 to just passed the 50° fitting at Station 79+32. The coating and pipe at this location are in good shape with minimal/do degradation of the coating or the underlying pipe cement mortar coating. Hammer sounding indicates the cylinder-mortar bond is weakening at some places at the pipe haunch.

*Figure 29 - ARV 9 - ARV 8 Pipe Condition at ARV 9*

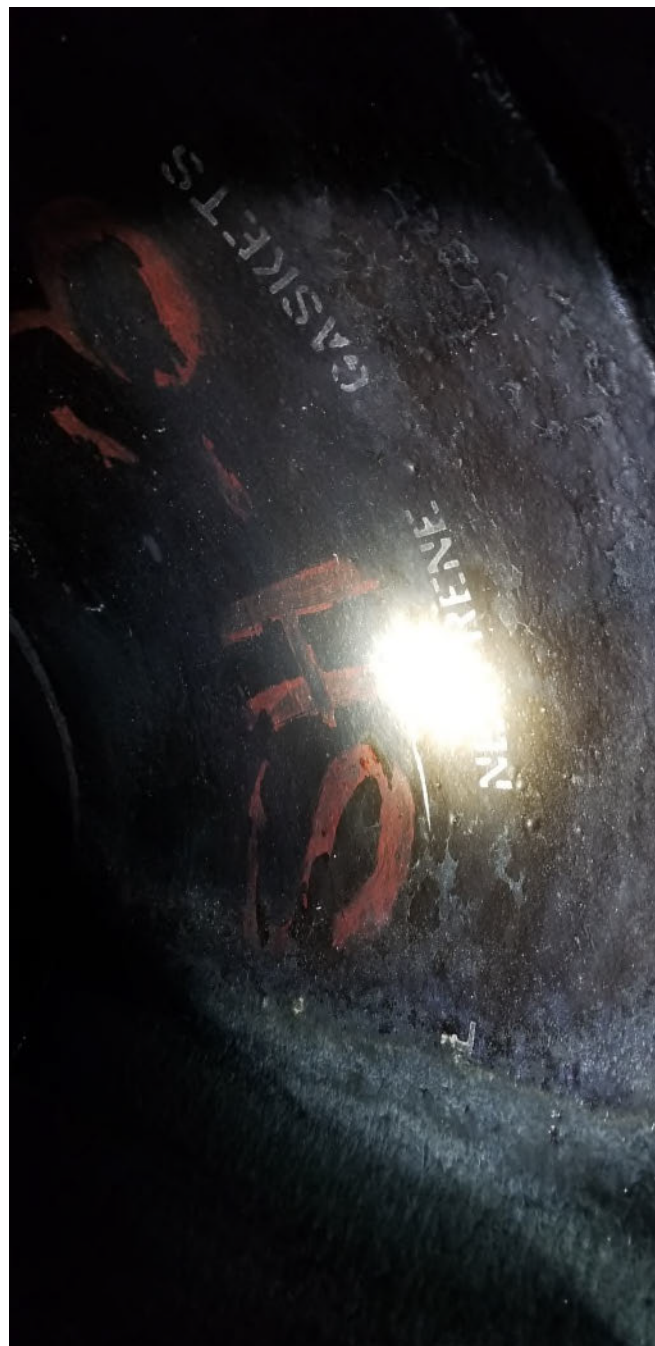
Figure 30 - ARV 9 - ARV 8 Pipe Wall
