**Historical Architectural Review Board
COA Final Review Sheet**

HDC-2022-00058

Address: 1410 W. Linden Street

Proposal: Legalize porch replacement (Violation Correction)

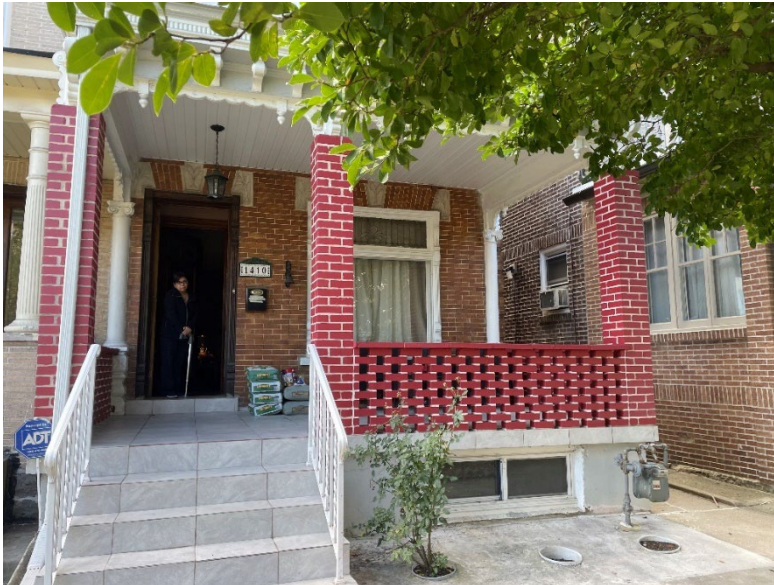
**1410 W. Linden Street after replacement.
(Applicant)**

The brick piers and railings do not replicate the historic in material composition, size, shape, profile, dimension, appearance, or finish and do not comply with Guidelines 3.7.4 or 3.7.5. Staff recommends removing the brick and replicating the historic columns, capitals, balusters, and railings. In the revised scope, the contractor proposes to install 8-inch wood columns and states that they match the dimension of the original. Staff finds the round wood columns to be an acceptable match.

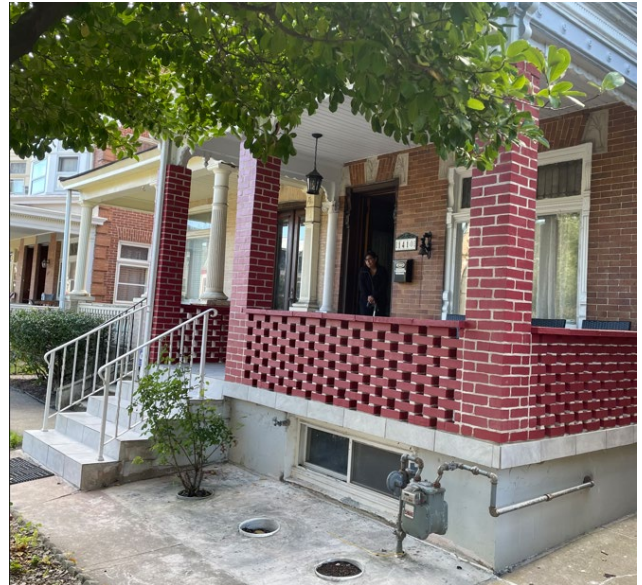
**1410 W. Linden Street porch after replacement.
(Applicant)**

While the original porch decking and steps had been removed at some point in the past and replaced with concrete, the installation of ceramic tile on the steps and floor do not comply with Guideline 3.7.8. Staff recommended removing the tile and re-exposing the painted concrete steps and floor. The contractor has agreed to reverse the installation of the tile.

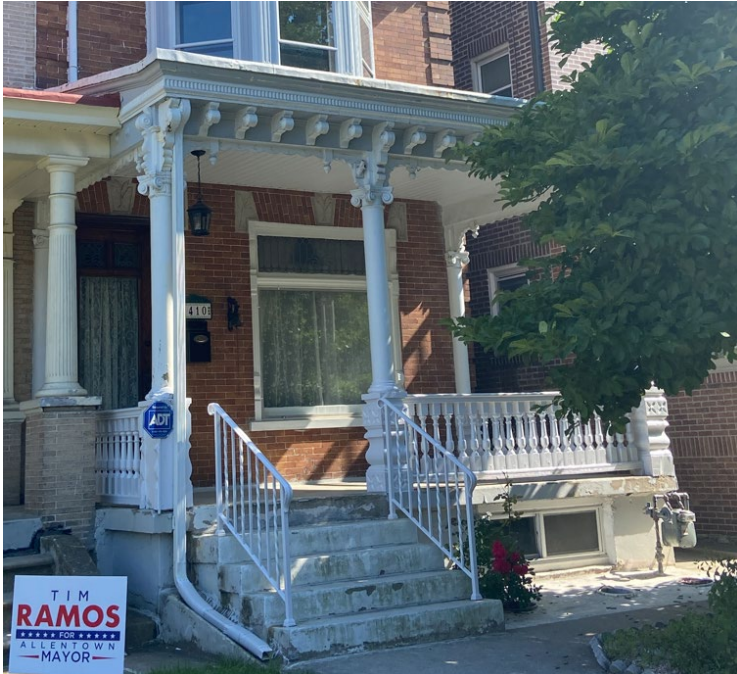
1410 W. Linden Street porch prior to replacement, 2021.
(Easton Architects)

The property at 1410 W. Linden Street has a richly detailed façade and is exemplar for its metal cresting and decorative carved wood elements. The columns, capitals, and balusters contributed greatly to the character-defining elements of the building's façade. The loss of those features has negatively impacted the building's architectural significance. The removal of the wood features and installation of brick piers and railings, as well as the addition of ceramic tile flooring, do not comply with the historic district's design guidelines. The guidelines advocate for repair and restoration and, when not possible, replacement in-kind. The staff notes that prior to replacement, no outstanding violations existed on the property, and there was no indication that the porch presented a dangerous or unsafe condition. Staff contends that the porch was in repairable condition.

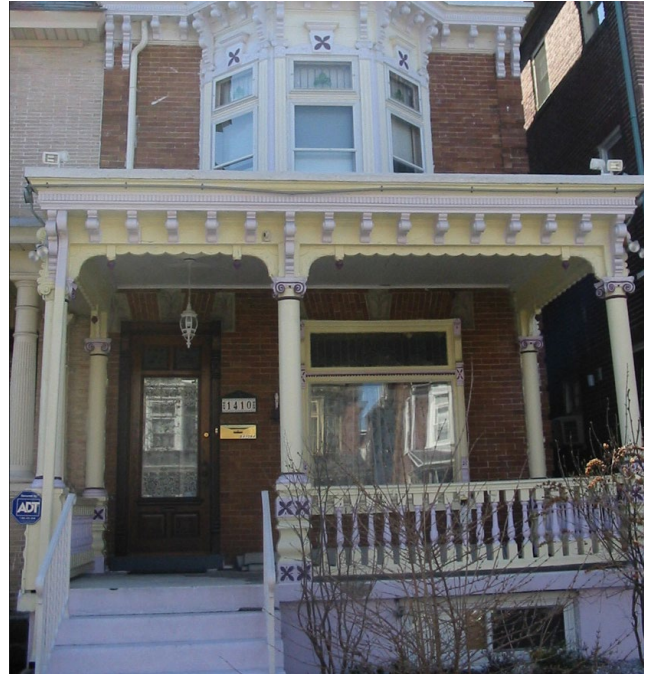
Original decorative wood porch balusters, railings, columns, and capitals, c. 2004. (HARB files)

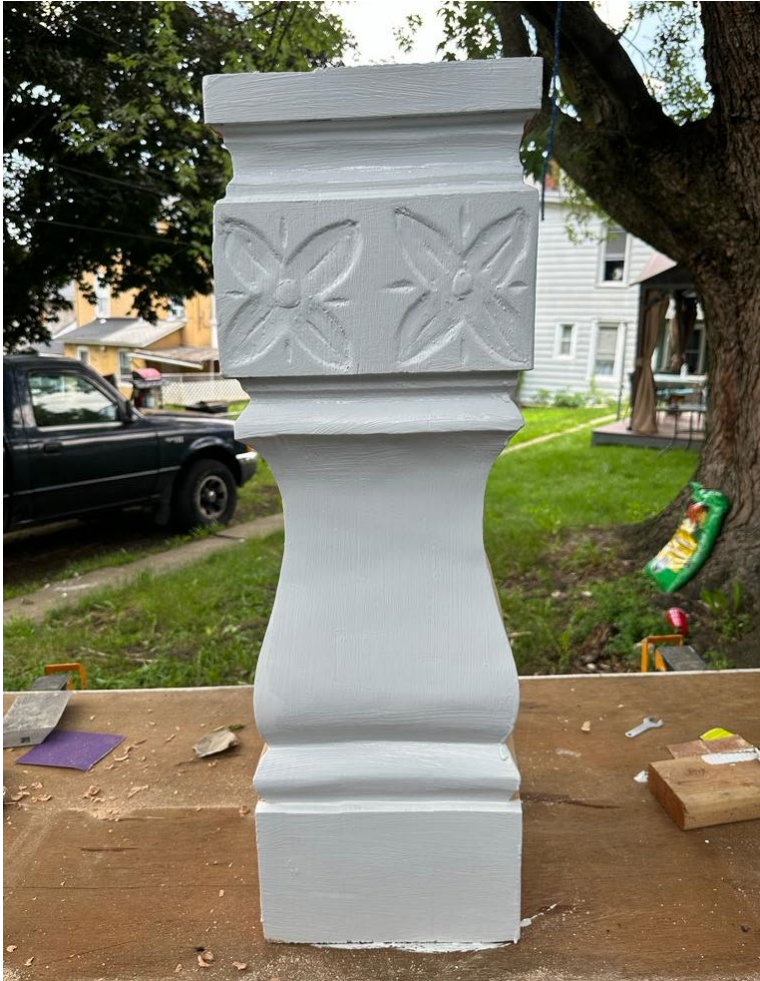
The applicant submitted a revised column base for review. The photograph of the sample base more accurately replicates the historic base in design and appearance. Staff recommends approval of the proposed base, provided the incised design is also included at the plinth. Staff notes that the HARB has requested that the applicant provide further details on the Ionic scroll at the capital, as well as balusters and railings that more closely replicate the original.

**Detail of new column base.
(Applicant)**
