**Historical Architectural Review Board
COA Preliminary Review Sheet**

HDC-2024-00053

Address: 820 Liberty Street

Proposal: Repair work at rear of house following a fire.

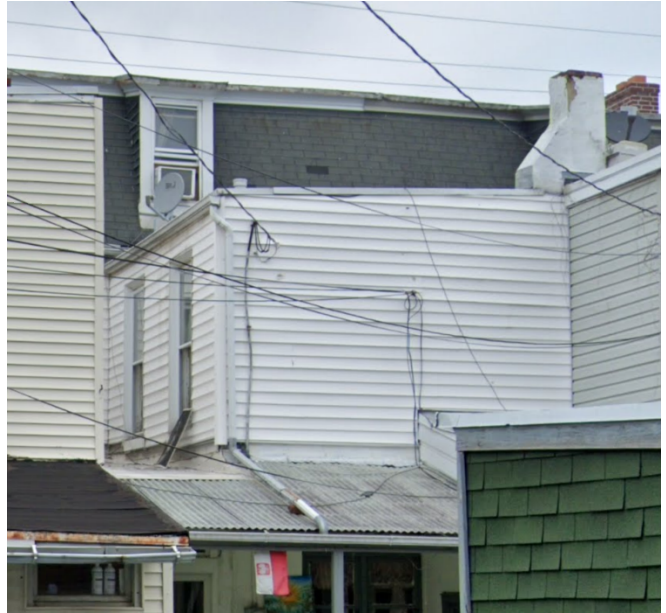
Rear of Property, 2011 (Applicant)

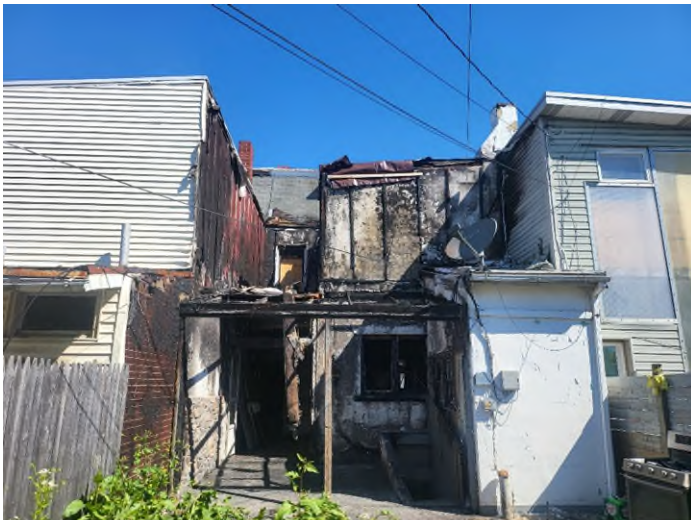
Rear of Property, 2019 (Applicant)

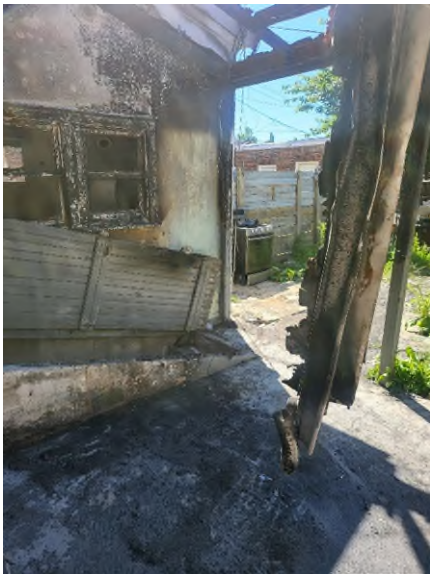
Current Condition at Rear (Applicant)

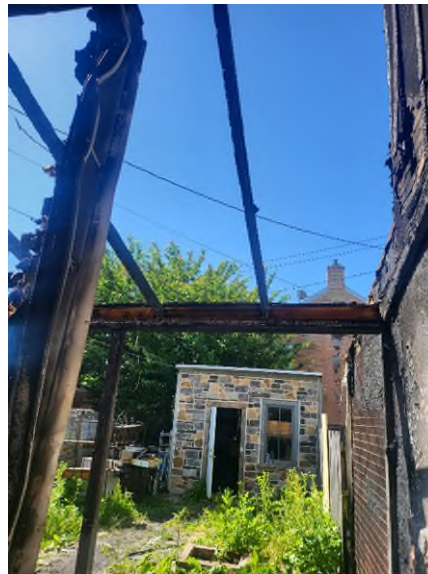
Fire Damage at Rear (Applicant)

- Conditions that all materials are replaced in kind with their condition prior to the fire.

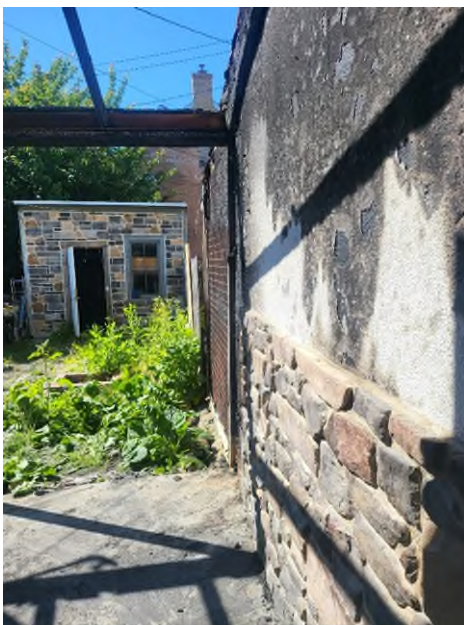
Fire Damage at Building Rear (Applicant)
