HDC-2023-00040

Address: 745-47 W. Turner Street District: Old Allentown Historic District Applicant: Cola Realty LP, owner

Proposal: Legalize removal of decorative lintels and installation of capping (violation correction)

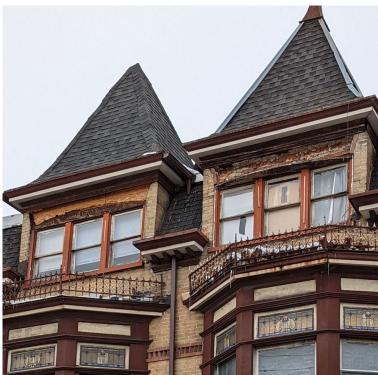
Photo showing the temporary lintel repair at 747 and the fallen brick at the lintel of 745 W. Turner Street, 2022.

The lintels were historically comprised of a decorative carved wood lintel below an arched soldier course of brick. A crown molding separated the lintel from the turret cornice. While the crown molding remains, the brick collapsed and was removed. The owner temporarily inserted plywood above the carved wood lintel at 747 W. Turner Street, and staff questions whether the wood portion of the lintel remains behind the current metal capping. At 745 W. Turner Street, the carved wood lintel appears to have collapsed with the brick, and the lintel has also been capped.

The HARB discussed Guideline 3.2.5, stating that the guideline requires replacement features to be replicated as closely as possible in material composition, size, profile, shape, pattern, and appearance. The HARB noted that the wood lintel would need to be curved and that the incised design would need to be replicated. The HARB also noted that the lintels failed at both buildings because of the arch and suggested that the mason investigate a method to properly install the brick and wood lintels to avoid a future collapse.

• The brick and wood lintels will match the historic in material composition, size, profile, shape, pattern, and appearance.

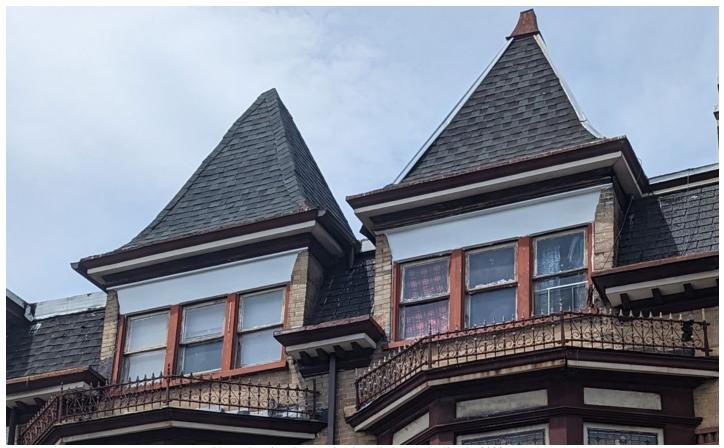
Photo showing the capping installed over the lintels, 2023. (HARB files)

The removal of the brick and wood lintels and installation of metal capping does not comply with the design guidelines. The guidelines recommend in-kind replacement and advocate against installing any type of capping, per Guideline 3.2.6.
