## CITY OF ALLENTOWN

**R71 – 2022**

**Certificates of Appropriateness for work in the Historic Districts: Certificates of Appropriateness for work in the Historic Districts: 1553 W. Turner Street, 347 N. 9th Street, 210 N. Howard Street, 619 Gordon Street, 334 N. 9th Street, 1444 Linden Street and 323 N. 9th Street**

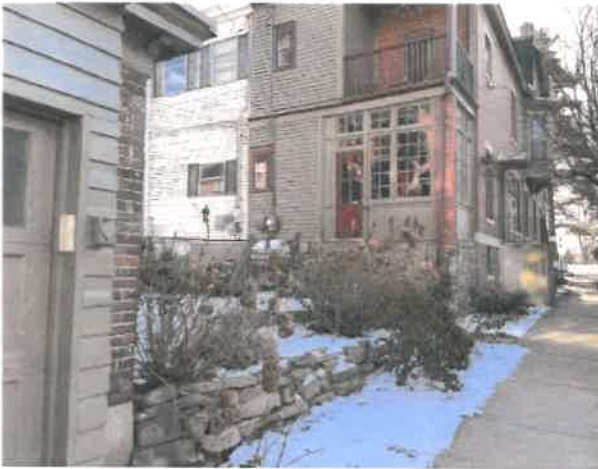
**Rear facade, rear yard, and detached garage as seen from N. 16<sup>th</sup> Street toward W. Turner Street. (Applicant)**

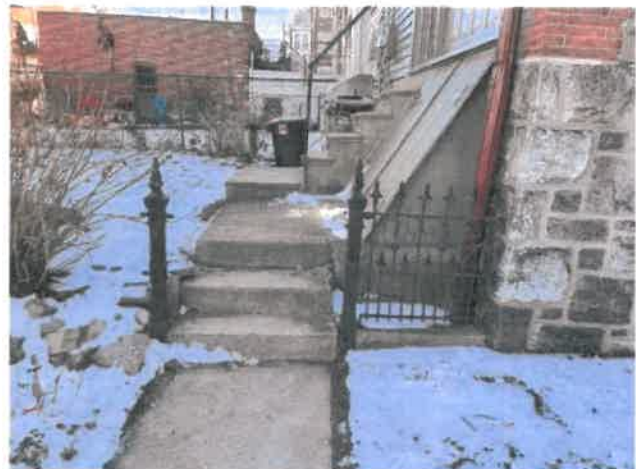
**Existing concrete steps and walkway in area of proposed work. (Applicant)**

The proposed work is consistent with the Guidelines. The addition is proposed for the rear of the building, which is appropriate although it will be visible along N. 16<sup>th</sup> Street because the property is a corner lot. The addition of a rear deck does not appear to significantly impact the visibility of the rear facade or overall architectural character. The concrete stairs and walkway, and angled basement doors (Bilco door), are not considered character-defining features of the historic building. The existing iron railing and posts appear to be original and should be salvaged for reuse.

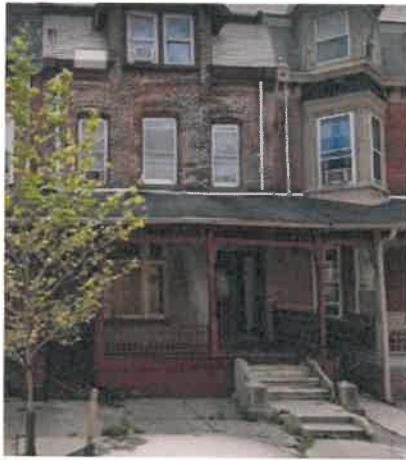
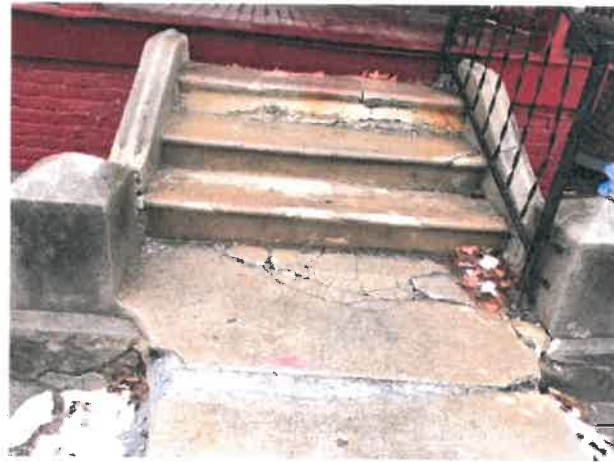
As received from Applicant. Remove damaged concrete stairs and replace with new concrete stairs of same size.

The proposed replacement steps do not meet the Guidelines as an appropriate replacement. The proposed design is a single-run stair with no side walls. This design does not resemble the existing stair, which has two runs and an intermediate landing, side walls, end posts, and bullnose treads. An appropriate replacement should match the existing feature as closely as possible. The use of concrete is appropriate as an in-kind replacement material. It is recommended that the applicant clarify if new handrails are part of this scope of work.

HARB chair Dave Huber made a motion to approve with conditions, the application presented on 04/04/2022 for replacement of concrete stairs at 334 N. 9<sup>th</sup> Street with the following conditions agreed to by the applicant: including retain the sidewalls and rebuild stairs between, or rebuild sidewalls to replicate the existing in dimension and profile. replacement stairs to have bullnose edge detail to match existing and remove lower stair and landing extension and install new square stock baluster handrail to meet code.

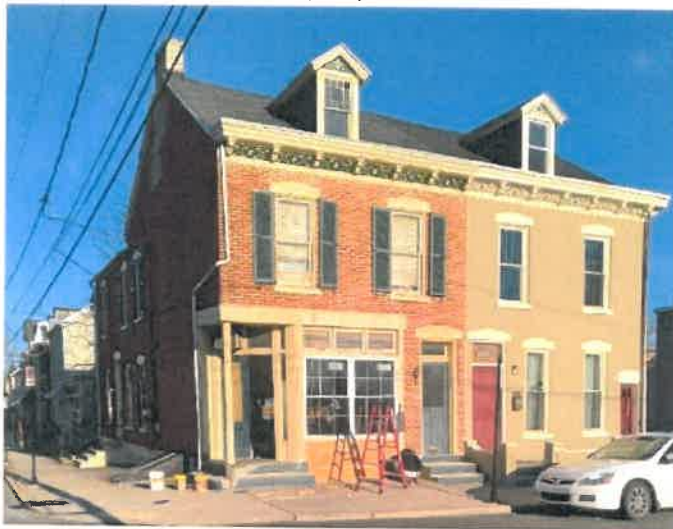
- Removed wood-framed display windows and replaced with vinyl-framed windows.
- Altered the bulkhead beneath the display windows

**Existing primary facade  
(Staff)**

The replacement windows do not meet the Guidelines. They do not match the original configuration, proportion, or material of the original display windows, and they alter the overall proportions of the storefront. The 6/6 sash windows are not an appropriate replacement for the 3-lite fixed windows. Vinyl is also not an appropriate material. The Applicant should clarify if wood was used for the bulkhead below the windows, since the original bulkhead was wood.

The proposed replacement doors do not meet the Guidelines. Repair and reuse of the existing original doors is the most appropriate treatment. In-kind replacement is the next appropriate treatment if repair is not possible, with new wood doors that match the existing original doors. Materials other than wood can be appropriate but replacement doors should match

HARB members recommend replacing the vinyl windows with wood sash and existing glass to replicate the original design, proportion and configuration and to repair and reuse the existing wood door.

HARB member Glenn Lichtenwalner made a motion to approve with conditions the application dated 04/04/2022 for 347 N. 10<sup>th</sup> Street with the following conditions agreed to by the applicant: reinstall window glazing and provide in-kind replacement of wood sash to match existing profile and dimension and repair and reinstall existing wood door; and finds the application to be in compliance with Chapter 3, Sections 3.5.7-3.5.9, 3.6.5, 3.6.6, 3.6.8, 3.6.9, 3.13.2 and 3.13.4 of the Historic District Design Guidelines and find that there are not circumstances unique to the property.

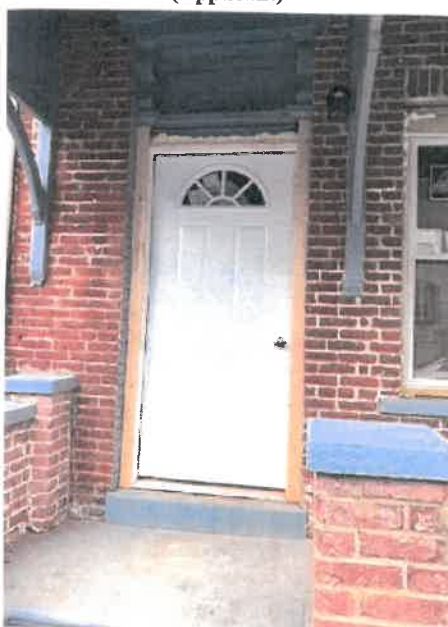
**Front door after alteration  
(Applicant)**

The replacement door and windows are not consistent with the Guidelines. Photos submitted by Applicant indicate that the original door, window, and window transom were salvaged. Repair and reuse of the original features is the most appropriate treatment. Restoration of the original size of the openings is also recommended. If repair and reuse is not possible, replacement in-kind to match the original features is the next appropriate treatment.

HARB members stated in order to move forward the existing door is recommended for repair and reuse and the windows need to be reused if possible and replicated to match the existing.

HARB member Glenn Lichtenwalner made a motion to approve with conditions the application dated 04/04/2022 for front door and window replacement be reversed to be in-kind repair and reuse of existing windows and door at *619 W. Gordon Street* with the following conditions agreed to by the applicant: that they remove the newly installed door and window and restore the original opening and reinstall the original door with matching trim and restore the original opening and reinstall the original window and install trim to match the original in kind; and finds noncompliance with Chapter 3 of the Historic District Design Guidelines: and find that there are circumstances unique to the property: unique features allowing decision include the original window and door can be reused.

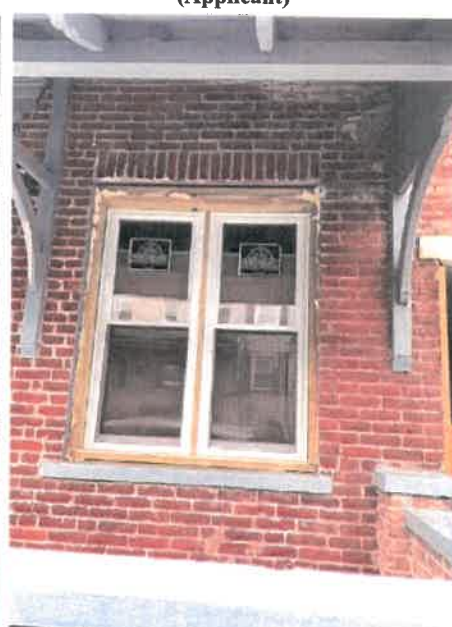
**First floor window after alteration  
(Applicant)**

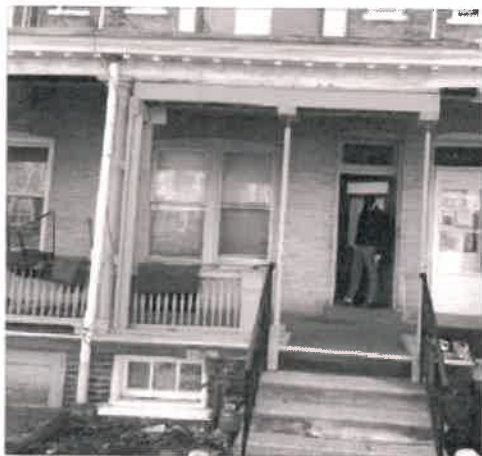
As Provided by Applicant: Change/repair porch columns, which involves replacing/repairing the header beam. Fix/repair porch wall (by the steps).

**Current Porch Condition  
(Applicant)**

The proposed repair and replication of historic porch elements in wood is appropriate. The proposed tapered wood columns are appropriate with new capitals and bases matching the existing historic elements in size, shape, profile, and materials. The use of FRP columns instead of wood is not recommended.

The header repair appears appropriate and should match the existing historic components in appearance, profile, dimension, and finish. The new structural header replacement and exterior finished with new painted wood trim boards to match existing historic fascia is appropriate. It is appropriate to leave the existing wood brackets (corbels) and molding intact. All wood elements should be painted to match existing historic trim.

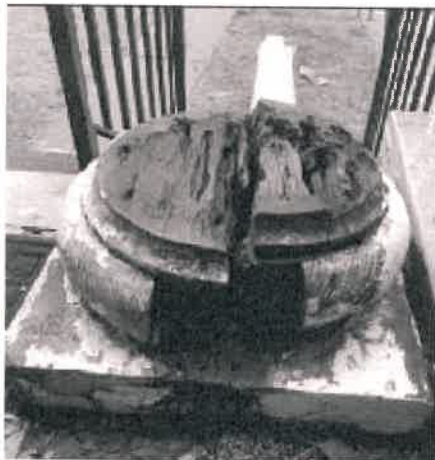
**Existing Column Base Condition  
(Applicant)**

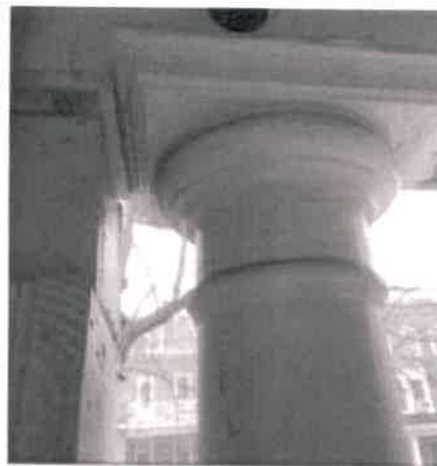
**Existing Column Capital  
(Applicant)**
