HDC-2022-00066**Address: 933 W. Pine Street****District: Old Allentown Historic District****Applicant: ANEP Investments LLC, Owner****Proposal: Legalize siding and vinyl windows; install garage door (Violation Correction)****Building Description:**

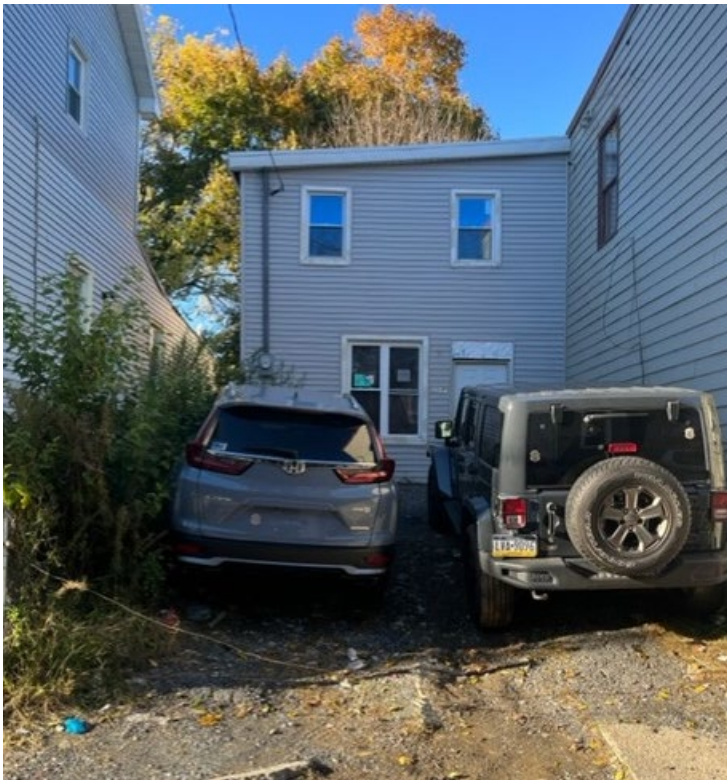
933 W. Pine Street after exterior alterations.
(Applicant)

Staff questions whether the historic wood siding remains under the vinyl siding. The new cladding does not match the historic in material composition, size, profile, shape, pattern, or appearance and is not appropriate and does not comply

with Guidelines 3.2.5 and 3.2.6. The building historically had flush vertical boards. Staff recommends removing the vinyl siding and either exposing the original siding (if present) or installing new wood siding to match the historic.

Similarly, staff finds the second-story vinyl windows to be inappropriate in material composition, size, profile, appearance, and configuration. While the historic windows no longer remain, the age and function of the building suggest that the windows were likely wood six-over-six double-hung sash windows. Appropriate replacement windows should comply with Guideline 3.5.9. The photo prior to the exterior alterations shows that the windows did not have exterior trim, but did have a thin wood sill that should be replicated. The new vinyl windows do not comply with Guidelines 3.2.6 or 3.5.9.

Denial of the legalization of the vinyl windows and siding, pursuant to Chapter 3, Section 3.2 Wood Siding & Trim and Section 3.5 Windows. Approval of the removal of the first-story infill and installation of a new garage door, provided the following:

- the infill is carefully removed so as not to damage the historic framing;
- new wood trim is installed to match the historic trim; and
- the new door is wood and is either paneled or contains a crossbuck design.

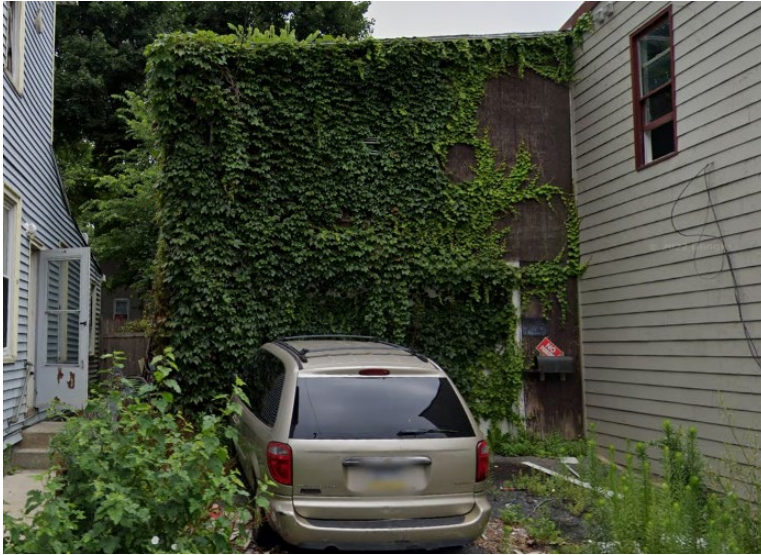
933 W. Pine Street prior to exterior alterations, 2019. (Google StreetView)

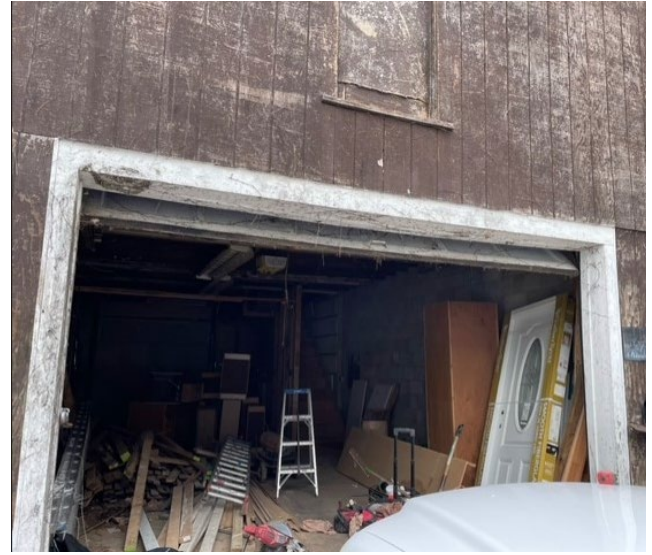
933 W. Pine Street prior to exterior alterations, undated. (Applicant)
