CITY OF ALLENTOWN

RESOLUTION

R188 – 2022

Certificates of Appropriateness for work in the Historic Districts:

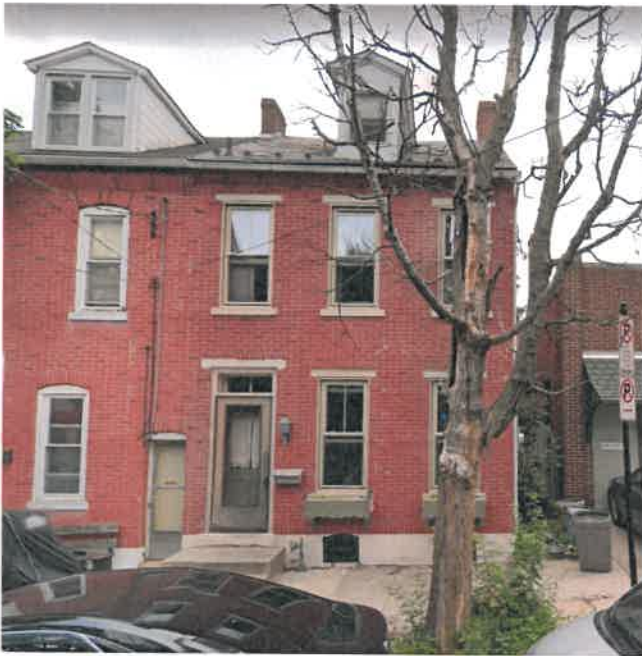
Existing slate roof at 433 N. 11th Street, 2019.
(Google StreetView)

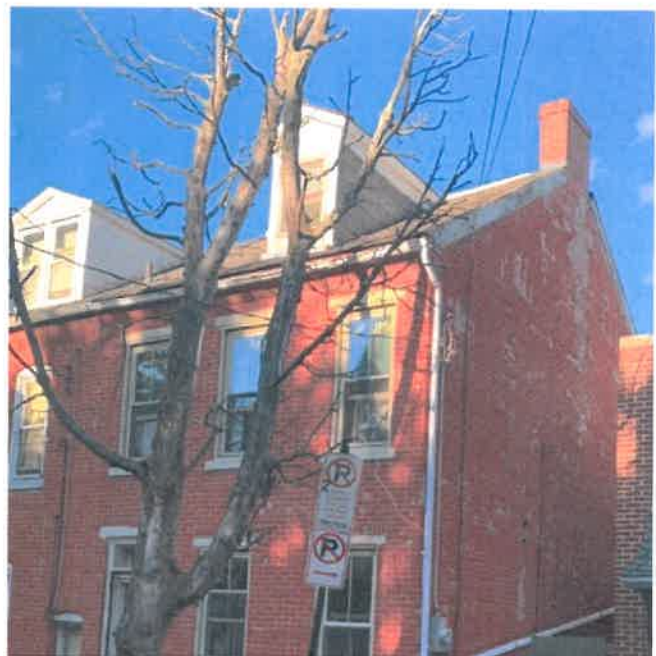
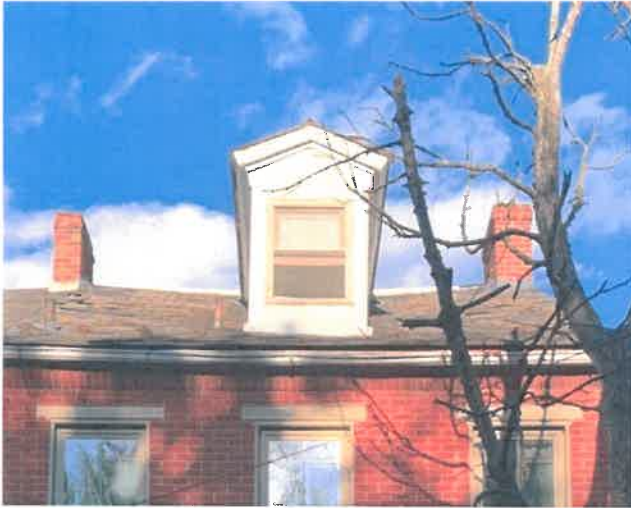
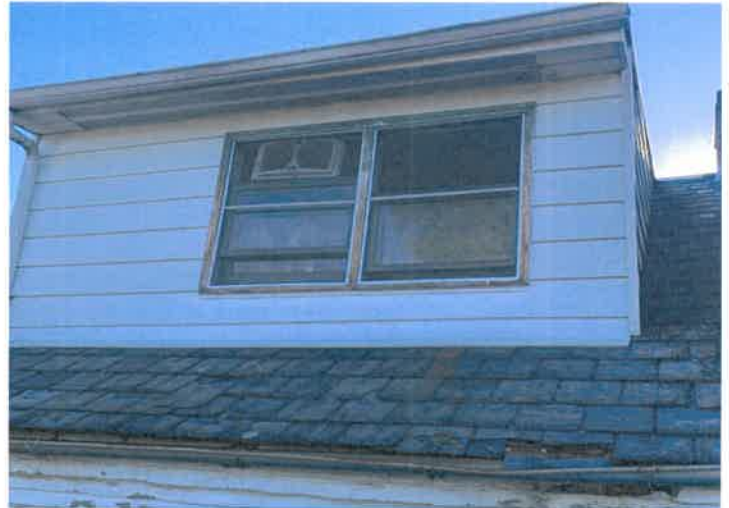
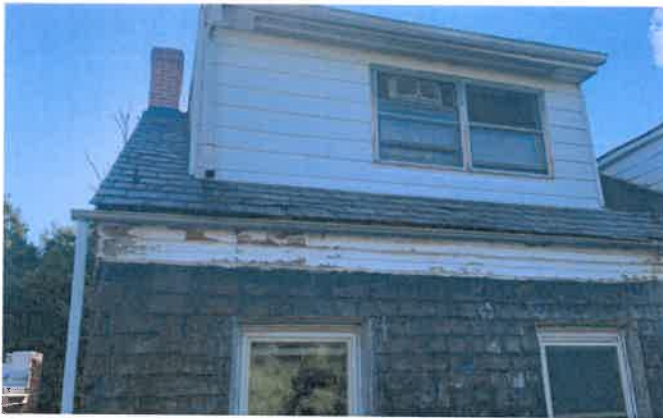
Existing slate roof at 433 N. 11th Street.
(Applicant)

Existing rear slate roof at 433 N. 11th Street.
(Applicant)

The applicant contends that the existing slate requires replacement because the slate is highly deteriorated. Staff notes that the condition photos show that several areas of slate are broken, missing, and displaced and the condition of the roof is generally poor. The applicant is proposing to install a dimensional asphalt shingle with exaggerated tapering that would differ in shape and color from the existing slate. The proposed shingles do not comply with Guideline 3.1.6. Staff recommends using a shingle that more closely replicates the existing slate in dimension, shape, profile, color, exposure, and overall appearance, such as GAF Slateline or a synthetic slate.

Approval, pursuant to Chapter 3, Section 3.1 Roofs, provided that the new roofing material matches the historic slate in dimension, shape, profile, color, exposure, and overall appearance.

HARB Vice Chair AJ Jordan moved to approve w/conditions the application presented on *11/7/2022* for the roofing replacement at *433 N. 11th Street* with the following conditions agreed to by the applicant: the slate replacement material be of a type/manufacture previously approved by the HARB and must be submitted for staff review and approval in a color that replicates the original as closely as possible, and finds compliance with the following sections of the Guidelines for Historic Districts: Chapter 3, Section 3.1 Roofs, and finds that there are not circumstances unique to the property. HARB member Phillip Hart seconded the motion, which passed unanimously.

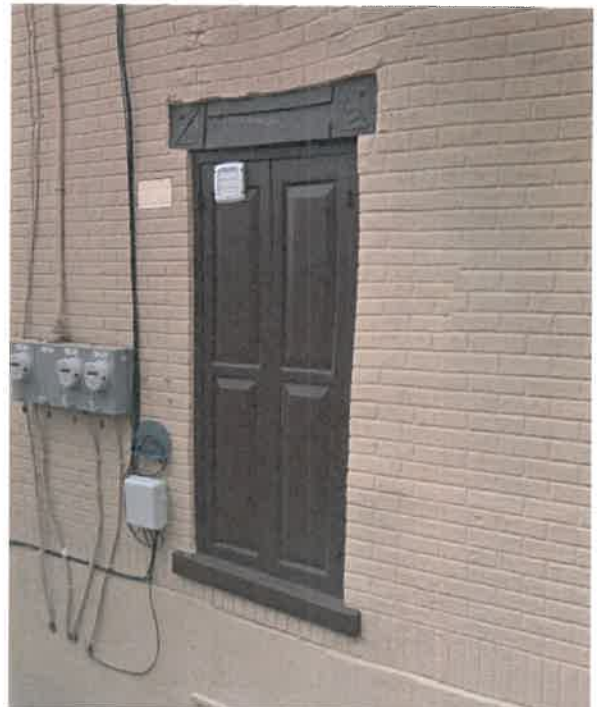
First-story window on Refwal Street façade prior to being infilled. (Google StreetView)

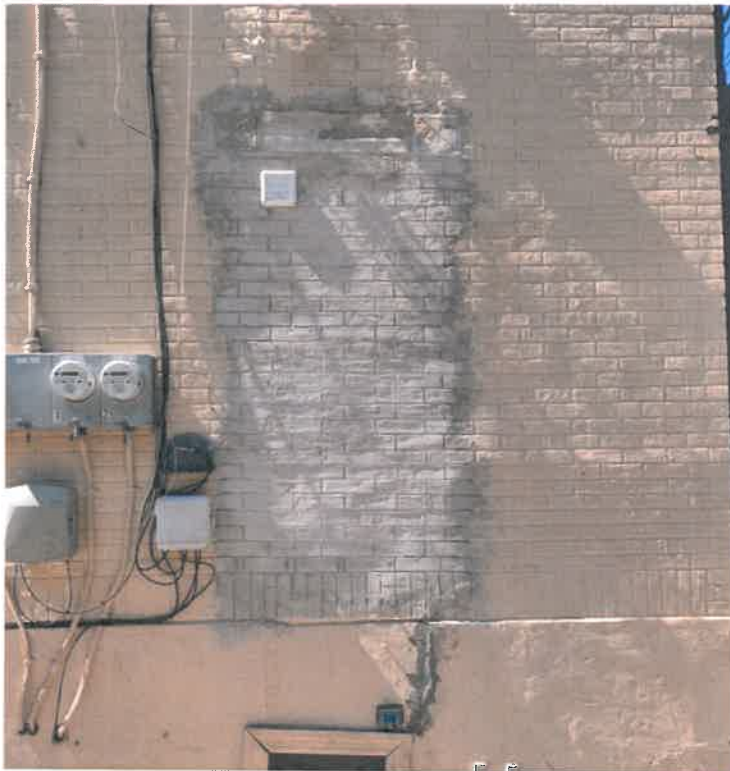
Refwal Street window after being infilled.
(Applicant)

The staff finds that eliminating the opening as proposed does not meet the Design Guidelines, because it alters the ratio of window openings to solid wall surfaces (3.5.10) and disrupts the rhythm of openings on the façade (3.5.11). Removing the wood sill and coating the decorative wood lintel does not meet Guideline 3.5.1, because it alters original window components. The submitted documentation of the work does not show that adequate waterproofing was installed around the opening or infill materials. This indicates a risk that moisture will be trapped in the masonry wall and cause future deterioration. The staff recommends that the new infill be removed, the opening be properly waterproofed, and that the window be infilled in a more appropriate manner by reinstalling the wood sill, removing the coating from the lintel, reinstating the reveal in the brick, and reinstalling a wood frame with shutters in a fixed closed position.

HARB member Glenn Lichtenwalner moved to approve w/conditions, the application presented on 11/7/2022 for the legalization of the infilling of the Refwal Street opening to correct a violation at 814 W. Liberty Street with the following conditions: infill the full opening left from the removal of the non-original window, sill and lintel with materials to replicate the existing brick and brickote, agreed to by the applicant, and finds compliance with the following sections of the Guidelines for Historic Districts: Chapter 3, Section 3.5 Windows, and finds that there are circumstances unique to the property: this is not an original window, it is a c. 1994 replacement window and the leaking condition surrounding this window was causing irreparable damage to the existing and adjacent historic masonry fabric. HARB Vice Chair AJ Jordan seconded the motion, which passed unanimously.

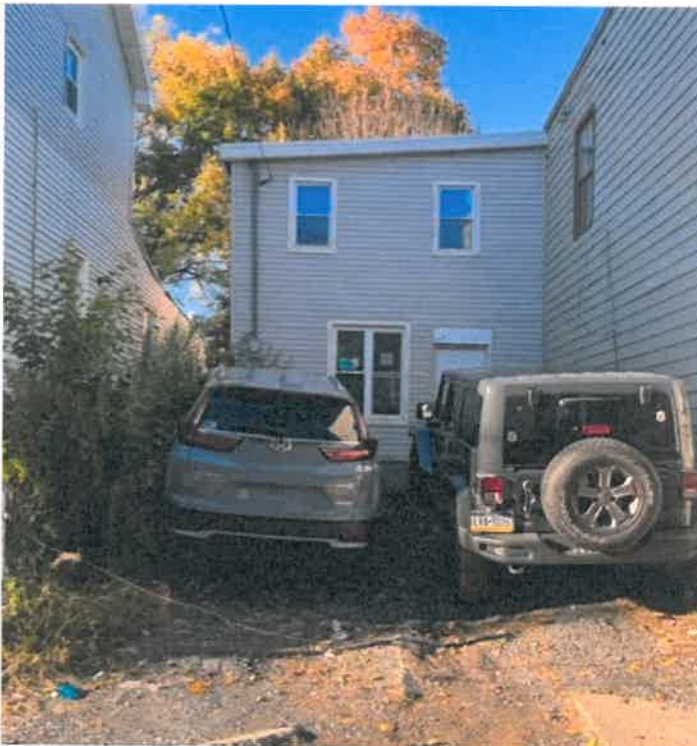
**933 W. Pine Street after exterior alterations.
(Applicant)**

with Guidelines 3.2.5 and 3.2.6. The building historically had flush vertical boards. Staff recommends removing the vinyl siding and either exposing the original siding (if present) or installing new wood siding to match the historic.

Similarly, staff finds the second-story vinyl windows to be inappropriate in material composition, size, profile, appearance, and configuration. While the historic windows no longer remain, the age and function of the building suggest that the windows were likely wood six-over-six double-hung sash windows. Appropriate replacement windows should comply with Guideline 3.5.9. The photo prior to the exterior alterations shows that the windows did not have exterior trim, but did have a thin wood sill that should be replicated. The new vinyl windows do not comply with Guidelines 3.2.6 or 3.5.9.

- the infill is carefully removed so as not to damage the historic framing;
- new wood trim is installed to match the historic trim; and
- the new door is wood and is either paneled or contains a crossbuck design.

HARB Vice Chair AJ Jordan moved to approve the application presented on 11/7/2022 for the legalization of vinyl windows and siding and installation of a garage door to correct a violation at 933 W. Pine Street as submitted and find compliance with the following sections of the Guidelines for Historic Districts: Chapter 4, Additions to Existing Buildings, Section 4.1.4 finds that there are many unique circumstances to this property including a lack of historic context for the selection of alternative siding materials as well as the lack of historic context for this unique structure as it was built originally to be unique to the neighborhood street wall and context. HARB member Glenn Lichtenwalner seconded the motion, which passed 4-1, HARB Chair Dave Huber dissented.

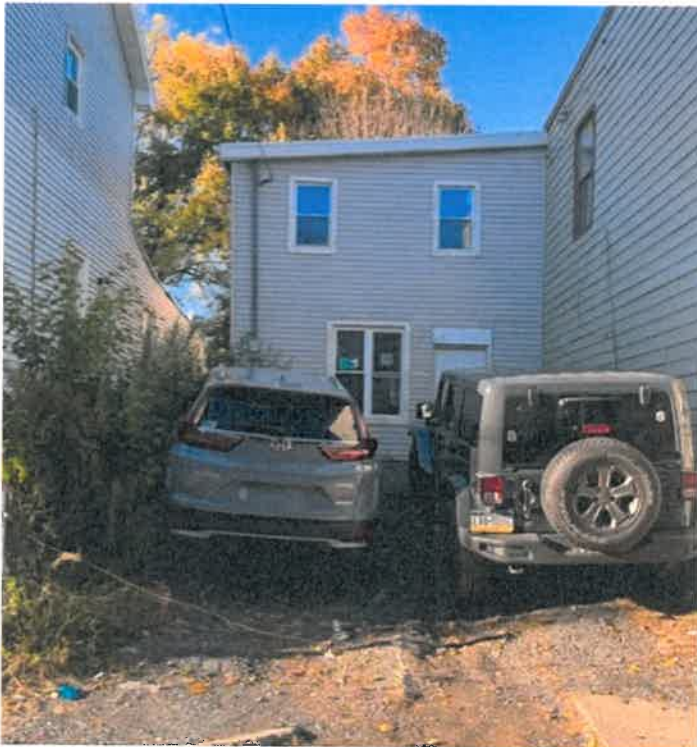
**933 W. Pine Street after exterior alterations.
(Applicant)**

with Guidelines 3.2.5 and 3.2.6. The building historically had flush vertical boards. Staff recommends removing the vinyl siding and either exposing the original siding (if present) or installing new wood siding to match the historic.

Similarly, staff finds the second-story vinyl windows to be inappropriate in material composition, size, profile, appearance, and configuration. While the historic windows no longer remain, the age and function of the building suggest that the windows were likely wood six-over-six double-hung sash windows. Appropriate replacement windows should comply with Guideline 3.5.9. The photo prior to the exterior alterations shows that the windows did not have exterior trim, but did have a thin wood sill that should be replicated. The new vinyl windows do not comply with Guidelines 3.2.6 or 3.5.9.

- the infill is carefully removed so as not to damage the historic framing;
- new wood trim is installed to match the historic trim; and
- the new door is wood and is either paneled or contains a crossbuck design.

HARB Vice Chair AJ Jordan moved to approve the application presented on *11/7/2022* for the legalization of vinyl windows and siding and installation of a garage door to correct a violation at *933 W. Pine Street* as submitted and find compliance with the following sections of the Guidelines for Historic Districts: Chapter 4, Additions to Existing Buildings, Section 4.1.4 finds that there are many unique circumstances to this property including a lack of historic context for the selection of alternative siding materials as well as the lack of historic context for this unique structure as it was built originally to be unique to the neighborhood street wall and context. HARB member Glenn Lichtenwalner seconded the motion, which passed 4-1, HARB Chair Dave Huber dissented.
