**HDC-2022-000XX (Temporary HDC-2022-00021)**  
**Address: 1448 W. Linden Street**  
**Applicant: Owners, David and Carmit Bach**  
**HARB Meeting Date: May 02, 2022**

**Building Description:**

**Project Description:**

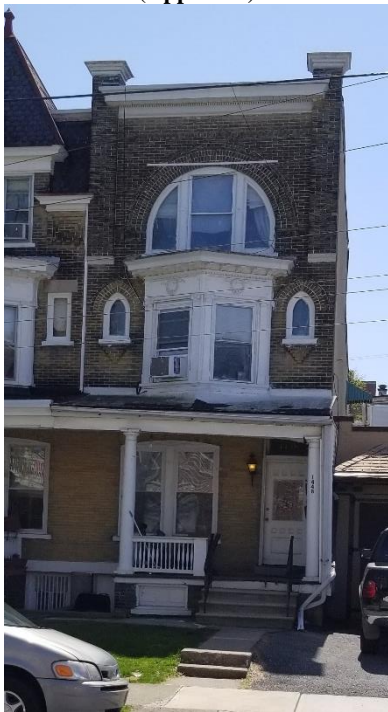
**Primary Façade, view looking south  
(Applicant)**

This building is in the West Park Historic District. This 3-story brick end of row house, ca 1900 is a porch house with multiple units. The roof is flat with brick pilasters from the 2nd floor to the roof with flat tops. The 3rd floor has a half circle brick lintel, the center window is a 1/1 sash with ¼ circle windows on either side. The 2nd floor has a triangle bay with 1/1 sash windows and a vignette in the wood lintels; on either side are lancet windows with arched brick lintels. The bay has a projecting cornice with brackets. The 1st floor has a two 1/1 sash windows with brick lintels and a single glazed door with transom. The wooden porch has classic columns, a basement window, bull-nose steps with wrought iron railing, projecting cornice, turned wood balustrades and railings. There is a below ground grocer’s alley door and the end wall of the porch has closed with siding.

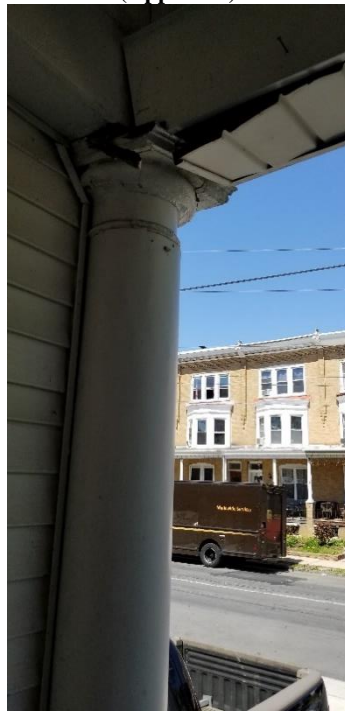
**Porch Column and Header  
(Applicant)**

**Header:** Structural header replacement with new wood is consistent with the Guidelines. The header is encased in vinyl (or similar sheet material, as shown in the photographs); removal of the vinyl is appropriate and encouraged. Non-breathable materials like vinyl sheet traps moisture and can lead to wood deterioration. The most appropriate treatment for the new structural header would be to finish the exterior with wood. Flat wood trim would be appropriate or trim that matches the historic appearance (as an attached row house, neighboring properties may have existing original examples). All wood should be painted.

“Two white columns stand on either side of the porch entrance. (See attached photo). The cap and top of the column (on western side of stairs) are deteriorating and should be replaced. The other column (on eastern side of stairs) is also starting to show its age and will likely require replacing in the near future. As such, it makes sense to replace both columns under same project.” (Detailed Work Description, page 2)

It is observed that the west column shaft is wrapped in what appears to be sheet metal (or vinyl sheet). This conceals the current condition but the wood is likely in poor condition below because of trapped moisture; wood deterioration is visible at the capital and base. The base appears to have been previously replaced because it no longer has the round profile seen on other original columns.

In-kind replacement with wood is the most appropriate treatment and consistent with the Guidelines. Generally, fiberglass is not recommended from a sustainability perspective.

Retaining the east column is the most appropriate treatment rather than pre-emptive replacement. Small-scale repair treatments can treat conditions as needed and can keep the historic material intact.

1. Replacement of the structural porch header with new wood header.
2. Replacement of two wood porch columns with new wood columns. The new columns shall match the existing east column.
3. Replacement of wood porch floor decking with composite wood decking.

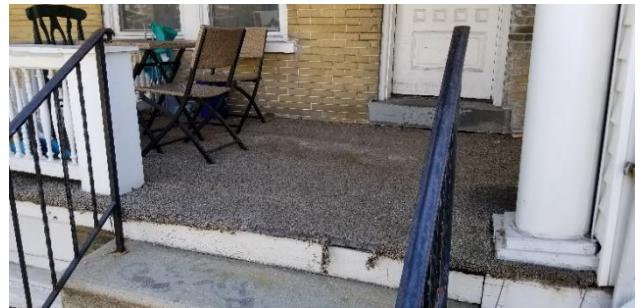
**Porch Floor Decking (Applicant)**

**Floor:** Use of composite decking is consistent with the Guideline 3.7.8 as an alternate material. Either of the two submitted composite products would be appropriate from a material perspective. The dimension of the selected boards should be as similar to the existing dimensions as possible.
