CITY OF ALLENTOWN

RESOLUTION

R140 – 2022

Certificates of Appropriateness for work in the Historic Districts:

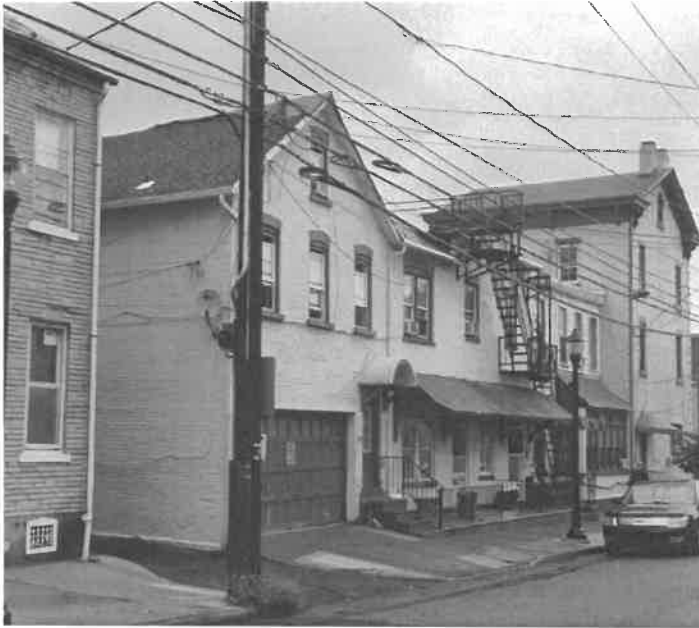
This application proposes to replace the slate of the gable roofs at 402 N. 6th Street (AKA 611 and 615 W. Gordon Street) with a dimensional asphalt shingle, such as GAF Timberline shingles. The roofing work appears to have been started by another contractor without permits or a COA and stopped at the request of a building inspector. In its current state, the building retains some slate, has some areas with replacement asphalt shingles, and has some areas where slate has been removed and no shingles have been installed. These areas are tarped and require immediate action.

402 N. 6th Street showing gable roof replacement, September 2022.
(Applicant)

HARB Vice Chair AJ Jordan made a motion to approve the application presented on 09/12/2022 for the roofing replacement at 402 N. 6th Street (AKA 611 W. Gordon Street) with the following conditions agreed to by the applicant to use the alternative slate material presented and that all roofs be replaced with this material and finds that the application is in compliance with the following sections of the Guidelines for Historic Districts: Chapter 3, Section 3.1 Roofs, and finds that there are not circumstances unique to the property. HARB member Glenn Lichtenwalner seconded the motion, which passed unanimously.

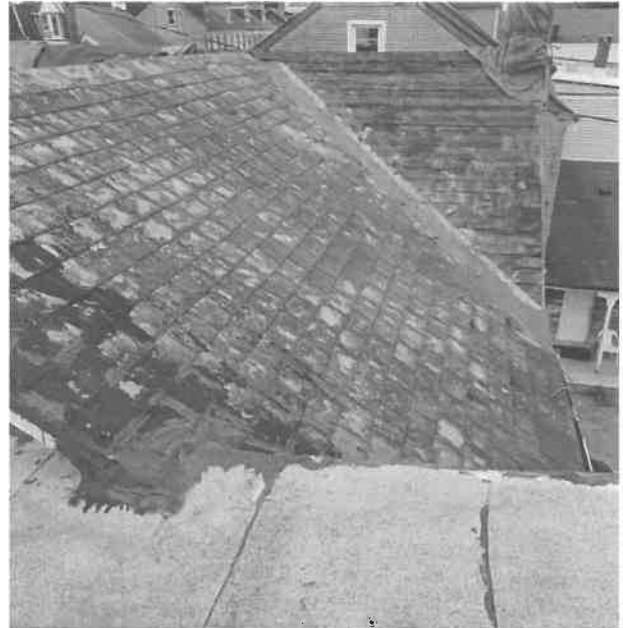
402 N. 6th Street remaining slate. (Applicant)

The applicant contends that the existing slate requires replacement, because the fasteners have disintegrated and are not currently holding the slate shingles on the roof. The applicant is proposing to install GAF Timberline shingles in the pewter color to match the asphalt shingles that were installed by a previous contractor without a permit.

The staff suggests replacing the slate with a product that more closely matches the historic slate in dimension, shape, profile, color, exposure, and overall appearance, such as GAF Slateline. Replacement asphalt shingles are recommended to have straight cuts and even exposures to resemble historic slate. The staff requests that the HARB consider whether the owner may retain the asphalt shingles that were installed without a permit or COA, or if the shingles should be replaced with a more appropriate product.

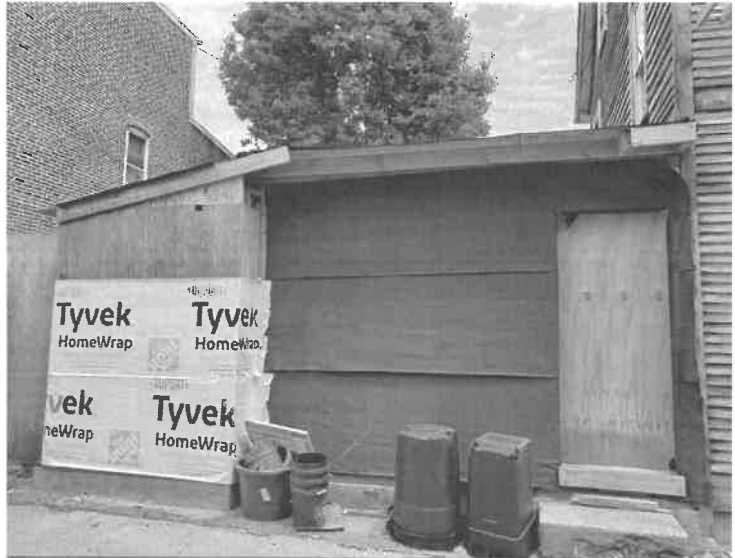
This application proposes to demolish and reconstruct the one-story rear ell. The applicant contends that the existing condition of the rear ell is beyond repair and requires reconstruction. The photograph provided by the applicant showing the existing conditions appears to illustrate that the ell has already been partially reconstructed with a new slab foundation, rafters, and plywood covering the walls. The floor plan indicates that one door will be installed in the rear wall with no other openings proposed. One boarded opening is shown in the photograph on the Refwal Street elevation. The staff questions whether the two other openings on the Refwal Street façade will be reconstructed.

Existing condition of rear ell facing Refwal Street. (Applicant)

The staff has requested additional information to determine whether the reconstruction of the ell is appropriate. Specifically, staff has requested elevation drawings or annotated photos with all exterior dimensions to show the proposed appearance of the ell; details and measurements of each building feature; a list of materials/features to be salvaged and reinstalled; and details on proposed windows, doors, and any new materials. Staff requested photos to illustrate the conditions and the necessity for reconstruction. The photos submitted appear to show a new condition rather than the deteriorated condition of the ell.

HARB member Glenn Lichtenwalner made a motion to approve the application presented on 09/12/2022 for the reconstruction of the rear ell at 811 W. Gordon Street as submitted with vinyl windows based on prior COA approval for the main volume, establishing a precedent for approval and finds that the application is in compliance with the following sections of the Guidelines for Historic Districts: Chapter 3, Section 3.2 Wood Siding & Trim, Section 3.5 Windows, Section 3.15 Demolition, and finds that the circumstances unique to the property are the addition is part of a larger whole. HARB member Phillip Hart seconded the motion, which passed unanimously.

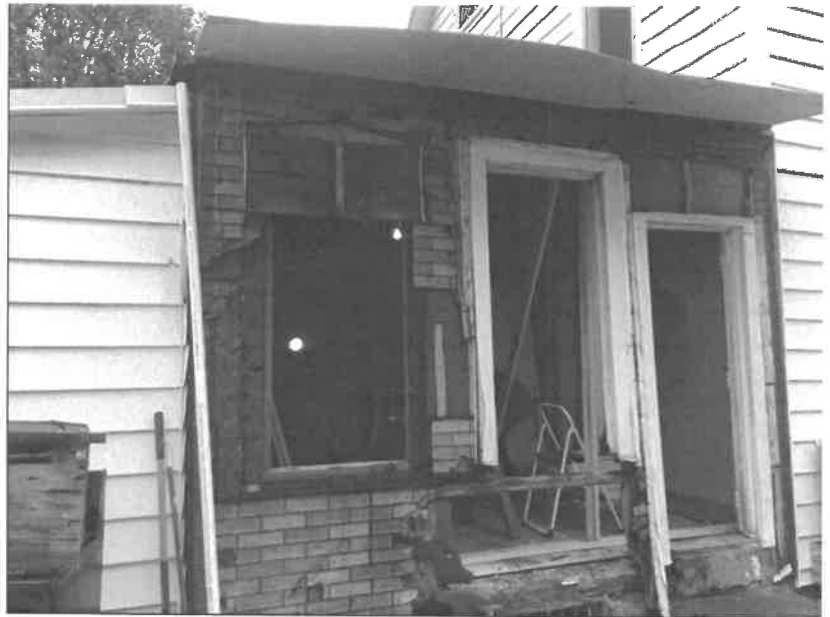
Photo of the rear ell following the removal of the siding. (HARB files)

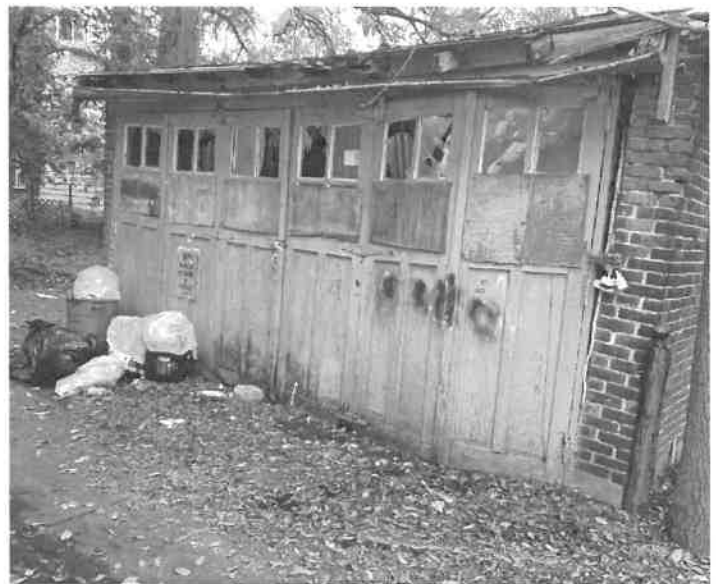
This application proposes to demolish the one-story brick garage of 948 North Street. The garage is located at the rear of the property, at the intersection of Palm and Brush Streets, with frontage on Palm Street. The roof collapsed at some point in the past, leaving the garage susceptible to the elements and causing further deterioration. On August 22, 2022, a city inspector from the Department of Building Standards and Safety designated the garage as an unsafe structure and ordered that it be razed or repaired within 30 days to abate a public safety concern. Owing to the extent of the damage, the owner is seeking to demolish rather than repair the structure.

Rear garage of 948 North Street. (Applicant)

The staff finds that the garage may have once contributed to the historic district but that the structure has lost its integrity from the damage and deterioration caused by the roof collapse. The building's compromised structural integrity has been documented by the Department of Building Standards and Safety as a public safety concern. The staff finds that the demolition is necessary to abate a dangerous condition and that the demolition will not have a negative impact on the district, because the garage is not visible from a primary street.

If the wood garage doors can be salvaged despite their severely deteriorated condition, salvage is recommended for potential repair and reuse at another building. If remaining wood window frames and/or sashes can be salvaged, this is also recommended.

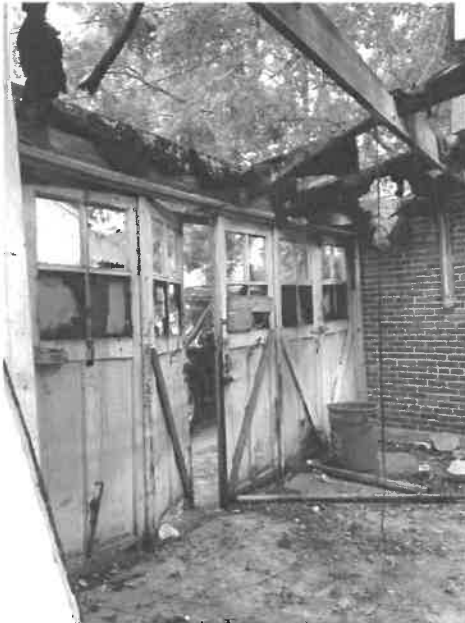
Interior of the garage at 948 North Street.
(Applicant)

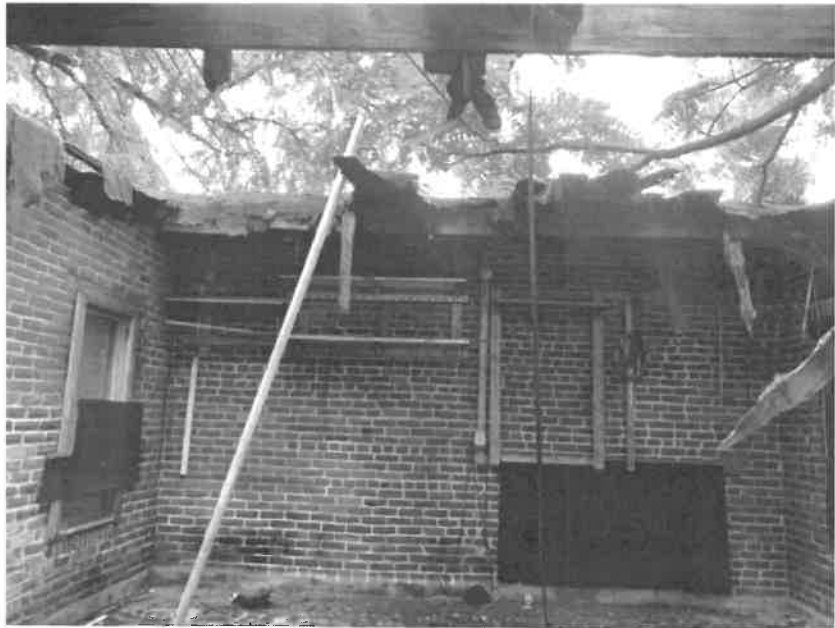
Interior of the garage at 948 North Street. (Applicant)
