HDC-2022-000XX (Temporary HDC-2022-2023)

Address: 430.5 N. 10th Street

HARB Meeting Date: May 02, 2022

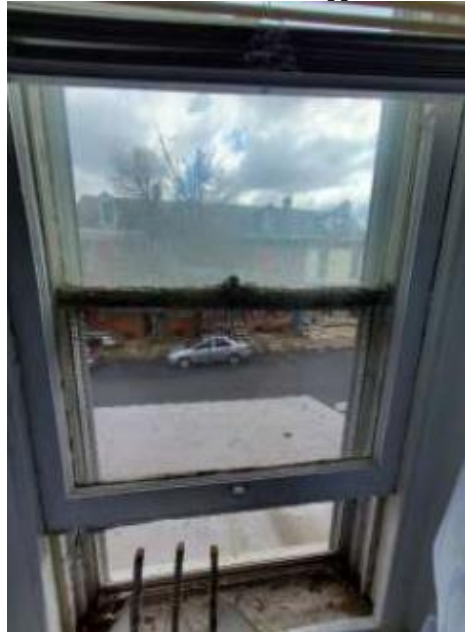
2nd Floor Front Window (Applicant)

Provided by Applicant: Replacement of eight (8) lead-based paint hazard deteriorated windows with new aluminum clad windows. (Two - 2nd floor front, two - 3rd floor front, one - 2nd floor side, one - 2nd floor rear, and two – 3rd floor rear).
Noted from Supplied Materials: The scope of work notes that new windows will be fit to existing openings and new screens will also be installed.

TA stated the current condition of the windows in the scope of work are presenting a potentially hazardous condition at the level of deterioration they exhibit.

Repair and reuse of wood windows, or in-kind replacement, are the most appropriate treatments. Aluminum-clad wood windows are an acceptable alternate material per Guideline 3.5.9. The proposed replacements are 1/1 double-hung, which match the existing configuration and operation, and will be fit to the existing opening. These factors are consistent with the Guidelines.

1. Replacement of eight (8) lead-based paint hazard deteriorated windows with new aluminum-clad wood windows, as submitted. Proposed windows shall be 1/1, double-hung windows and shall be fit to the existing openings.
2. As submitted, the windows to be replaced are located in the following locations:
 - a. Two - 2nd floor front
 - b. Two - 3rd floor front
 - c. One - 2nd floor side
 - d. One - 2nd floor rear
 - e. Two - 3rd floor rear
