Historical Architectural Review Board
COA Preliminary Review Sheet

HDC-2025-00003

Address: 213 N. Fountain Street

Proposal: Installation of new garage door, windows, and doors.

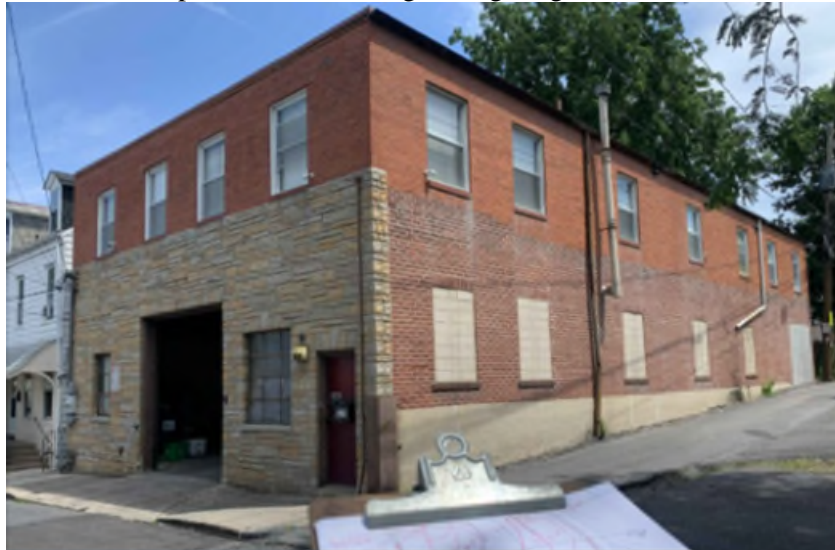
Current Exterior at Fountain St and Russell Street (Applicant)

Observations & Comments: The original building was a one-story garage that first appeared on the Allentown Sanborn Map in 1932. Since that time, a second story was added, permastone was applied to the Fountain Street elevation, the first floor windows and garage door along Russell Street were removed and infilled with CMU block, and the second floor industrial windows were replaced with 1-over-1 sash windows.

It would be appropriate for the existing first floor windows on Fountain Street to be repaired instead of replaced, or sufficient evidence should be shared showing that the windows cannot be repaired. While the proposed windows include a muntin pattern consistent with the existing original windows on the first floor, they do not match in materiality and frame dimension. The replacement first floor windows along Russell Street should be steel windows matching the existing first floor windows on Fountain Street in size, type, operation, profile, and appearance.

- The existing first floor windows on Fountain Street remain and are repaired as required, or evidence submitted that the windows are beyond repair.
- The replacement first floor windows along Russell Street match the existing first floor windows on Fountain Street in material, size, type, operation, profile, and appearance. Replacement window product information is to be approved by staff, and finish color for existing and replacement windows is to be decided by applicant.
- The garage door on Fountain Street is an architectural sectional garage door in a design consistent with the historic period. The garage door on Russell Street may match the one on Fountain Street or be a solid sectional door. Garage door product information to be approved by staff.
- The building lighting is installed as submitted.

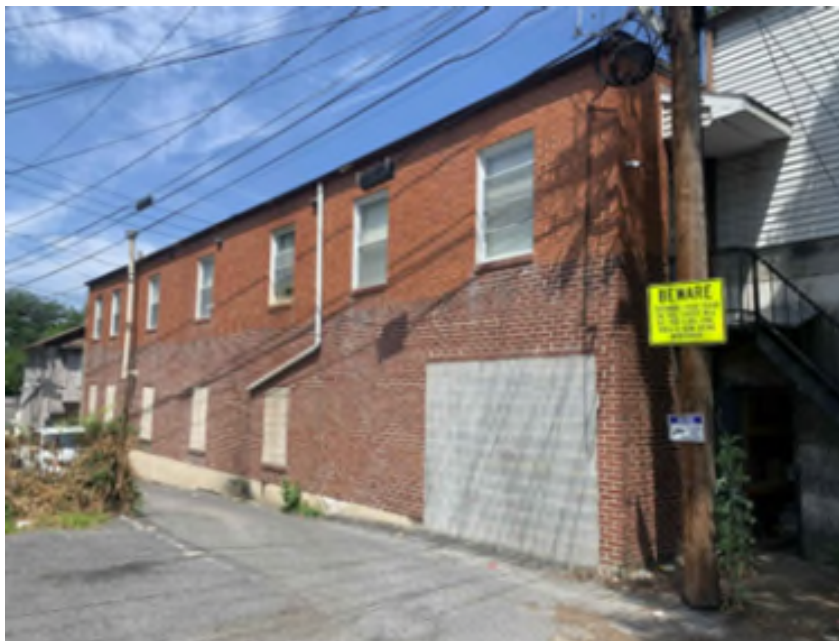
Elevation at Russell Street (Applicant)

The removal of the CMU block infill at the original windows and garage door locations along Russell Street is appropriate and commendable and helps restore some of the character of the original building.

The style of the proposed garage door is not consistent with the historic district. For the primary garage entry on Fountain Street, a more historically-consistent configuration would be appropriate. There are historic examples of 1930s garage doors that have upper lites, similar to the configuration of the proposed steel entry door. That style garage door paired with the proposed entry door would be a complementary pairing for the front elevation. Other examples of garage doors from that era consist of solid sectional doors with square inset panels, as seen nearby at 926 Oak Street. It would be appropriate for the garage door on Russell Street to be consistent these styles, but given its location on the secondary façade, it would also be appropriate to install a solid sectional door.
