RESOLUTION

R69 – 2021

Certificates of Appropriateness for work in the Historic Districts: 337 N. 8th St., 23 N. West St. and 1507 W. Turner St.

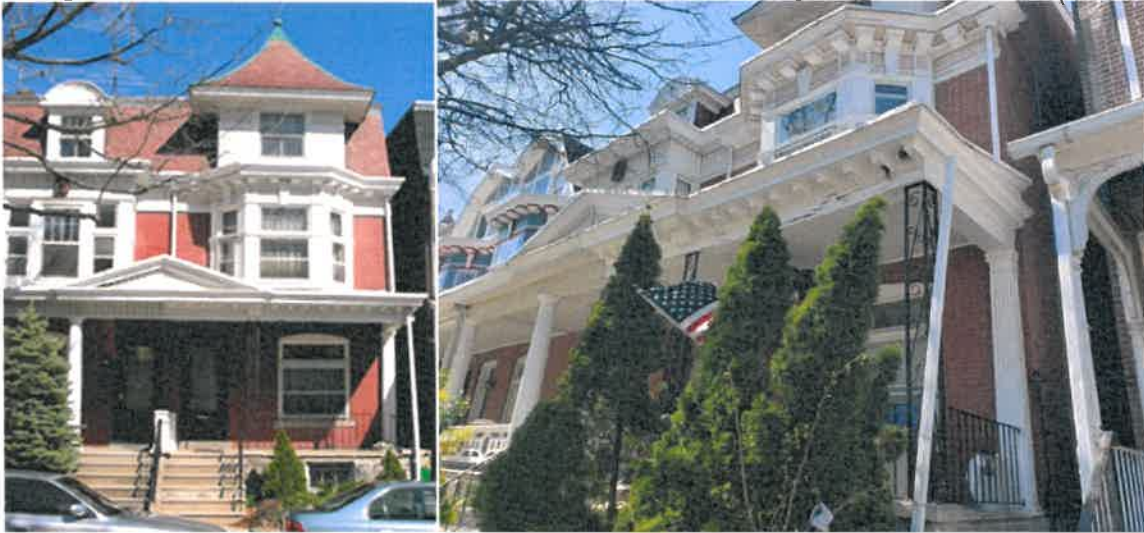
This brick 3-story end of row house, ca 1911 is a Colonial Revival. The mansard roof has red slate shingles, a large dormer with 8/2 sash window, projecting cornice and spire roof with a finial. The 2nd floor has a projecting cornice with brackets and a bay window with 1/1 sash windows, glass transom and a wooden keystone over the windows. The 1st floor has a picture windows with beveled glass transom and brick lintels. The wooden porch has a single beveled glass door, transom, and projecting moldings as well as wrought iron columns and railing and bull-nosed concrete steps and wrought iron railings. There is a visible basement window grille. The rear of the property has a wooden fence and gate with porches; the 1st floor is enclosed with siding and the 2nd porch has square columns, wrought iron railing and a door.

The proposed scope of work at the porch support columns is not appropriate as proposed. There is insufficient information in the application to fully evaluate the proposed alterations and materials.

As proposed, one non-historic metal support (at center) will remain; one non-historic metal support (at corner) will be replaced with a 6x6 post; and the one wood half pillar (at the shared entrance) will be removed and replaced with a full-height 6x6 post. The 6x6 posts will be “padded out to receive new PVC material to finish off the posts.” PVC cladding is not an appropriate material. There is no information about the finished appearance, shape, or size of the new columns. Removal of the existing wood half column is not justified. Removal of historic material should be avoided whenever possible. Installation of a new (half) column at the shared entrance will change the appearance of the building. There is precedent for a shared column within this block of houses. A shared column may have existed originally. However, the shared columns are *all* half columns supported by a base integrated with the shared railing.

It is not appropriate or recommended to cover the new exterior beam or the fascia with PVC product. As proposed, the “existing dentil pieces will be removed and recapped.” The dentil modillions should be retained and repaired or replaced like-for-like with wood to match existing. Dentil modillions should not be capped.

As proposed, the alterations to the porch supports columns will negatively impact the surrounding historic district. The subject building is the end of a long block of attached houses. This block is united visually by a continuous row of front porches with similar wood columns, railings, and pediments above the shared entrances. The proposed changes will not fully reverse the inappropriate metal supports and will result in the removal or inappropriate of original porch features. Replacement of the two non-original metal columns with appropriate columns would benefit the surrounding district.

The recommended scope of work is full replacement of all inappropriate metal elements with new supports to match the extant tapered round columns at the adjoining buildings should the determination by a structural engineer determine the need for additional support. Porch details—including the fascia and dentil modillions—should be repaired or replaced like-for-like and no elements shall be capped with PVC. It is recommended that the applicant submit drawings, graphic representations of the scope of work, and product data for proposed materials. The recommendation is to advise applicant on the appropriate scope of work and not approve the application as submitted.

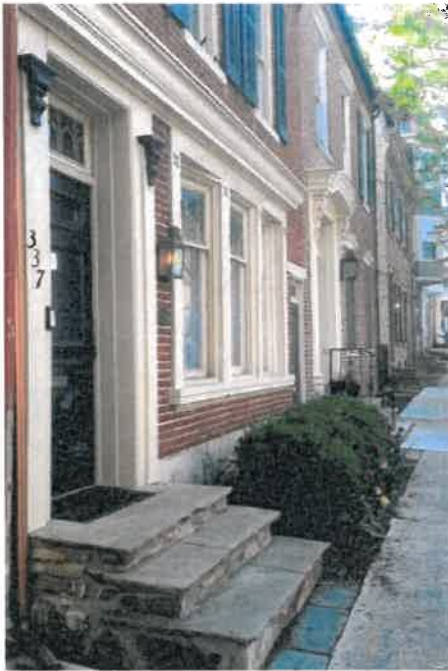
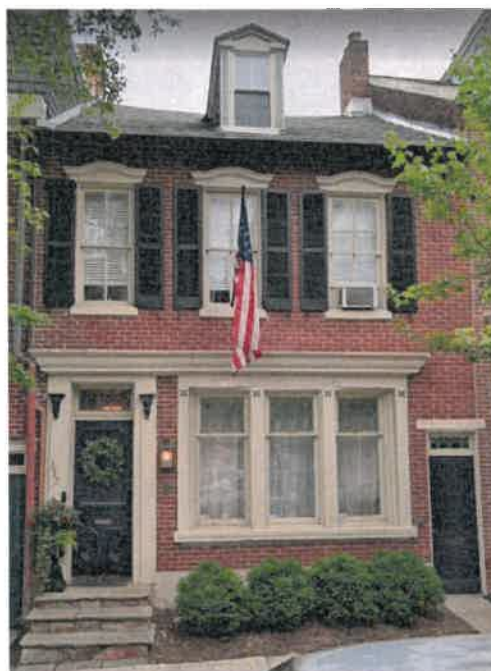
This 2½-story painted brick Federal/Victorian row house with Italianate influences, ca 1875 is in excellent condition. The gable roof has asphalt shingles with snow catchers, a bullet dormer, denticulated cornice and a single chimney.

The windows are 2/2 sash with Italianate eyebrow lintels on the 2nd floor and the 1st floor has 3 windows with flat lintels and stained-glass transoms displaying tulips. The main entry has a stoop with a single door that has a transom; there is a projecting molding that spans the top of the door and the large set of windows. There are projected moldings that frame the door and windows on the 1st floor. There is a slatted grocer's alley door with a stained-glass transom with a flat lintel and basement window grille.

The proposed installation of a new handrail is appropriate and will not impact the building's architectural character. Based on the submitted photograph and material description as wrought iron, the simple metal railing is appropriate for a building of this style and period. The applicant is encouraged to submit more specific product data or manufacturer information about the proposed railing to be used. The proposed railing is compliant with the Design Guidelines' general stoops and steps section.

The application does not specify the side of the stoop on which the handrail will be installed. The existing stone steps do not appear to have holes or physical evidence of a prior railing and the 2013 county assessor photo does not show a prior railing. There is no known documentation of a part railing for the purpose of replication. It is recommended to install the handrail on the left side to be consistent with neighboring building 335 N. 8th Street and others on the block. However, installation on either side of the stoop would be appropriate and not impact the building's character.

The proposed project is recommended to be approved as submitted with the recommendation that the new handrail be installed on the left side of the stoop. The applicant is encouraged to submit product data information sheets, drawings, or cut sheets for the proposed railing and door products for record-keeping purposes and to confirm that the installed products will match the supplied photographs.

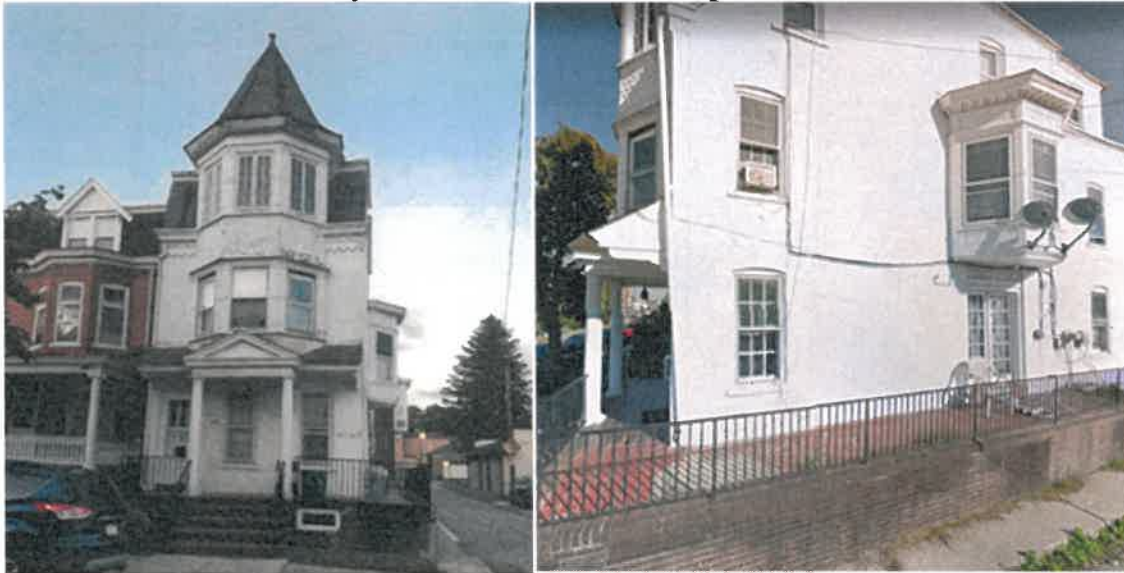
This three-story brick end of the row This 3-story brick/stucco single house, ca 1900 is a Colonial style. The flat roof has turret with slate shingles and a single chimney. There is an iron fence along the length of the brick porch which wraps around the west (front) and south (side) facades of the building. The windows are seventeen 6/6 sash, brick lintels and a bay window with transom. The main entry is a double door on a brick porch.

Two treatments are proposed for the side porch: the first is demolition and construction of a new independent stair to the existing French doors on the side (secondary) façade; the second is demolition and reconstruction of the side porch. The brick side porch does not appear to be an original feature of the building. Sanborn map research indicates that the original configuration was a full-width wood front porch and no side porch; the brick side porch and possibly brick front porch base appears to have been installed after 1950. No historic photographs have been found.

The proposed roof work includes replacement of deteriorated slate at the turret roof, replacement of the low slope building roof, and in-kind replacement of the deteriorated wood fascia and installation of a vented aluminum soffit. The low slope roof work is acceptable and does not require HARB review on its own per the Guidelines. Replacement of deteriorated wood trim with wood is acceptable; the new fascia should match the original in size, profile, dimension, and appearance. Vented soffits are effective solutions for air and moisture circulation and can be minimally visible. The soffit should be painted to match the wood trim.

Part 1-Porch: The application does not contain sufficient information to recommend approval of either scope of work proposed for the side porch: demolition and new stair construction or demolition and reconstruction. It is recommended by HARB that the owner engage a professional to determine the scope of work demolition and construction of new stairs versus demolition and reconstruction to assist the applicant in project planning. It is recommended that the porch portion of the application be tabled for future consideration and to incorporate HARB's opinion. Drawings and detailed description of the proposed scope of work, including materials to be used, should be submitted. It is understood that the applicant has consulted with a mason. A description of current conditions from the mason, or the mason's attendance at a HARB meeting, would be beneficial to better understand the need for demolition.

Part 2: Roof, flashing, soffits, and trim: The proposed use of an EPDM roof on the flat, non-visible portion of the roof is acceptable. The proposed slate, and wood trim work on the turret roof is recommended for approval. True slate materials are recommended in locations of deteriorated slate with Ecostar Empire Slate or Majestic Slate as approved alternatives. Alternate slate should match the original shingles in size, thickness, shape, and color as closely as possible. The new slate should be installed in the same pattern and with the same exposure (the amount of each tile visible) as the existing roof. In this case, the fishscale shape is a key factor. The ridge caps and finial are to be retained and restored if possible or replaced in kind. New material shall match existing in shape, profile dimension and composition. The wood trim and soffit details

should be replicated to match the existing out of wood materials and it is not advisable to add soffit venting.

Part 3: The basement door as proposed with raised rail panels and two glass lites at the top is acceptable and should be painted to match the color of the house and existing door frame which is to remain.
