CITY OF ALLENTOWN

RESOLUTION

R3 – 2026

Certificate of Appropriateness for work in the Historic Districts:

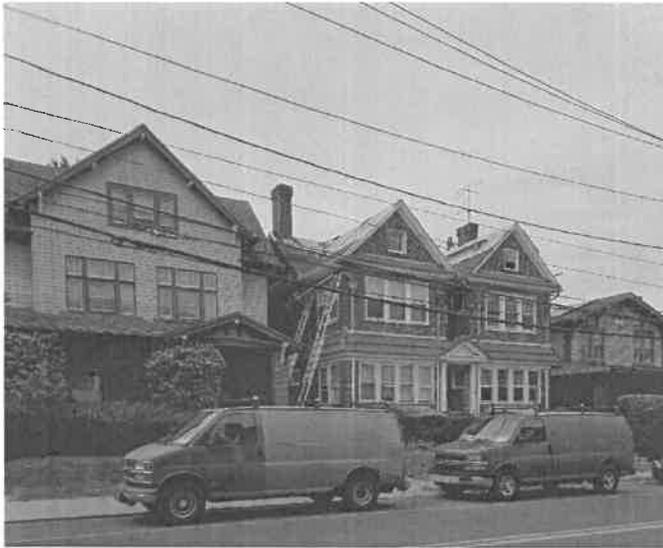
Previous Condition (Applicant)

Current Condition (Applicant)

Observations & Comments: The original roof of 126-128 N 15 Street was Spanish barrel terra cotta clay tile. It appears that the original roofing materials have been completely removed at the main roof areas, and replacement with a red shake style architectural asphalt shingle was begun until work was stopped. The applicant has submitted an alternate material for review: Brava's Spanish Barrel Tile, a synthetic material that matches the original clay tile. This product appears to be an appropriate alternate material, as color options, profile, and appearance are consistent with the original historic clay. No specific color was proposed by the applicant. From the color chart, Antique Clay appears to be the closest match to the original clay; the applicant may obtain samples and submit photos to Staff showing the sample and the remaining original tile for final color selection.

- The original clay tile at the projecting eaves at the first floor and gable ends are maintained and not replaced
- Proposed changes to any other roof-related elements such as gutters or downspouts are submitted in a separate application.
- Final color is approved by Staff

- Samples of the barrel configuration with colors closest to the existing color is submitted to staff for color approval. Photos submitted should show the samples next to the existing/original clay roof tile.
- The hips, rakes, and ridges are consistent in design throughout the roof and submitted to staff for approval.
- Detail for valleys to be submitted to staff for approval; if valleys are open they are to be copper, or the valleys can be closed as suggested in the manufacturer's documentations.
- The existing gutters and downspouts are maintained.
- If there are any other changes to roof components, a separate application will be made.

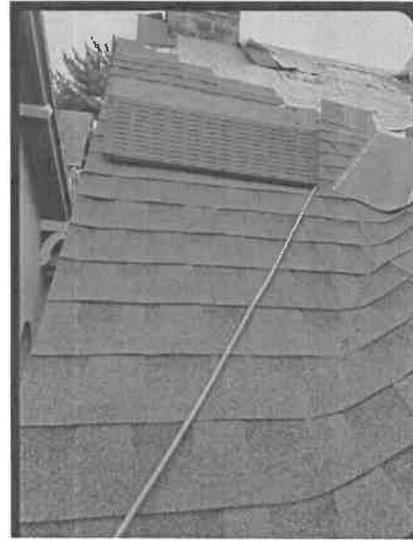
Current Condition (Applicant)

Current Material on Roof (Applicant)

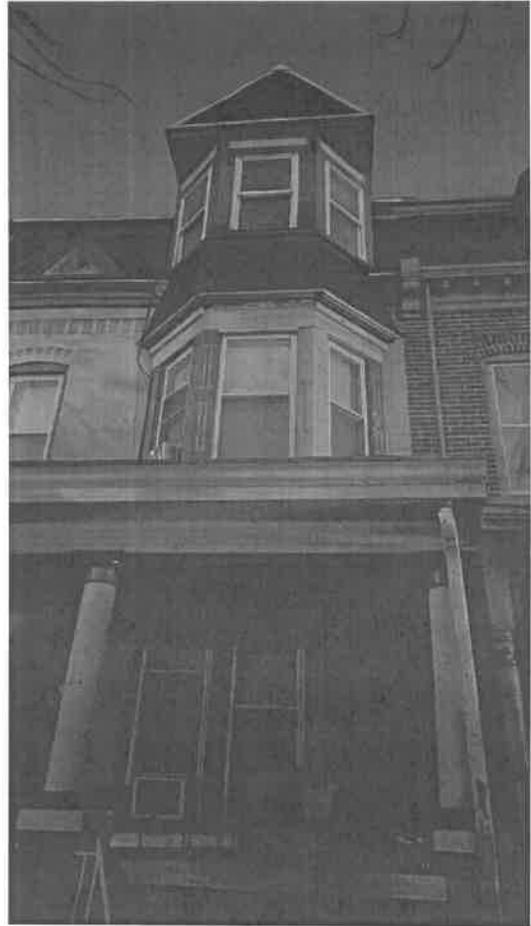
From application: The existing exterior window panels and surrounding wood components exhibit deterioration, including rot in multiple locations. In addition, sections of the soffit board are missing, leaving the assembly exposed and vulnerable to further damage.

Current Condition (Applicant)

Staff Recommendation: Staff request more information on the extent of the work area and the approach for achieving a consistent plane of the trim's surface. Generally, the proposed approach to replacing the wood trim is appropriate. All exposed wood surfaces should be painted.

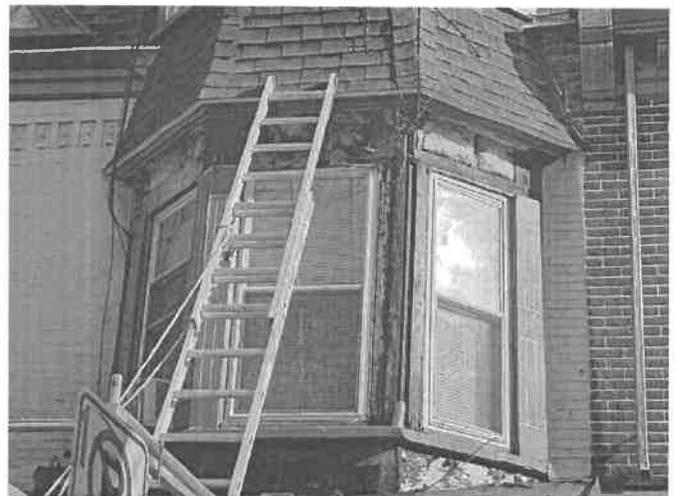
Wood Removal (Applicant)

The applicant stated that his company was hired to replace the deteriorated wood panels; many were severely rotted in a poor condition. The rotted wood was removed and replacement wood added to create a sound, weathertight condition. The applicant proposed taking a physical tracing of the original panels as a basis for recreating the trim. The Board discussed a few options for how that could be achieved, such as using a router, a CNC machine, or handcarving. Mr. Hart suggested that the means of creating the panels is up to the contractor; the goal is for the panels to be visually similar to the original ones.

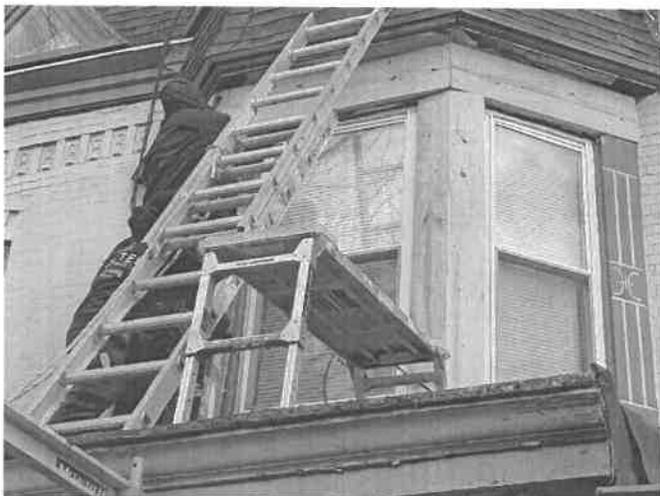
Wood Replacement/Current Condition (Applicant)

The proposed scope calls for adding new scribed trim onto replaced substrate. Based on the submitted photos, it appears that replacement wood is in plane with original scribed trim. More information would be helpful to understand how a consistent finished plane will be achieved; ensuring that edges align appropriately to adjacent elements, such as other trim and window sills.

- Wood trim replacement material would be cedar, cypress, or mahogany. Final material to be submitted to staff
