**Historical Architectural Review Board
COA Preliminary Review Sheet**

HDC-2024-00046

Address: 620 N 6th Street

Proposal: Replacement of three aluminum windows. (Violation Correction)

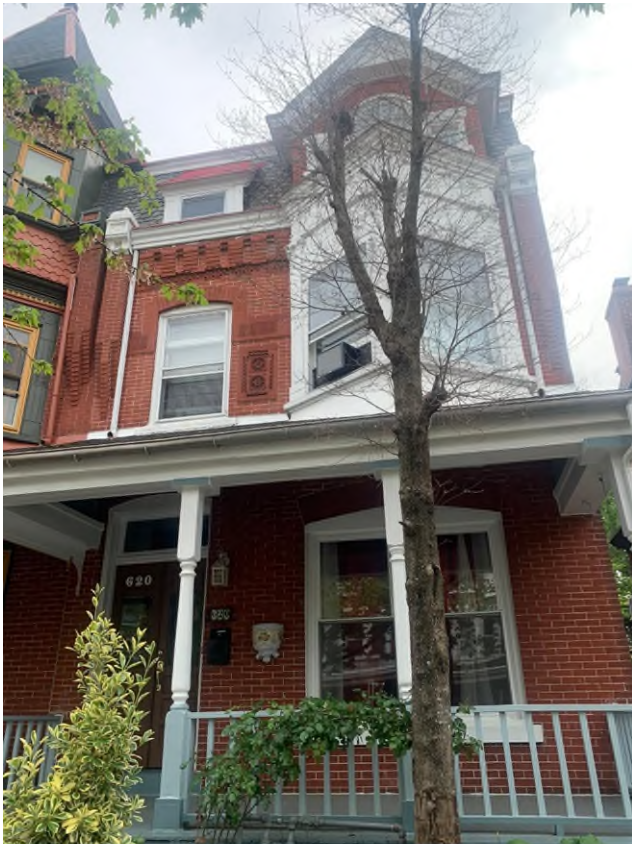
Current Front Elevation (Applicant)

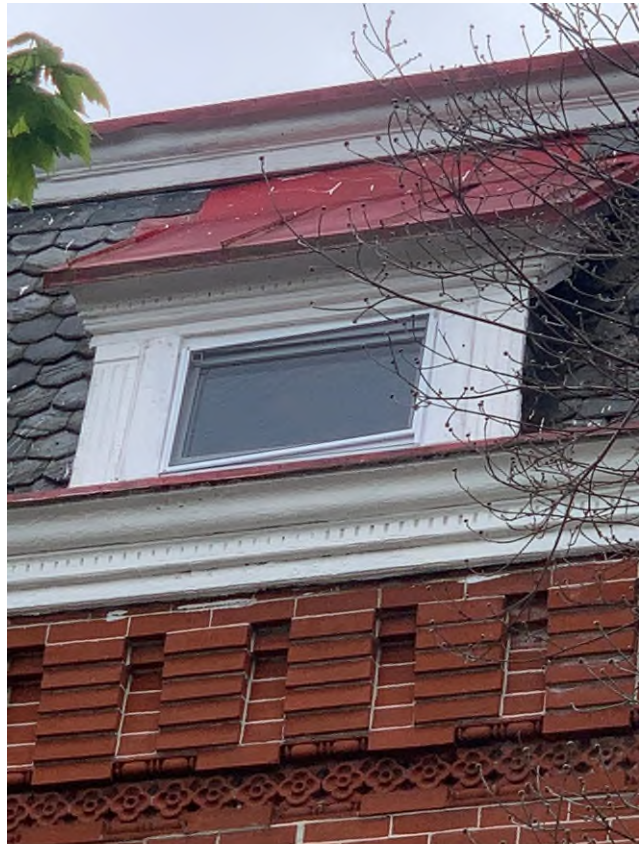
Installed Third Floor Window (Applicant)

Observations & Comments: The installed replacement windows do not reflect the historic detailing and material, and are therefore not appropriate. It would be helpful if the owner/applicant can provide photos of the windows beforehand, or evidence that they needed to be replaced rather than repaired. It appears that the upper story window did have special detailing that was not replicated and should have been. The first floor windows appeared to be fixed windows with a transom above and exterior storm windows, and the installed replacements are 1/1 sash windows with no transoms. Staff request clarification on the material of the window construction. The application indicates the windows were replaced with "aluminum." Unlike aluminum clad wood, aluminum-only is not acceptable, as aluminum-only windows cannot replicate the detailing of muntins and trim.

Staff Recommendation: It is recommended to deny the application.

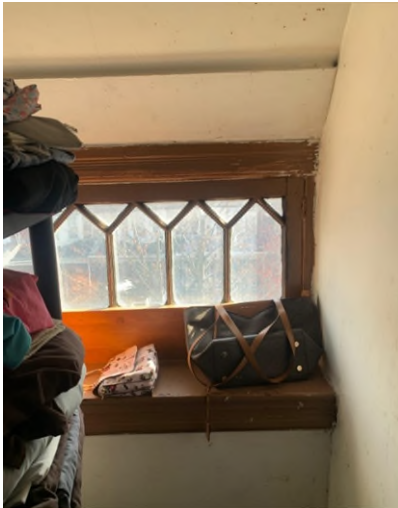
Previous Third Floor Window (Applicant)

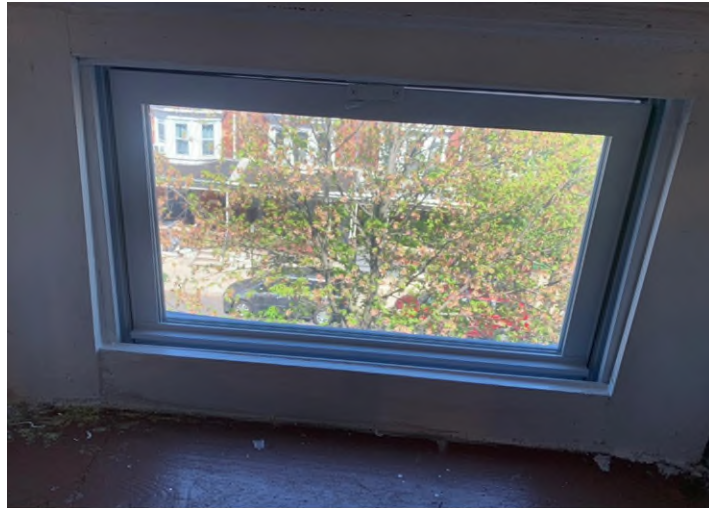
Installed Third Floor Window (Applicant)

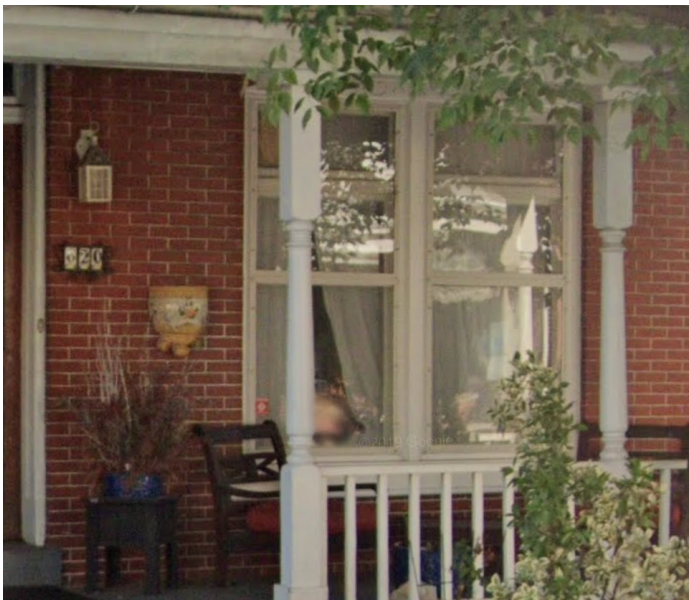
Previous First Floor Windows, c.2019 (Google)

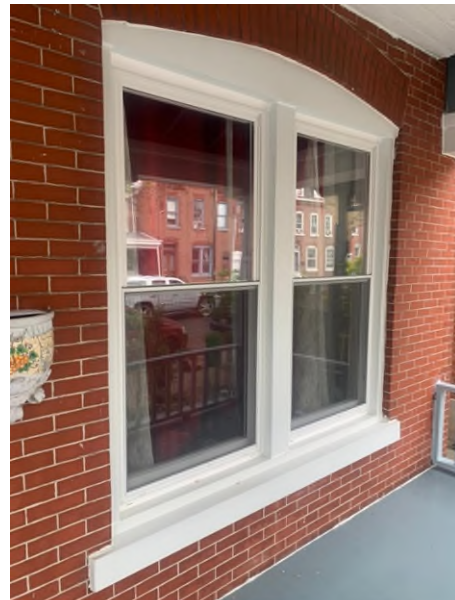
Installed First Floor Windows (Applicant)
