HDC-2022-00030

Address: 526 W. Liberty Street

District: Old Fairgrounds Historic District

Proposal: Legalize porch reconstruction (Violation Correction)

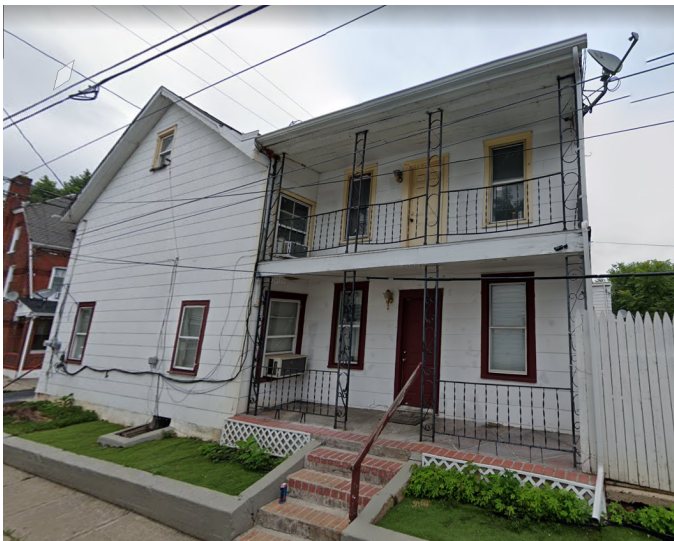
Law Street elevation of 526 Liberty Street in 2019.
(Google StreetView)

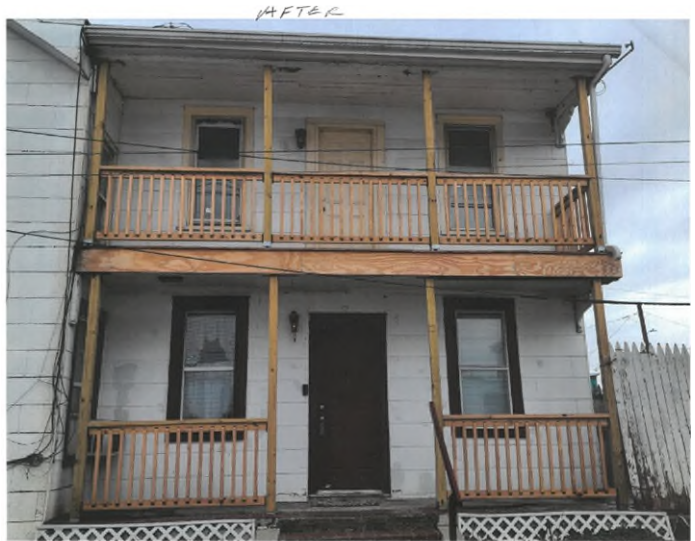
Law Street elevation of 526 Liberty Street after work was completed.
(Staff)

The installation of the wood posts and railings is appropriate in material. However, the dimensional lumber posts are not consistent with Guideline 3.7.8. An option to mitigate the existing dimensional lumber is to conceal the exposed steel

brackets at the base of each post with simple trim. All wood members should be painted. While the posts, balusters, and railings are utilitarian and lack any decorative features, no evidence exists to provide guidance on a more appropriate restoration.

Approval, provided the wood posts, balusters, and railings are painted and wood trim is added at the base of each post, pursuant to Chapter 3, Section 3.7 Porches and Steps.

1. The wood posts, balusters, and railings are to be painted.
2. Wood trim is to be added to the base and top of each post.
3. Posts are to be chamfered.
4. Railings are to be reoriented to ensure balusters do not overlap the face of the rails.
