**Historical Architectural Review Board  
COA Final Review Sheet**

**HDC-2023-00079**

**Address: 201 N. 10th St**

**Proposal: Apply stucco to brick wall at side of property**

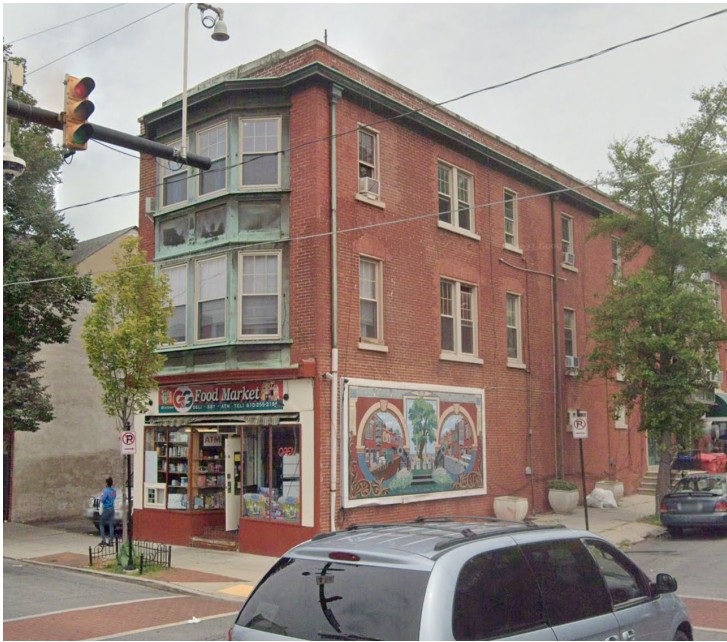
**Turner and 10<sup>th</sup> Street elevations of 201 N 10<sup>th</sup> Street, 2021.  
(Google StreetView)**

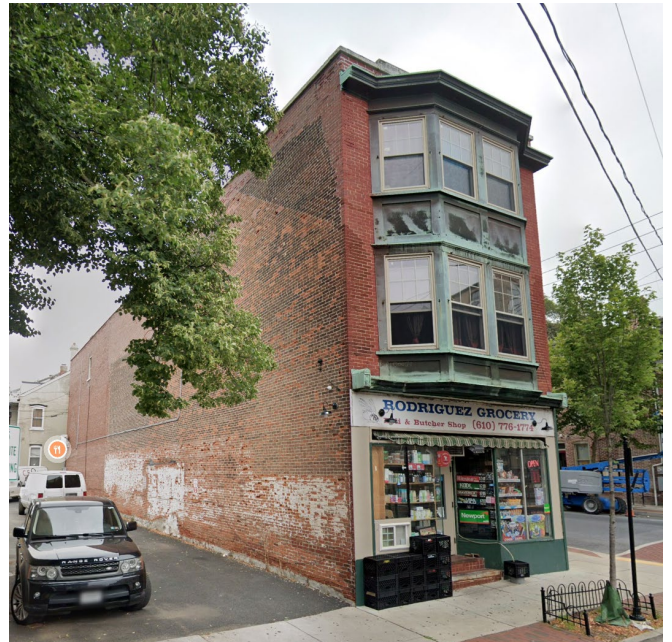
**North façade of 201 N 10<sup>th</sup> Street, 2019.  
(Google StreetView)**

A building historically stood on the adjacent property at 203 N. 10<sup>th</sup> Street and was demolished at some point in the past, leaving the two adjoining party walls exposed to the elements. Owing to the exposure, the north elevation of 201 N. 10<sup>th</sup> Street contains soft, porous brick that has been deteriorating since the demolition of the adjacent structure. To stabilize the brick, the applicant is proposing to apply stucco over reinforced wire mesh fastened to the mortar joints. While Guideline 3.3.7 advises against painting, coating, or sealing historically unpainted brick, staff notes that party walls are an exception, since the brick of these walls was never intended to be exposed to the elements. The brick at party walls is significantly weaker than the high-fired brick of a typical building façade. Because of the susceptibility of the brick to deterioration, staff finds coating a portion of the wall to be an appropriate intervention, provided the stucco is compatible. Staff further notes that the exposed party wall at 205 N. 10<sup>th</sup> Street has already been stuccoed.

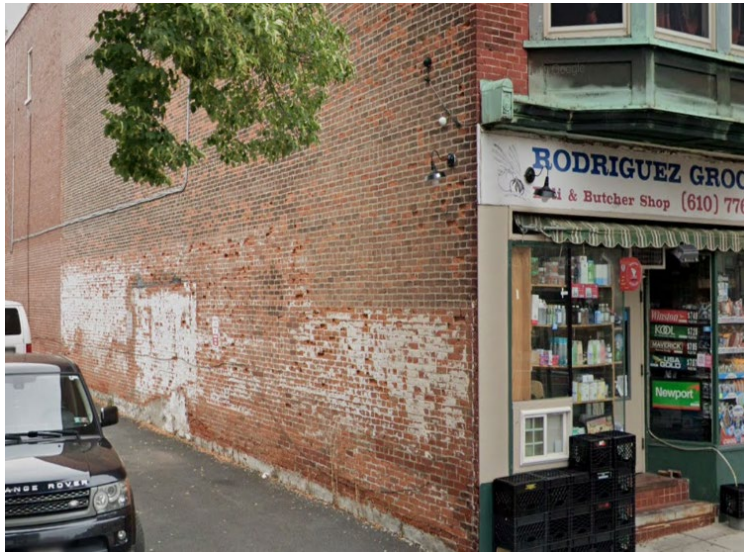
Detail of north façade of 201 N 10<sup>th</sup> Street, 2023.  
(Google StreetView)

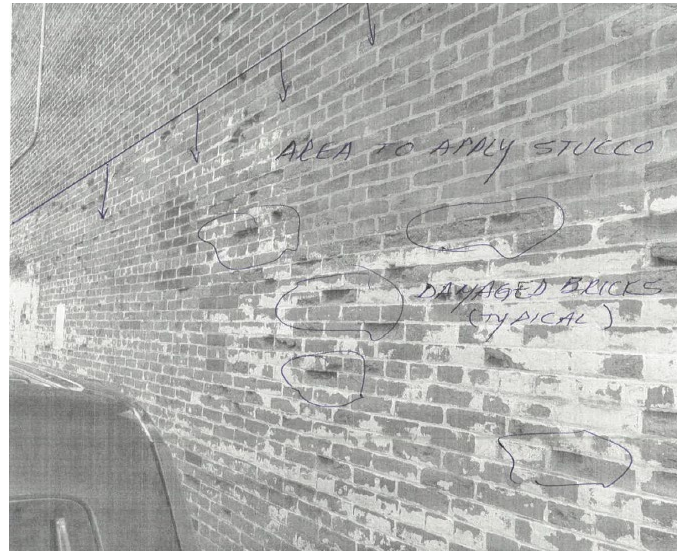
North façade of 201 N 10<sup>th</sup> Street, 2023.  
(Applicant)

An appropriate stucco should be softer than the brick to avoid exacerbating the deterioration. Staff recommends using a lime-based stucco and points to guidance provided in a National Park Service Preservation Brief regarding the preservation and repair of historic stucco, see Figure 1 below:

Staff also advises against painting or sealing the stucco to avoid trapping moisture, which can lead to further deterioration.

Approval, provided the stucco contains a sufficient amount of lime so that it is softer than the brick, pursuant to Chapter 3, Section 3.3 Masonry.
