**Historical Architectural Review Board
COA Final Review Sheet**

HDC-2023-00050

Address: 1625 W. Linden Street

Proposal: Install fiberglass casement windows (violation correction)

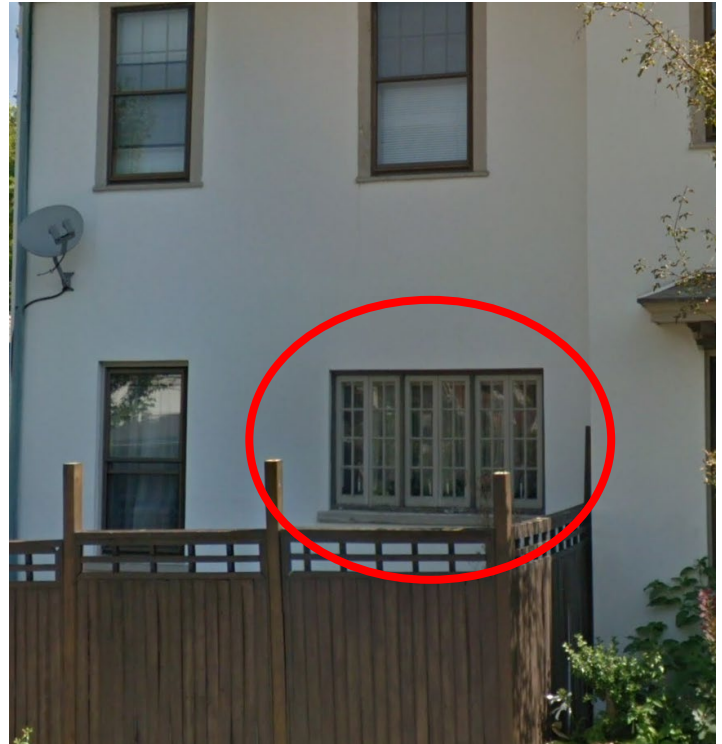
**Side façade of 1625 W. Linden Street with the historic window
circled in red, 2016.
(Google StreetView)**

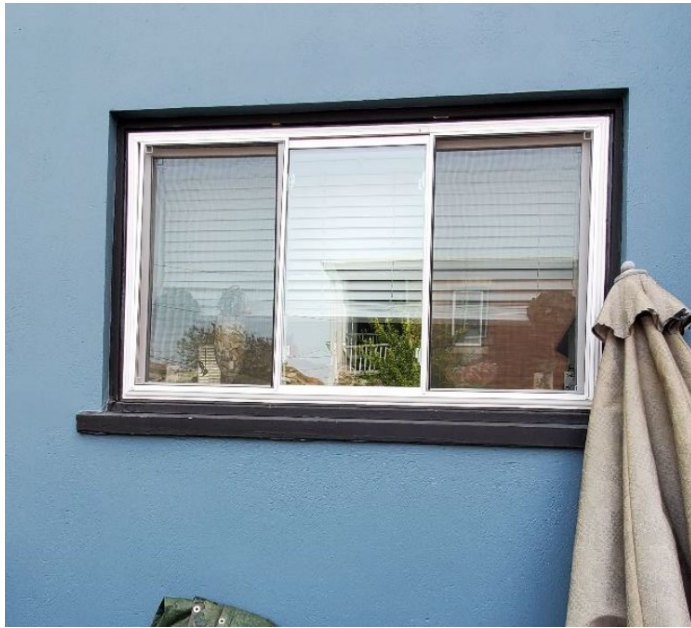
Vinyl replacement window in violation.
(Applicant)

The opening on the West Street elevation historically consisted of three double-casement windows with eight panes in each leaf. The owner removed the historic windows and inserted a vinyl tripartite slider that does not meet the design guidelines. To correct the violation, the Lead Hazard Control Program staff has submitted a proposal to remove the vinyl window and install two pairs of fiberglass double-leaf casement windows with an eight-pane configuration in each leaf. The simulated divided light windows would feature exterior muntins.

The windows generally meet the design guidelines, because they would be an appropriate material and would maintain the type, operation, profile, and general appearance of the original casements; however, the configuration would change from three casements to two casements. Staff finds that the configuration change does not meet Guideline 3.5.9, though the change would not result in an infill or change to the masonry opening. The applicant contends that the manufacturer cannot fabricate casements narrow enough to allow for the installation of three sets of windows to match the historic configuration.

Staff notes that Lead Hazard Control Program has submitted an application to replace most windows at the property and that the remainder of the windows will meet the design guidelines and will match the historic windows. To maintain consistency throughout the entire property, staff suggests that the vinyl slider window be replaced with the same Andersen 100-series windows that will be used throughout the building, despite the change in configuration.

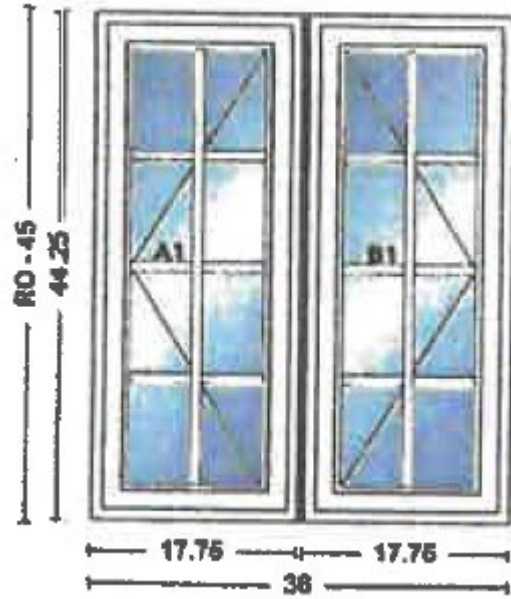
Spec of the 8-pane double-casement proposed to replace the vinyl window; two sets would be installed rather than three.
(Applicant)

The HARB discussed the two options and agreed that the two 36-inch French casements would be more appropriate.

Mr. Jordan moved to approve the application presented on 9/5/2023 as submitted to install two 36-inch fiberglass French casement windows at 1625 W. Linden Street, pursuant to Chapter 3, Section 3.5 Windows. Mr. Lichtenwalner seconded the motion, which carried with unanimous support.
