Historical Architectural Review Board

Final Staff Review

HDC-2024-000105

Address: 1028 W Chew Street

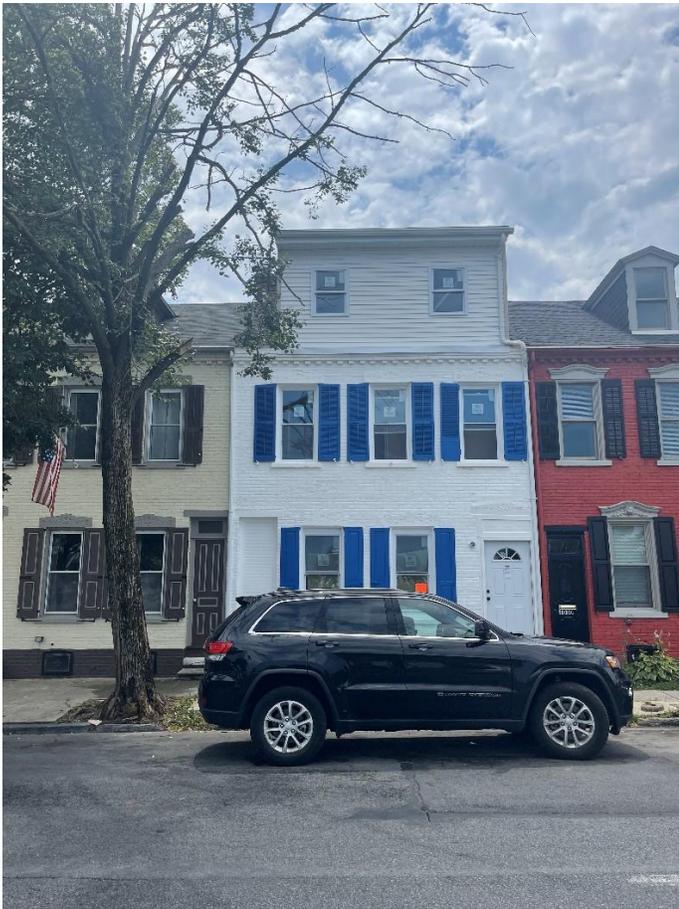
Current Front of House (Applicant)

- The application describes building new dormers. While there was originally a dormer at the third floor of the house, it was narrow – about the width of the original window. The work has extended the dormer to be nearly the full width of the house, which is not appropriate.

- The installed siding is white vinyl siding. Vinyl siding is not an appropriate material in historic districts.
- No information has been submitted about the type of roofing installed. Materiality and product information would be needed to review the roof.

- There were originally two entry doors to the building along Chew Street. A fiberglass door with a fan lite has been installed at the right entry, which is not appropriate in configuration. A four-panel door that matches the original shown in the previous application would be appropriate. The left side entry door has been removed entirely, and while there is a recess where the doorway and transom were, the door and transom were removed and the opening bricked in and painted. This is not an appropriate treatment.

- The gutters installed appear to be k-style gutters, which are not appropriate. Half round gutters would be an appropriate profile.
- More information is required to review the extent of work at the rear of the building.

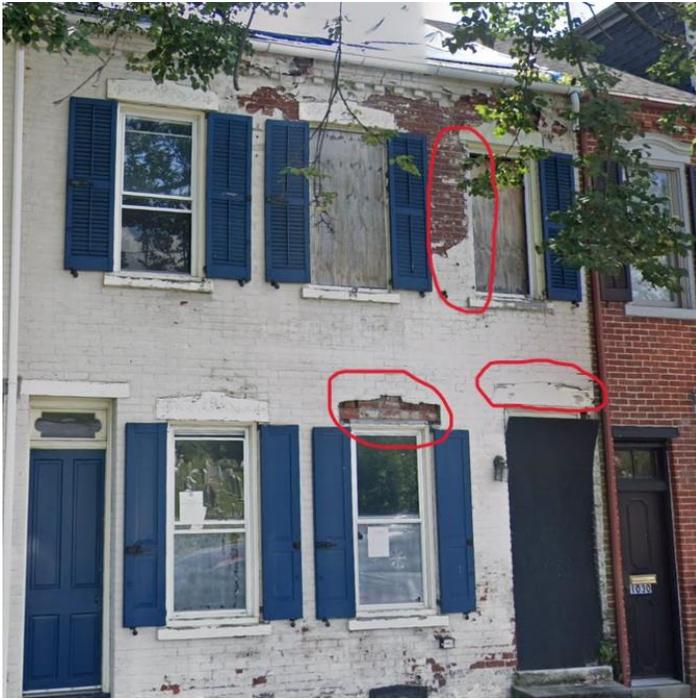
Front Elevation, Missing Window Header (Previous Application)

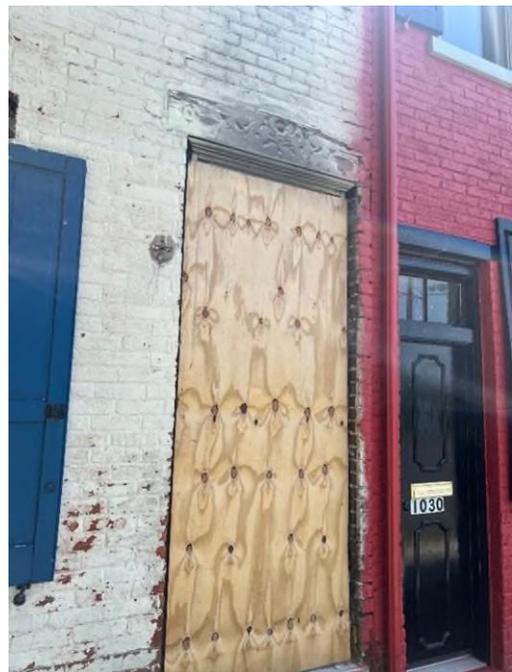
Existing Entry (Previous Application)

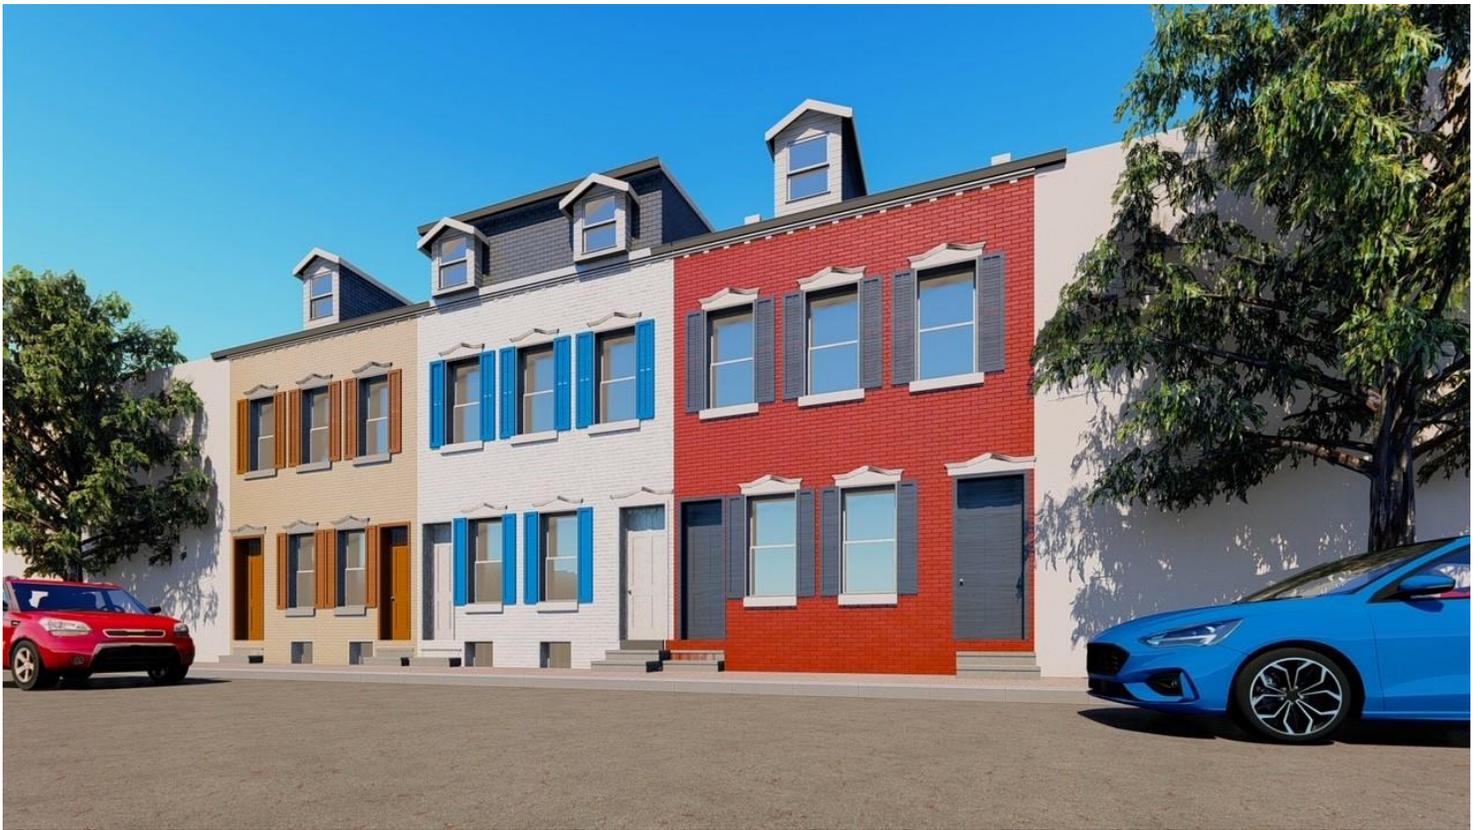
Rendering, 9/3/2024 (Applicant)

- Windows protruding from the third-floor addition, to allude to the geometry of neighboring dormers
- Modified materials at the third-floor addition walls to replace the vinyl siding. More information is needed to comment on the proposed alternate material.
- Paneled doors at the main entry and grocer's alley

While these proposed modifications do not eliminate or reduce the third-floor addition, the applicant appears to be taking steps to mitigate the negative effects of the new work.

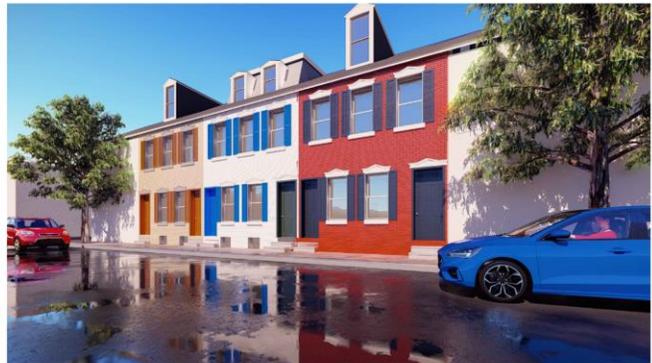
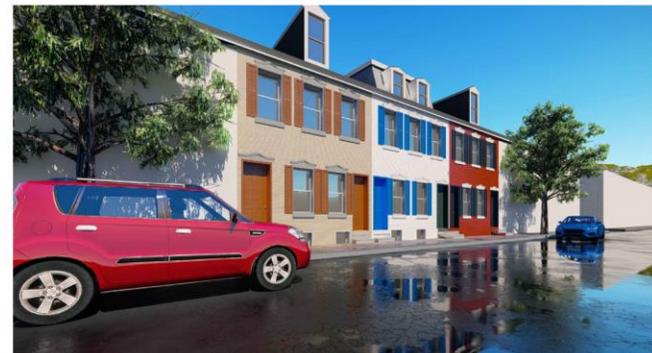
- The third-floor addition is proposed to be modified, including relocating the windows, adjusting framing so that the windows appear to have a configuration closer to a traditional dormer, and revising the vinyl siding to engineered wood siding.
- A 6-panel door is proposed to be installed at the historic baker's alley.
- A 5-panel entry door is proposed to replace the previous door with fanlite.
- The engineered wood siding is proposed to be the cladding on the third floor addition at the rear.

While these proposed modifications do not eliminate or reduce the footprint of the third-floor addition, the applicant appears to be taking steps to mitigate the negative effects of the new work. The third-floor addition does not maintain the original configuration of the dormer. Per Guidelines Section 4.1.9 (Additions to Existing Buildings), "dormer additions should not overwhelm the historic roof and should be scaled to preserve the predominance of the original roof form. New dormers are inappropriately large if they span from end to end of the original roof or if they reach from eave to ridge, or if they occupy the majority of the roof slope's area. New dormers on primary facades are rarely appropriate."

Vinyl siding is proposed at the rear of the building, which is visible from the public right-of-way. Vinyl is not an appropriate material in the historic district. A more appropriate material would be the continuation of the proposed wood siding.

- The front dormer facing West Chew Street is set back to a minimum 2' from the face of the brick wall and is oriented vertically, not slanted. Windows are set flush with the exterior face of the dormer and trimmed with casings, including pediments and caps as presented.
- Siding on the dormer reveal will be a maximum of 6" and smooth material in keeping with Guidelines.
