Historical Architectural Review Board
COA Preliminary Review Sheet

HDC-2025-00008

Address: 1528 Linden Street

Proposal: Violation correction - Vertical platform lift installation with landing infill and railings.

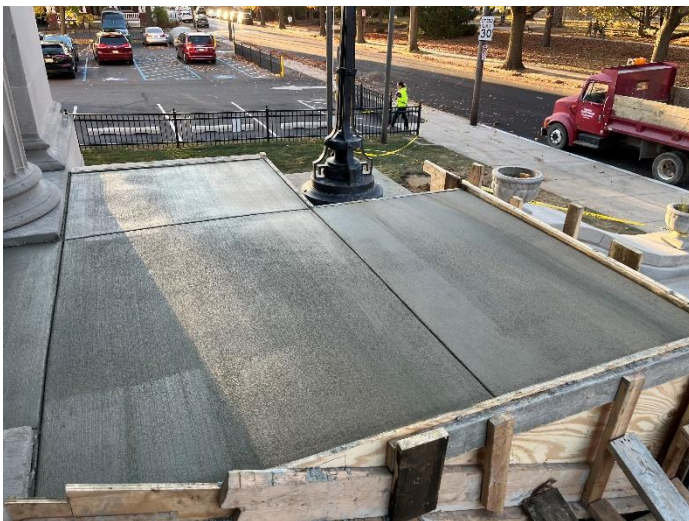
Top Landing (Applicant)

The Guidelines recommend considering provisions for reversibility so that modifications can be easily removed without damaging historic fabric in the future. It appears in the photos that concrete was built up over the existing stairs and tiled entryway. Any future removal of this concrete may compromise the integrity of the historic materials.

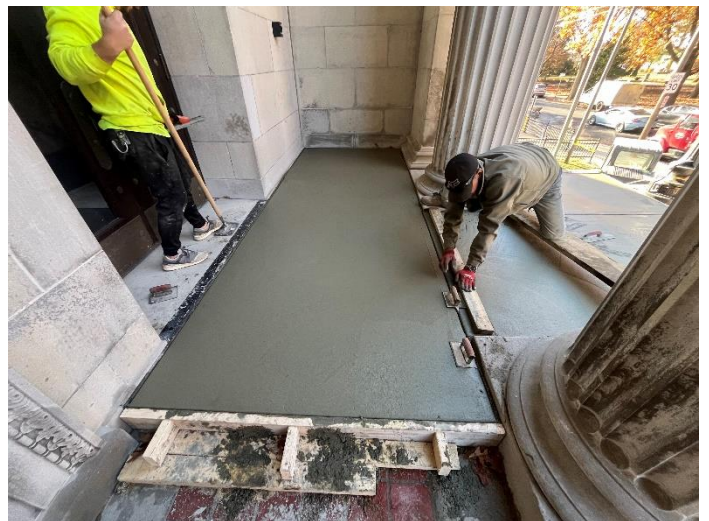
Entry Landing (Applicant)

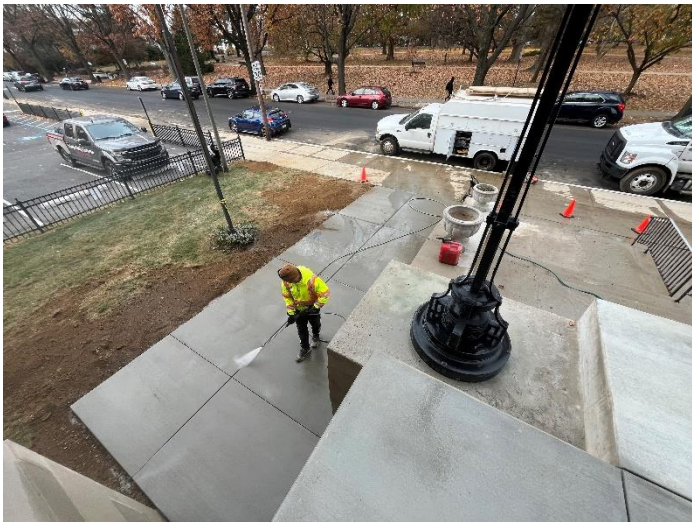
New Sidewalk (Applicant)

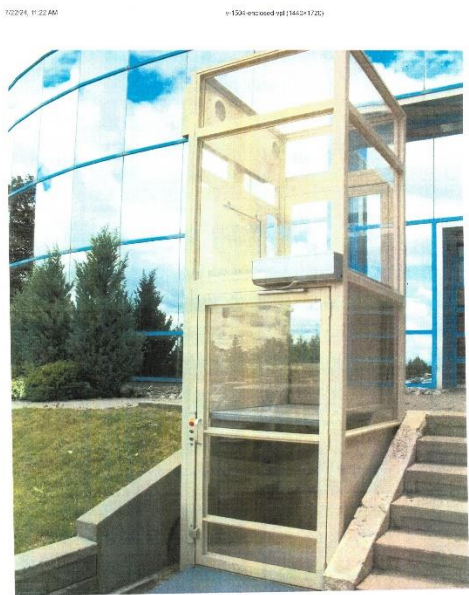
Proposed Lift (Applicant)

Information has been submitted regarding the configuration of the lift. The metal components in the sample image appears to be a buff color. A color that complements the existing surrounding stone would be appropriate. It would be helpful for the applicant to confirm the intended finish color of the lift.

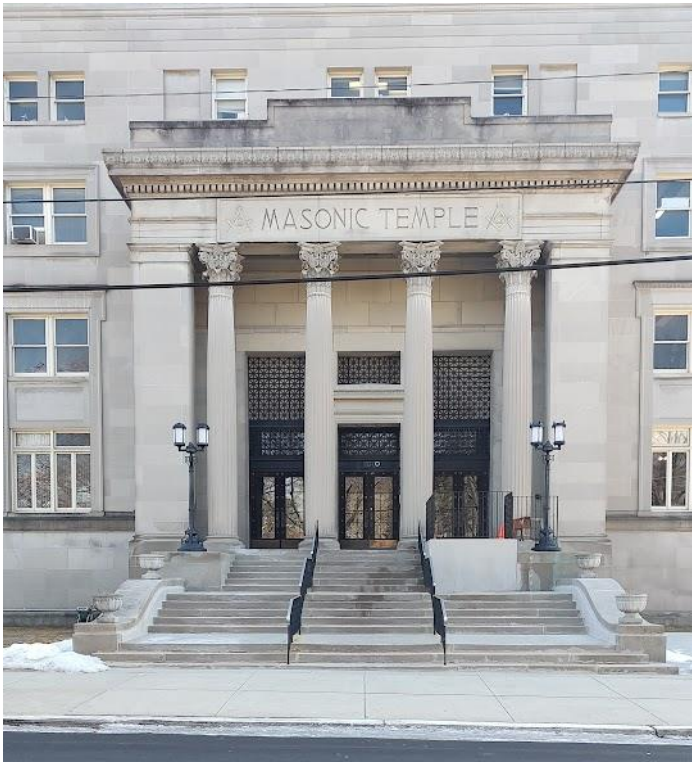
Current Condition – Front Elevation (Staff)

While providing an accessible entry at the main entry is desirable, the top landing does affect the composition of the front elevation and the original historic entry. Given that the first floor is quite elevated above grade and there are limited access points to the building, providing an accessible entry would be challenging. More information from the applicant would be helpful to understand the process for coming to this solution and if other options were explored, such as a ramp, and if there were dimensional requirements that resulted in the top landing extending past the lamppost.

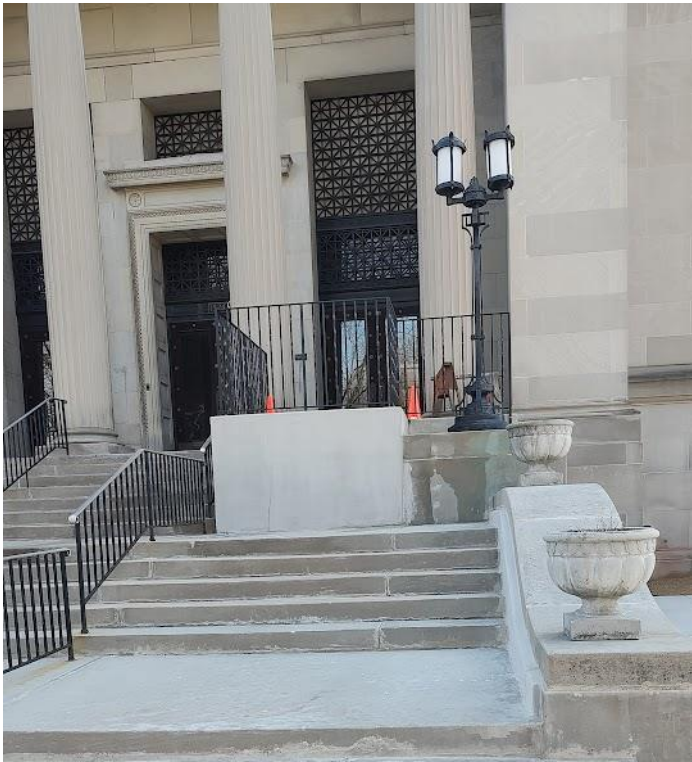
Current Condition – Railing/Top Landing (Staff)

The new railings at the top landing are similar to the existing stair railings in materiality and finish but appear to have a different profile.
