**HISTORIC ARCHITECTURAL REVIEW BOARD
CITY OF ALLENTOWN
November 1, 2021
FINAL REVIEW**

Property located at: 28 N 11th Street

Historic District: Old Allentown

Case: HDC-2021-00013

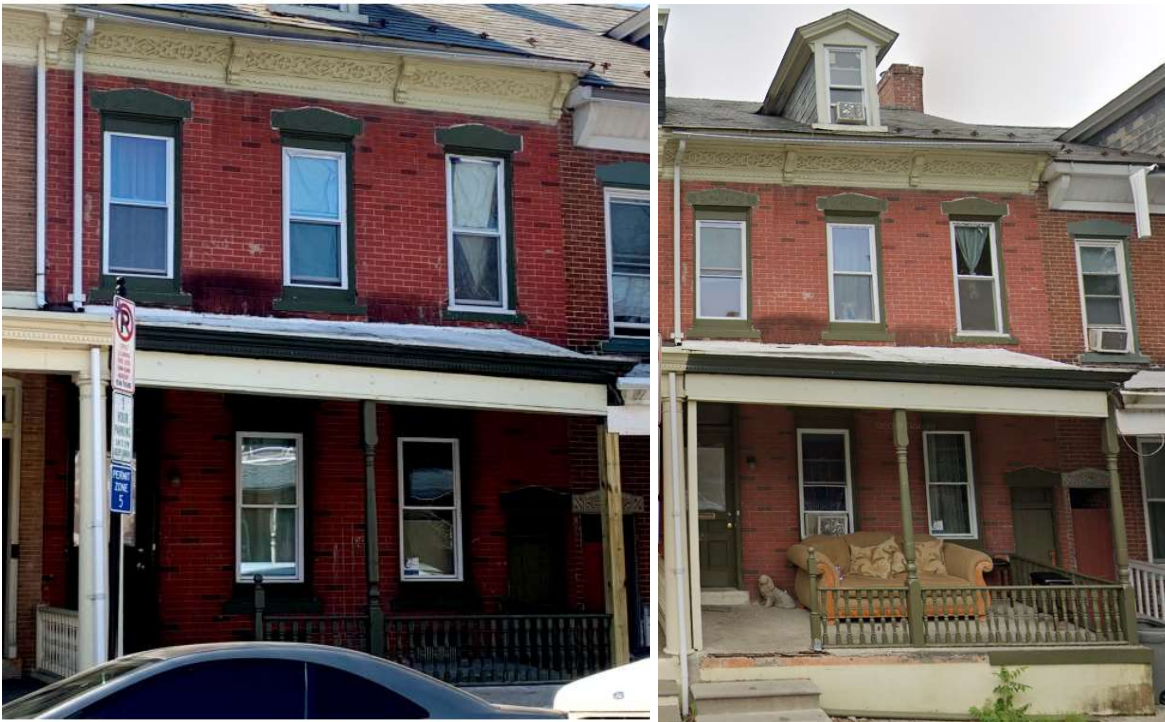
This 2½-story brick row house, ca 1888, is a Queen Anne Porch house with Eastlake influences. The slate gable roof displays a single dormer, snow catchers, and a bracketed, denticulated cornice with an extensively stenciled frieze board. The dormer has a 1/1 sash replacement window. There is a single shared chimney.

The 1st and 2nd floor windows are 1/1 sash set into openings topped with incised Eastlake lintels. The main entry is a glazed single door with a transom. The porch was previously altered with the replacement of the turned balustrades with a smooth board façade. Turned wood balustrades were reinstalled. There is a grocer's alley door with a transom and an incised Eastlake lintel. There are concrete steps.

The existing 6x6 post is an inappropriate alteration and requires reversal. The lumber post does not match the existing historic porch features and is not consistent with the Design Guidelines. The replacement of the lumber post with a new custom turned wood post that replicates the historic post is appropriate. The proposed custom post is to be fabricated to match the existing middle porch column in size, profile, dimension, and appearance. The custom in-kind replacement is an appropriate treatment.

The poor condition of the porch roof and base has been noted in past reviews. The replacement of the lumber post with a new wood post will not address all existing structural and appearance issues.

The proposed replacement of the inappropriate replacement windows appears to be appropriate. The window openings are proposed to be returned to their original dimensions and new frames will be installed. The proposed window options are double-hung aluminum or aluminum-clad wood windows. Aluminum-clad wood windows are an acceptable alternate according to the Guidelines. The proposed windows are 1-over-1 and will match the original windows and existing windows at this facade.

It is recommended to replace the existing lumber post with a new wood post. The proposed custom turned wood post that replicates the historic turned wood post in size, dimension, profile, appearance, material, and finish is the preferred treatment. The design of the post should match the existing turned wood post at middle of porch. When replacing the column, retain all existing surrounding historic porch material, including but not limited to wood balustrades, intermediate full-height post, and newel post.

The proposed window replacement appears to be appropriate by correcting the windows altered without HARB approval. The new aluminum-clad wood windows are consistent with the Guidelines and the window openings will be returned to their original dimensions. New wood frames, brick molds, and trim should match the original. Aluminum-clad wood windows are recommended over aluminum windows due to their better performance and appearance.

The repair and restoration of the porch base and steps is still recommended. Previous recommendations and HARB discussion should be considered.
