CITY OF ALLENTOWN

R180 – 2021

Certificates of Appropriateness for work in the Historic Districts:

**HISTORIC ARCHITECTURAL REVIEW BOARD
CITY OF ALLENTOWN, PENNSYLVANIA
October 4, 2021
FINAL REVIEW**

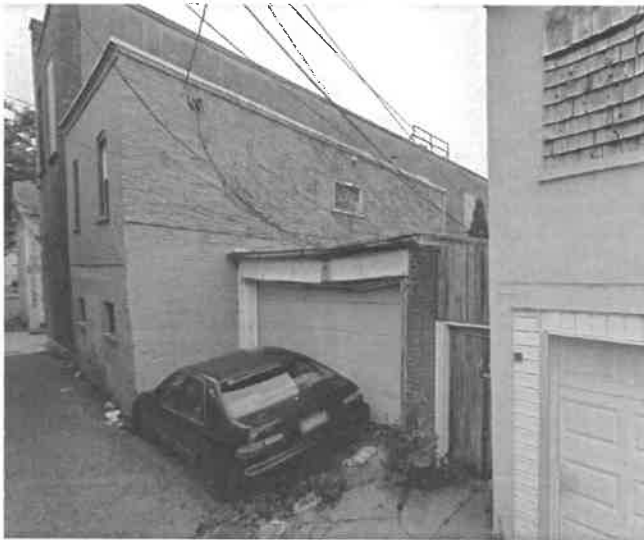
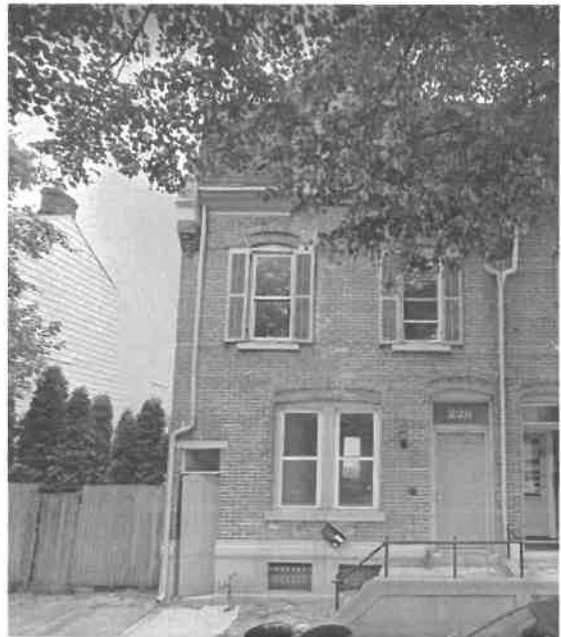
Property Location: 229 N. 10th

This 3-story brick row house, ca 1890 is Composite in style. The mansard roof has a double dormer covered with aluminum siding with a gable roof, corbelled brick brackets and pommels at the ends of the dentilated cornice, scalloped slate and a single chimney. The windows are 1/1 sash with Eastlake lintels. The main entry is a single door with transom, boarded shut grocer's alley and a visible basement window grille. The stoop has iron pipe railing. A projecting flower design in stone decorates the corner and middle of the front wall. A patch of brickote has been removed to reveal red brick beneath.

CY echoed this, stated it is beyond repair, the wood structure is rotted, door doesn't open, sagging structure, roof leaks.

Motion to approve demolition of garage and partial demolition of the existing brick wall along the property edge down to knee wall height of 3'-0", repoint the wall and add a brick or cast stone coping, ensure the existing concrete pad is in good condition, repair as needed and provide adequate drainage was made by HARB member Patricia Jackson, motion was seconded by HARB member Glenn Lichtenwalner. Motion carried with unanimous support.

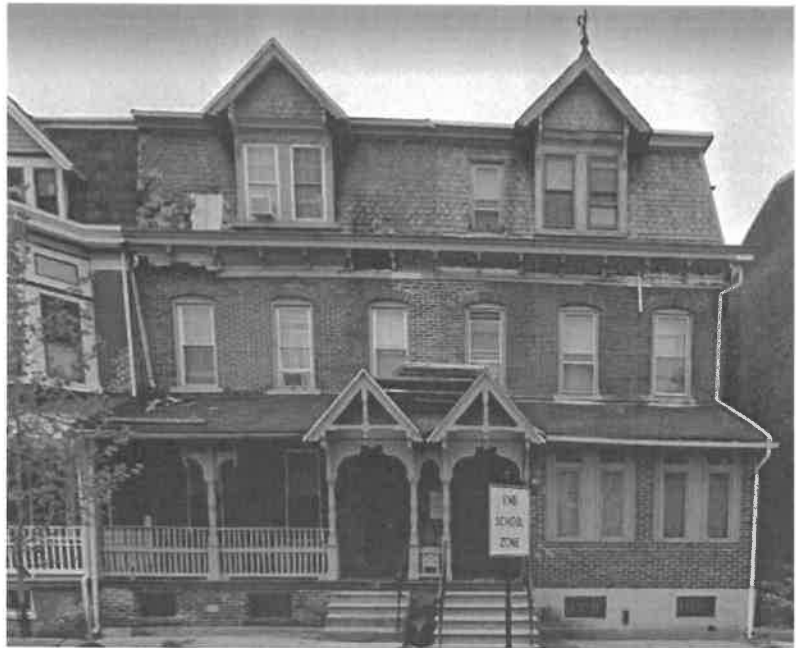
Property Location: 342-344 N. 9th St.

The windows are 1/1 sash set into segmental brick arches. The window openings are topped with segmental brick arch lintels. The main entry is a single modern door with projecting moldings. The porch has been enclosed with brick and glass blocks. The concrete steps have a wrought iron railing with a peak roof over them. There are 2 basement window grilles visible

The porch disassembly and partial removal has significantly impacted the historic building and the proposed reconstruction as submitted will negatively impact the building. The proposal to reconstruct the porch roof with wood and install beadboard at the ceiling are appropriate choices of materials. Reuse of original woodwork is encouraged and appropriate. The scope of work at the porch deck, railing, and brick base is insufficiently explained. The submitted elevation drawing of the proposed porch railing differs significantly from the existing design of the porch and is not appropriate. The porch floor level appears to be dropped below either the existing brick base or a new wall. The proposed railing is a capped picket with no columns; the existing railing is a two-level wood railing with molded caps and the porch columns are ornate turned wood over fluted bases that are key elements of the porch's design and match the adjoining building. The treatment of the brick base is unspecified. Tongue-and-groove wood boards are proposed for the porch deck, which is an appropriate material selection. However, the existing condition of the porch deck appears to be in fair condition and may not warrant full replacement; the reason for replacement should be discussed, including any life safety or code requirements. The columns and railing also appear to be suitable for repair and reuse, and a code-compliant design could be achieved.

Motion to accept the application with the stipulation that all original wood components be retained and reused to the greatest extent possible, like for like materials be used for replacement components; the owner and contractor provide photos for reference from the side of the building, showing details to be replicated on the front of the building; provide photos for the cornice and drawings for the rafter tails, provide materials list, remove the porch topper railings, provide 5" ½ round gutters and 3-tab asphalt roof shingles. The owner and contractor to provide a bracket

and cornice panel mockup to KP for review. The motion as stipulated above was made by HARB Chair Dave Huber, motion was seconded by HARB member Patricia Jackson. Motion carried with one vote in opposition from HARB member AJ Jordan on the basis that a more detailed application be presented prior to HARB approval.

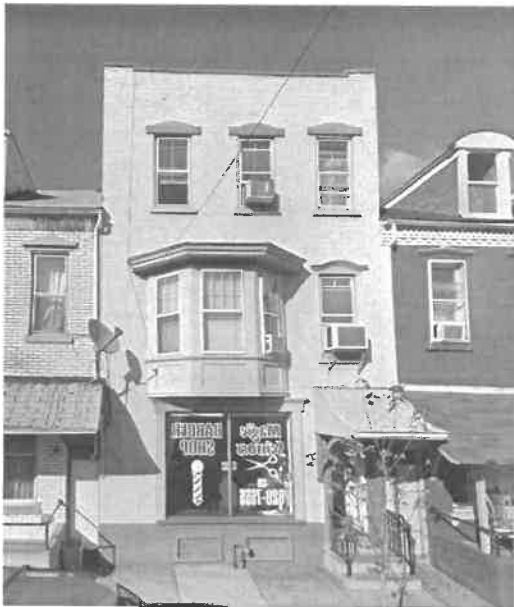
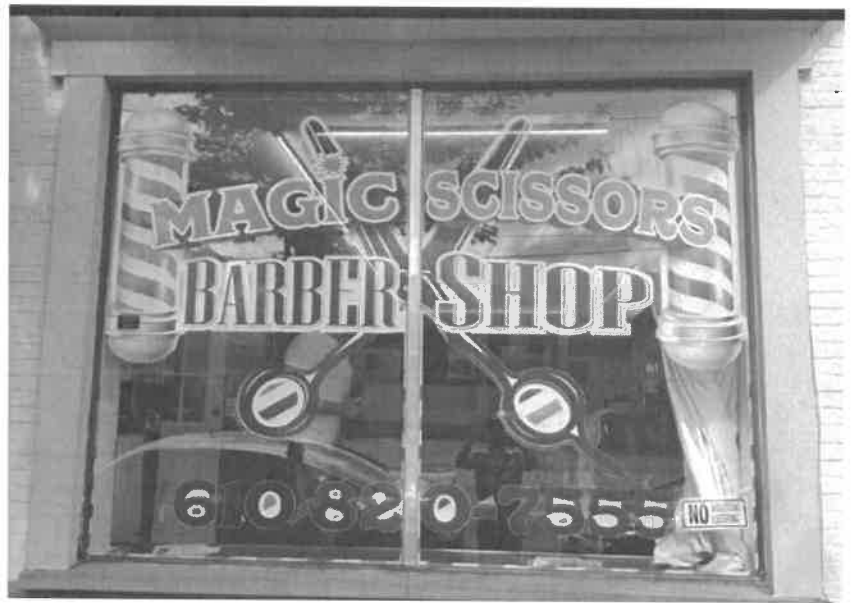
Property Location: 805 W. Chew

This 3-story brick row house, ca 1865 is Italianate in style and is a combination of commercial and residential usage. The roof is flat and cannot be seen, there may be a shared chimney. The 1st floor is a business with a large window; the main entry is a single glazed door with an Allentown Porch Roof over the door. There are concrete steps and a stoop with wrought iron railings leading up to the door. The 2nd floor has a single 2/2 sash window with an Edwardian three window bay with a cornice. The 3rd floor has three 2/2 sash windows, all the single windows have curved projecting Italianate lintels. The brick has been painted white with gray paint below the 1st floor windows. There are two basement windows that look to be boarded closed. The Allentown Roof that is in place over the doorway is a cyma-curve profile hood with closed ends and decorative wood brackets, the rafters are hidden and roof is asphalt shingles. This hood is one of six Allentown Porch Roofs in the neighborhood.

The proposed sign replacement does not contribute to the historic character of the building; however, the existing window sign also negatively impacts the building. The proposed sign appears to cover approximately the same amount of window area as the existing sign. The proposed lettering colors use darker blue than the existing sign, which appears to help the sign blend better into the background when the window is uncovered. This potential reduced visibility is encouraged; however, the lettering will likely be just as visible when the window is covered from the interior. The proposed design is symmetrical and more evenly divided across the two-light storefront window than the existing sign.

Motion to accept the application with the recommendation to change the phone number to white numbers and remove the infill pattern on the graphic representation of scissors was made by HARB member Glenn Lichtenwalner, motion was seconded by HARB Chair Dave Huber. Motion carried with unanimous support.

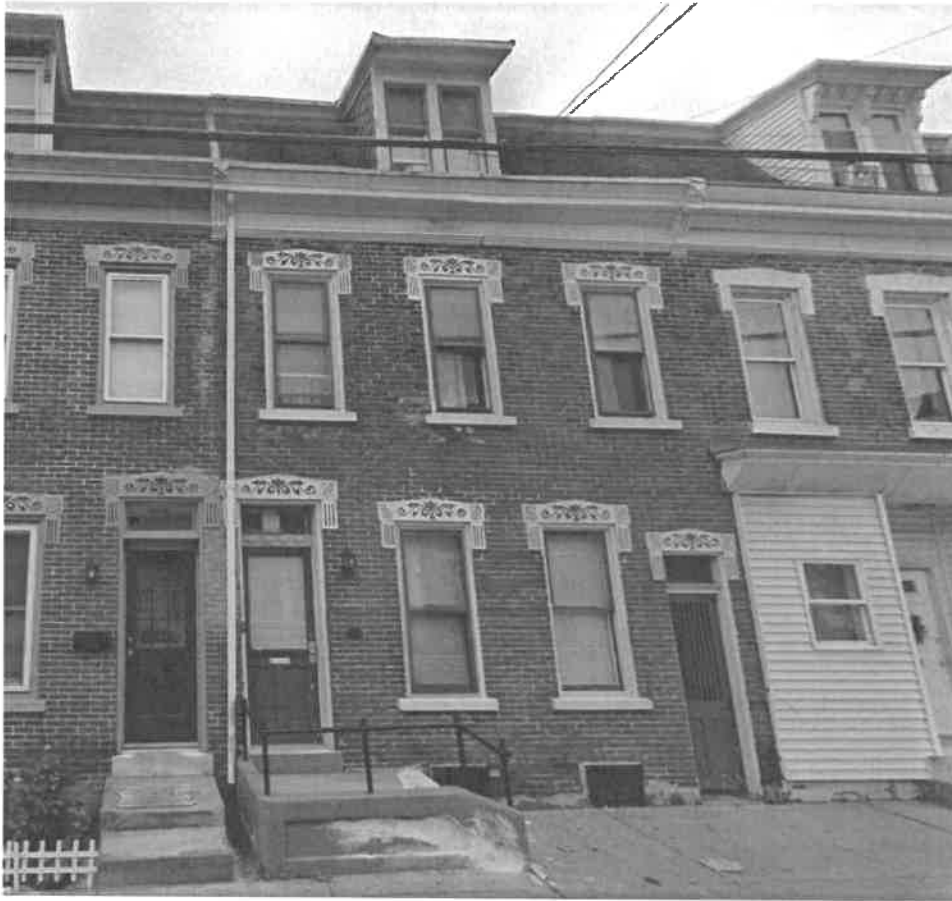
Property Location: 820 W Liberty St.

This 3-story brick row home ca 1887 is a Second Empire house. The mansard roof has asphalt shingles with a double dormer, projecting eaves and Italianate brackets. The windows have 1/1 sashes with Eastlake lintels. The main entry is a single glazed door with a transom. There are 2 basement window grilles visible. There is a grocer's alley leading to the backyard.

The proposed door replacement will have a positive impact on the historic building. The new door matches the door that was intact before the violation occurred. This door was wood with two lower panels and a large upper panel of glazing. The proposed new door matches this door in its materials, construction, and appearance. The proposed door is appropriate. No information for proposed hardware was submitted.

Motion to accept the application with the recommendation to use historically appropriate hardware and the stipulation that the old door and pre-hung frame be removed entirely, the jambs be restored, and the threshold replaced with an historically appropriate material either wood or bronze was made by HARB Chair Dave Huber, motion was seconded by HARB member Glenn Lichtenwalner. Motion carried with unanimous support.
