**Allentown Historical Architectural Review Board  
COA Preliminary Review Sheet**

**HDC-2024-00031**

**Address: 301 N 10<sup>th</sup> Street**

**Proposal: Replace siding**

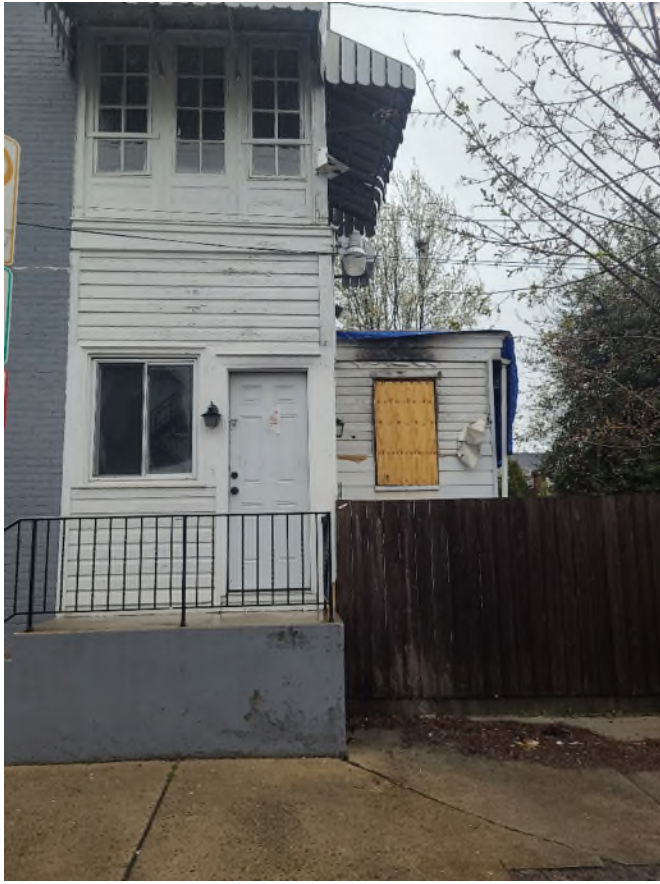
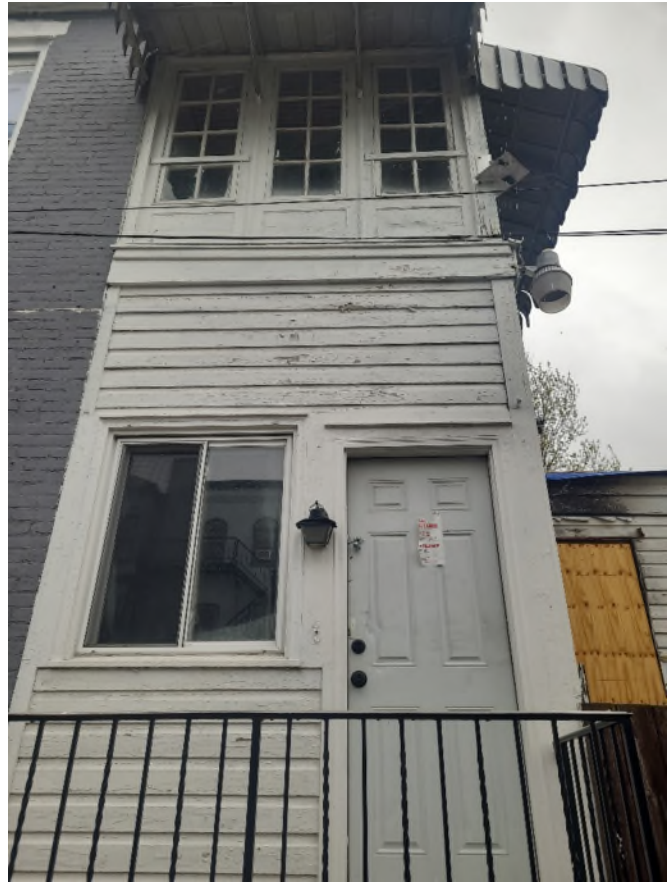
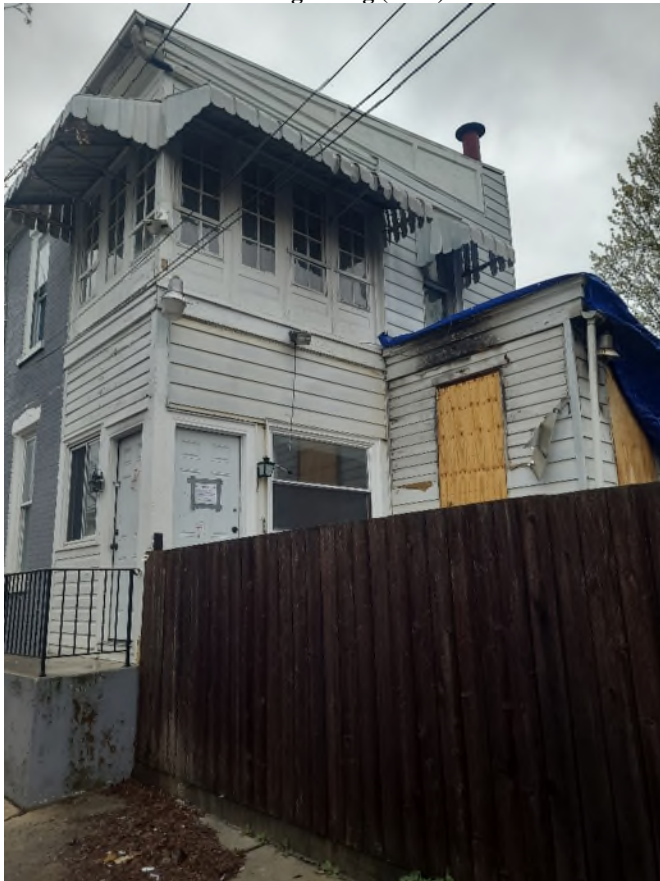
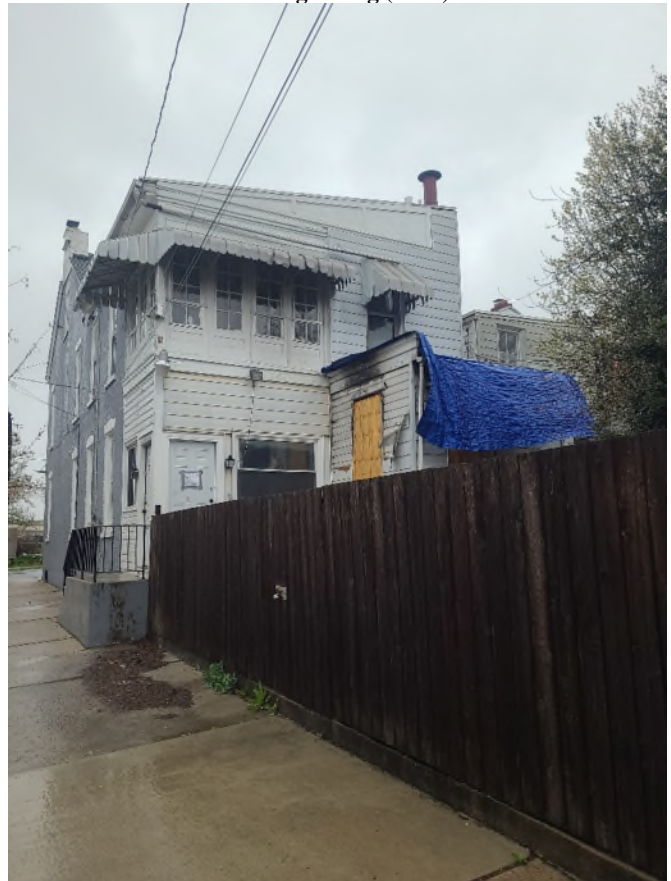
**Existing Siding (Staff)**

**Observations & Comments:** It is not clear based on the application the extent of the siding replacement; whether it is the entire rear portions with siding or just areas of damage. It appears there has been fire damage in the rearmost addition and the existing metal siding, which was previously installed to cover existing wood siding has been pulled away. Based on the photographs, it does appear that the existing wood siding remains beneath the metal siding and is largely intact. Replacing siding with a vinyl siding is not historically appropriate per the guidelines. It may be acceptable to replace the metal siding with an in-kind replacement, but per Section 3.2.7, the recommended approach would be removing the existing metal siding that is covering the original wood siding and repairing and repainting the extant wood siding.

**Staff Recommendation:** It is recommended to deny the application.

- Repair wood siding and paint.
- Repair broken windows (replace glass) and paint.
