Historical Architectural Review Board COA Preliminary Review Sheet

HDC-2024-00035

Address: 245 N 11th Street

Proposal: Roof Replacement

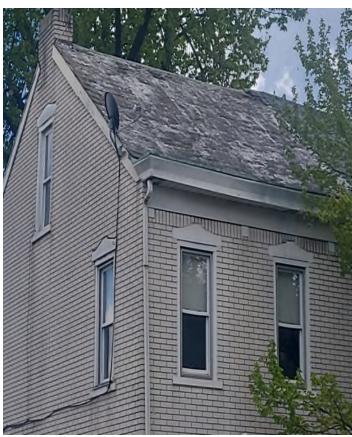
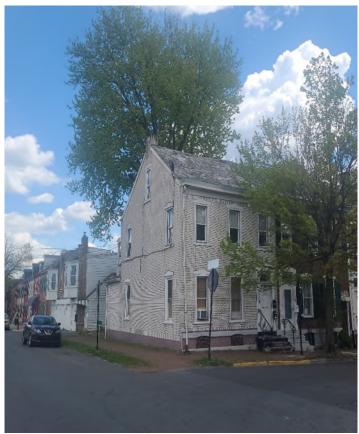
Current Roof (Applicant)

<u>Observations & Comments:</u> It appears that the existing roof is a non-historic 3-tab asphalt shingle roof and the proposed replacement material is an in kind replacement. Though, it is not clear if the proposed color matches the color of the existing roofing. The guidelines indicate that replacement materials should match the existing in color, which appears to be a medium to dark grey.

Discussion: The applicant noted the shingle colors will match the existing and the previous owner did a lot of repairs; the front is slate with silver coat and the back is 3-tab with architectural shingles. Given the clarification of the current roofing material, GAF Slateline or similar is recommended for the front slope. Discussion was held about what should be considered in-kind given the number of roofing surfaces that exist on the roof. The applicant noted that it is an increased expense for the shingle cost as well as installation cost for the GAF Slateline shingles. The applicant noted the Slateline shingles install differently than architectural shingles and there is less to a bundle for Slateline. Given the existing conditions, it was noted that GAF Slateline or similar would be acceptable at the front and 3-Tab or Slateline will be acceptable at the back.

<u>Staff Recommendation:</u> It is recommended to approve, with conditions related to the color of the in-kind replacement material selected to better match the existing roofing.

- Replacement material to resemble the original roofing as closely as possible (GAF Slateline Shingle or similar) will be utilized.
- At the back slopes, if the owner chooses, in-kind replacement of 3-Tab shingles can be utilized in lieu of Slateline.
- Color to match existing roofing materials (Charcoal or similar.)
