**CITY OF ALLENTOWN**

**R19 – 2024**

**Certificate of Appropriateness for work in the Historic Districts:**

**Historical Architectural Review Board  
COA Preliminary Review Sheet**

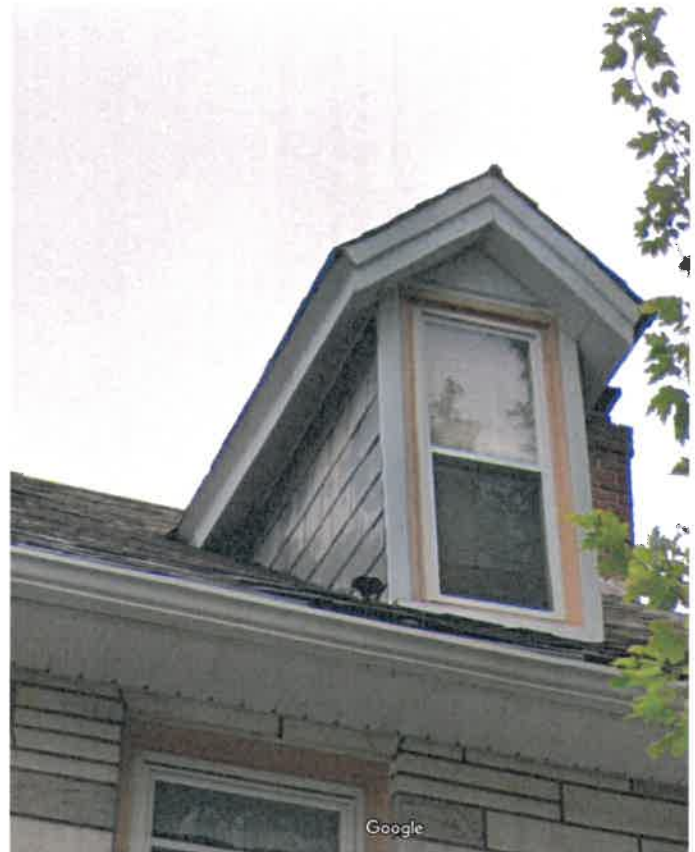
**Detail of roof, 2019.  
(Google StreetView)**

The applicant contends that the existing slate roof is failing and in poor condition. The current roof contains typical rectangular slate singles in a gray color. The application proposes to install GAF Slateline shingles, which are an appropriate alternate that generally match the existing rectangular slate in dimension, shape, profile, color, exposure, and overall appearance. Staff finds that the proposed shingle complies with the guidelines in Section 3.1 Roofs.

Mr. AJ Jordan moved to approve the amended application presented on 1/8/2023 for the removal of slate shingles, including the cheek walls and roof of the dormer, and installation of GAF Slateline shingles at 515 N. Park Street pursuant to Chapter 3, Section 3.1 Roofs, with the following conditions:

- the replacement GF slate line shingles will match the existing slate in dimension, shape, profile, color exposure, and overall appearance.

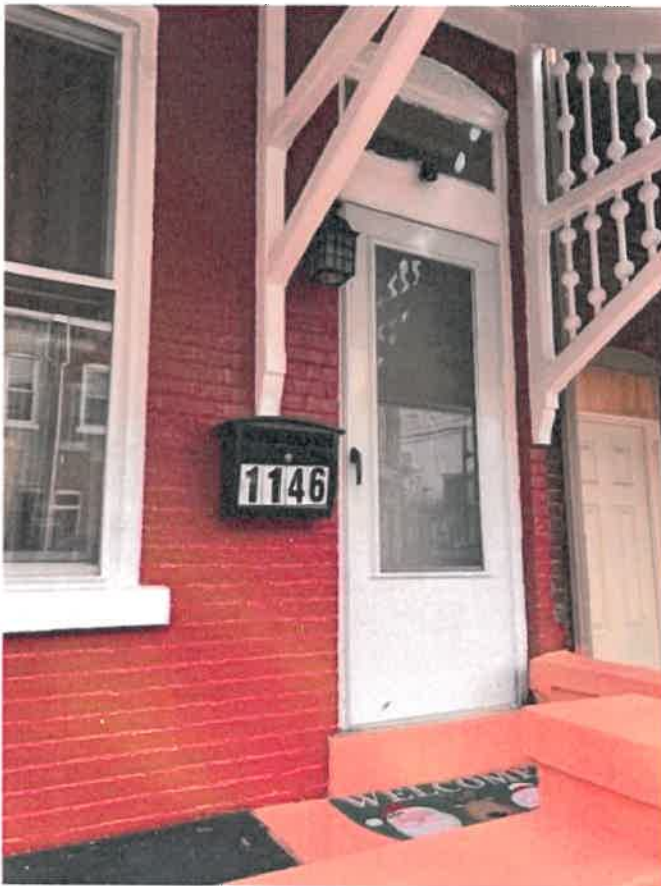
**1146 W. Turner Street, 2023.  
(Applicant Image-Storm Door)**

**Discussion:** It was clarified that both the storm door and the main door to the house were being reviewed. The applicant said the similar doors were already there when he purchased the home, and he replaced them to match them. While the discussion ensued, Google Streetview was consulted, and it was found that a similar storm door had been on the building since before 2008. Sympathetically, Mr. Huber pointed out the problem the homeowners faced when illegal changes were done before they bought a home. Mr. Jordan confirmed this was a very recent “in-kind” change. Technically the owner should have come to the HARB for review of a new set of doors. The applicant said he didn’t understand why he had to come to the HARB every time he did any changes to the exterior of the house. Mr. Huber said it was part of owning a home in an historic district. The HARB struggled with how to handle the violation. Mr. Jordan thought there were extenuating circumstances with this case and that it could be considered an in-kind replacement.

**Action:** It was decided this was a replacement in-kind. Mr. Alex Encelewski moved to accept the change pursuant to sections of the Guidelines for Historic Districts: Chapter 3, Section 3.6 Doors, and found that there were circumstances unique to the property: The unique circumstances were the door and storm door were already changed to non-conforming before the current owner purchased the home.

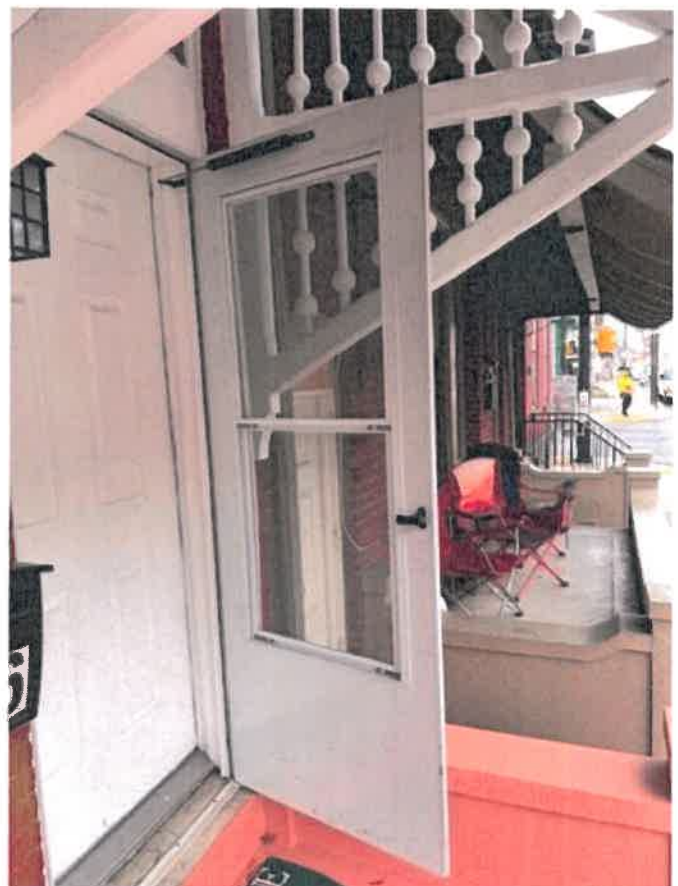
**1146 W. Turner Street 2023.  
(Applicant Image-Front Entry Door)**

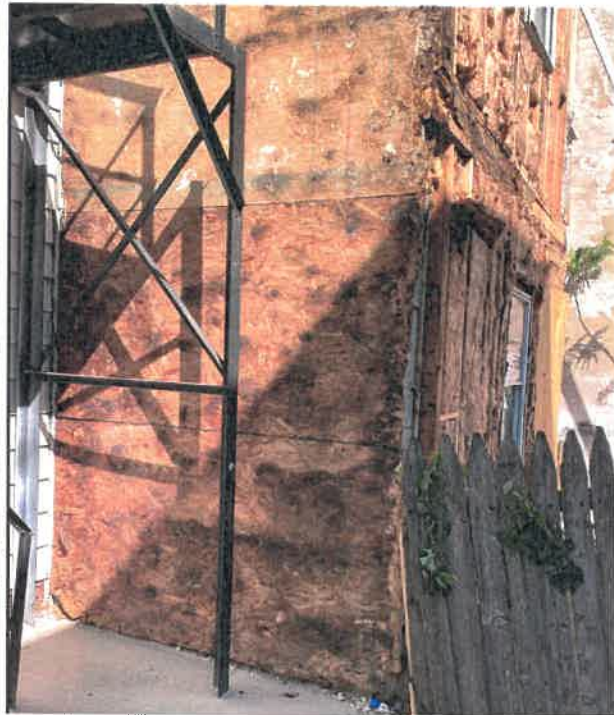
**Photo showing the wall condition following stucco removal.  
(City of Allentown)**

Staff finds that if the applicant satisfies the requirements to properly restucco the addition, the work will comply with the design guidelines since no historic material was lost and the reconstruction will largely be completed in-kind.

Mr. AJ Jordan moved to approve, with conditions, the application presented on January 8th, 2024, for legalizing the reconstruction of the rear addition of 327 N Nagle, pursuant to Chapter 3, section 3.15 demolition, and found that there were circumstances unique to the property, and that this application was largely a replacement in kind, except for the changed door location. The following conditions were agreed to by the applicant:

- The addition must be approved through code

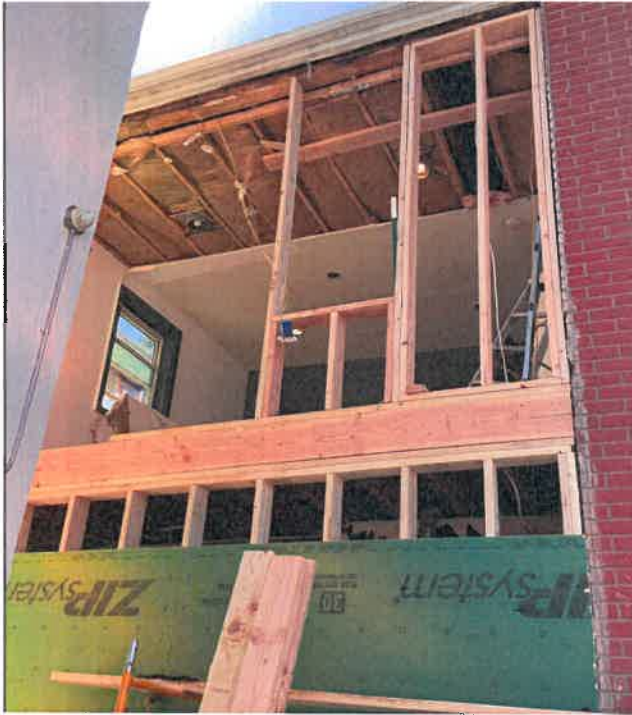
Side façade with walls removed and reframed.  
(City of Allentown)

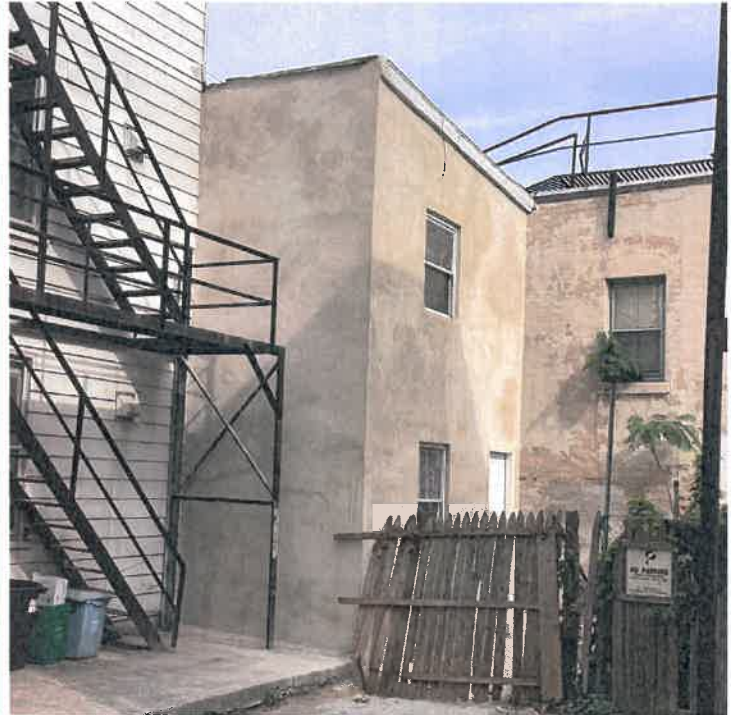
Rear of the rebuilt addition visible from Pine Street.  
(City of Allentown)

Staff finds that the addition held no architectural or historical significance and was constructed after 1932, though the exact date was not determined. The addition consisted of frame construction and contained no architecturally significant details or features. The north elevation included one second-story window and one entry door at the east end. The rear elevation had one window at each story, and the south elevation contained no openings and was partially visible from Pine Street.

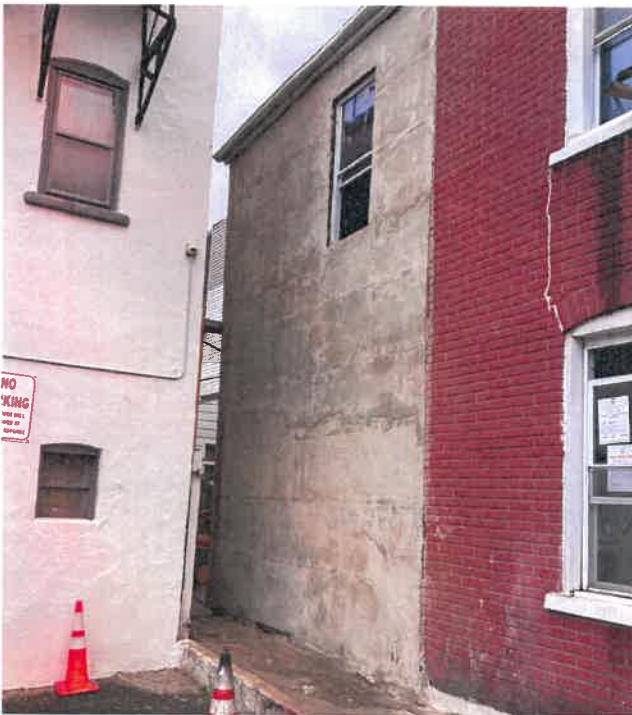
Photo showing rebuilt wall with door moved.  
(City of Allentown)

Mr. Jordan questioned whether the project needed a COA if it was reconstructed in kind. Mr. Huber pointed out the change in door location and it was decided a COA was needed.

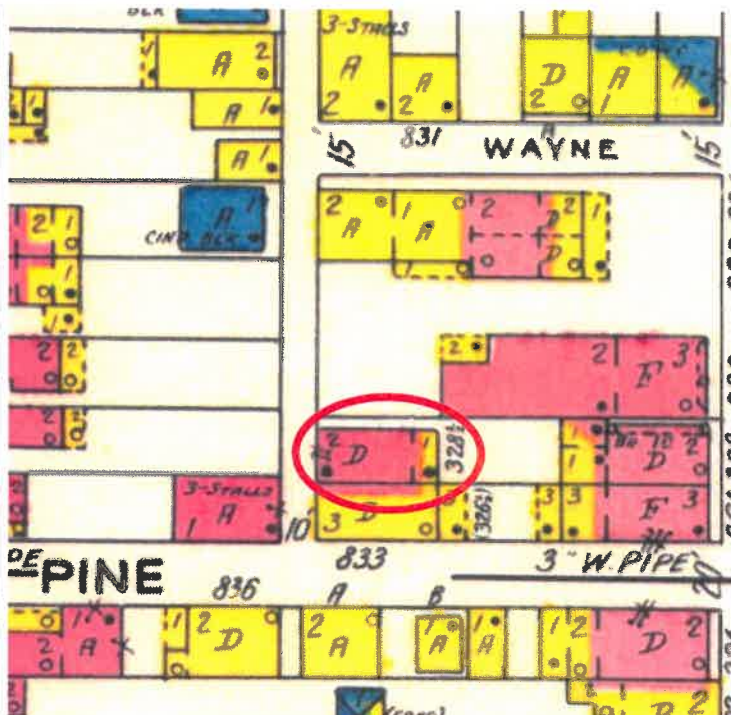
1932 Sanborn map showing that a small one-story frame addition existed.  
(Pennsylvania State University Libraries)
