CITY OF ALLENTOWN

R28 – 2024

Certificate of Appropriateness for work in the Historic Districts:

**Historical Architectural Review Board
COA Final Review Sheet**

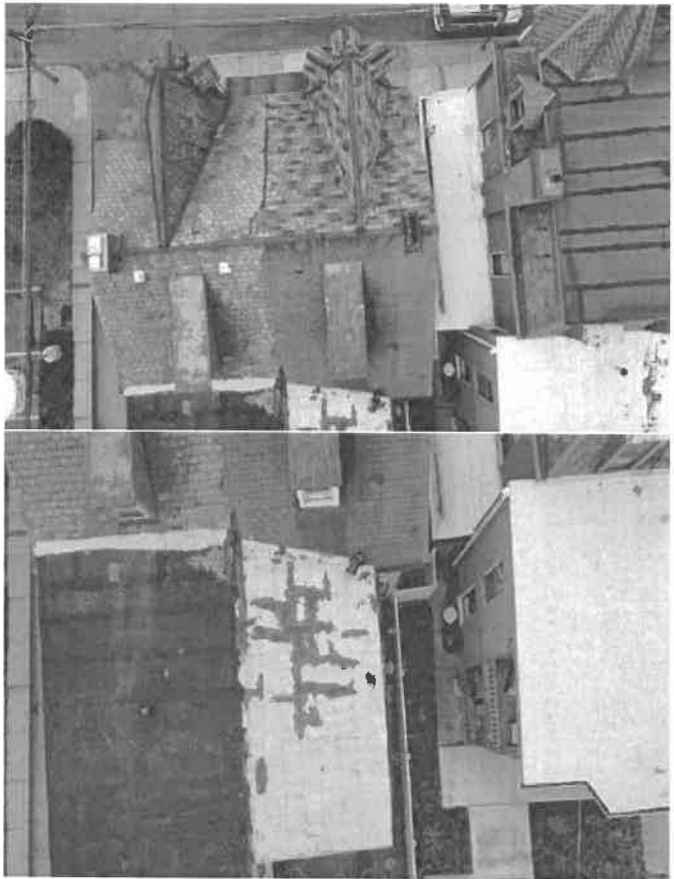
**Current roof condition
(applicant)**

Observations & Comments: Google Streetview from 2014 shows slate roofing on the gable roof and tower roof but the later satellite views shows replacement shingle roofing. Rolled metal ridge caps are still on the roof. Replacement of existing asphalt shingles on the gable roof and tower roof with new GAF Slateline shingles in the Antique Slate color would be historically appropriate. New or refurbished rolled metal ridge caps should be installed on the roof edges of the tower roof and dormers. The existing historic finial must be retained, repaired in needed, and reinstalled. It is recommended to paint the rolled ridge caps and finial in a matching red color (Tinner's Rd)

Staff Recommendation: Recommend approval as submitted with the condition that metal rolled ridge caps are refurbished and reinstalled or replacement in-kind. The finial must be retained, repaired, and reinstalled.

- The existing metal rolled ridge caps will be refurbished and reinstalled or replaced in-kind
- The finial will be retained, refurbished, and reinstalled.
- Half round gutter will be installed with hangers appropriately mounted at the bottom of the sheathing
- Snow catchers will be retained and reinstalled
- A shingled cap will be installed at the joint between the neighboring roofs.

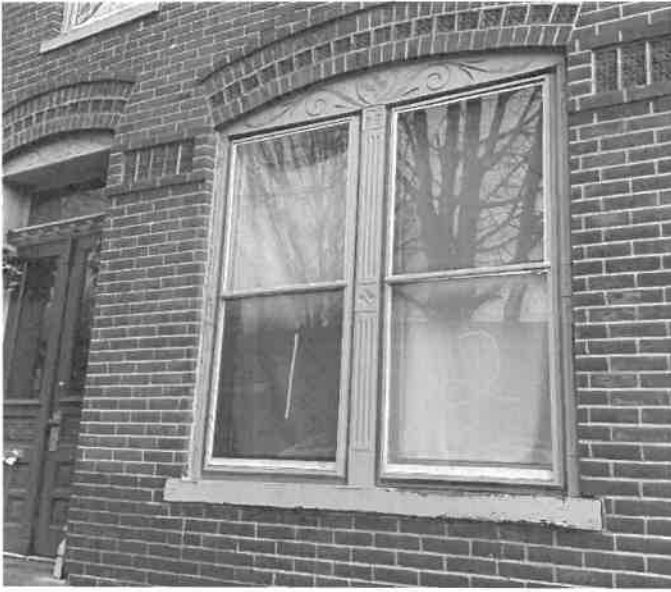
**Front windows of 433 N. 8th Street
(Applicant)**

Observations & Comments: The reason for replacing the historic window sashes is not evident or stated. The wood window sashes appear to be in good condition. The aluminum storm windows appear to be old. Ideally the windows, front and front corner in particular (windows 1, 2, and 3), should be retained, repaired as needed, weights and ropes repaired if needed, perimeter of frames caulked, and new energy efficient storm windows installed. The energy efficiency of a restored historic wood window with new storm window is roughly equivalent to a new insulated glass window.

Staff Recommendation: It is recommended to not approve the window sash replacement at the front and front corner of the building. It is recommended to approve the repair of the existing wood windows at the front and front corner of the

building and the installation of new aluminum storm windows in a color that matches or blends with the trim; or the installation of interior storm windows.

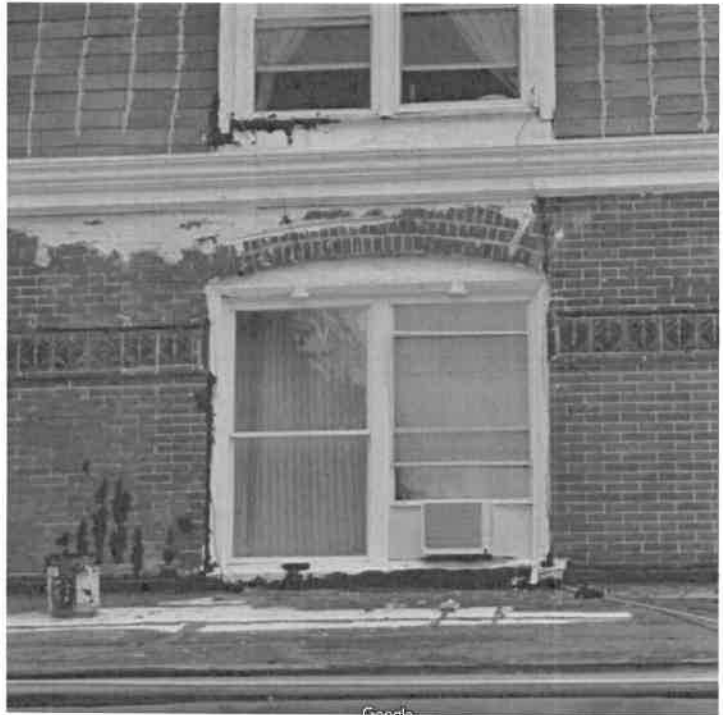
**Photo showing the windows and framing to be replaced.
(Google StreetView)**

Staff notes that the building description from the time the district was designated describes the front façade windows as two-over-two double-hung sash windows with Italianate lintels. Staff suggests that the description is incorrect and contends that the building has Queen Anne features and that the windows were likely one-over-one double-hung sash windows.

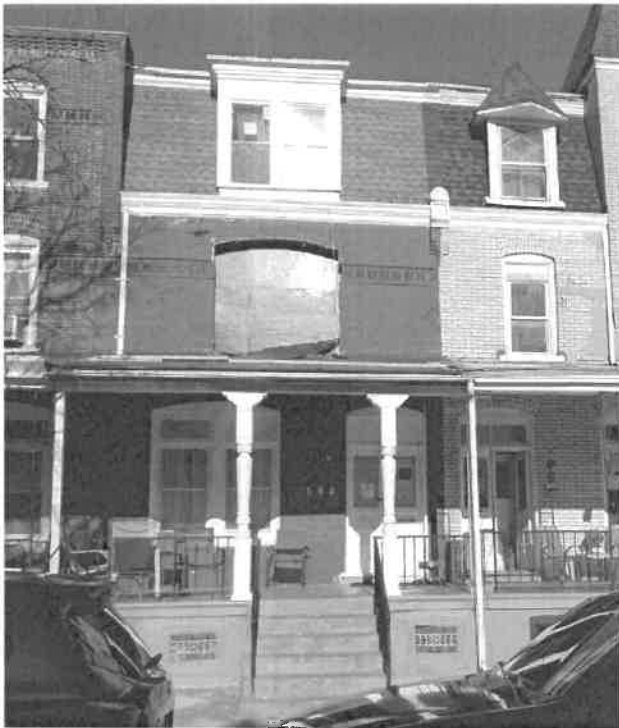
The second-story front façade windows and framing has been removed without a certificate of appropriateness and are currently in violation, though no formal notice has been sent. This application proposes to replace the historic windows and framing with new aluminum-clad wood windows and wood framing.

**Front façade with windows removed and boarded, 2023.
(Applicant)**

At the time the applicant submitted the application, the second-story windows and framing had been removed without permits or a certificate of appropriateness. The drawing included in the application shows the interior framing and proposed window replacement. Staff initially rejected the drawing and requested an exterior drawing showing the framing and masonry opening; however, the applicant again provided the same drawing of the interior framing. Staff finds that the HARB cannot properly review the proposed scope of work without a drawing that shows the exterior framing, noting that the decorative trim below the lintel and the center mullion have been removed and should be recreated to their original dimensions and appearance to comply with Guideline 3.5.15.

Staff further notes that the façade has paint and roofing tar on the brick that should be removed to bring the property into compliance.

- The exterior trim will be 1” thick, flat, rot resistant wood (not pressure-treated and not capped in aluminum)
- The sill will be a 4”-5” above the roof surface to the bottom and would be appropriately flashed from under the sill to the roof.
- The sill would be 3”-4” thick and made of rot resistant wood (not pressure treated and not capped in aluminum).
- The carved arched header piece will be reinstalled.
- The unique “keystone” details will be replicated.
- The window replacements are aluminum clad wood as proposed.
