## Historical Architectural Review Board COA Preliminary Review Sheet

HDC-2024-00025

**Address: 222 N West Street**

District: West Park Historic District Owner: Jose Capellan Vicente Applicant: Jose Capellan Vicente Proposal: Replace front door

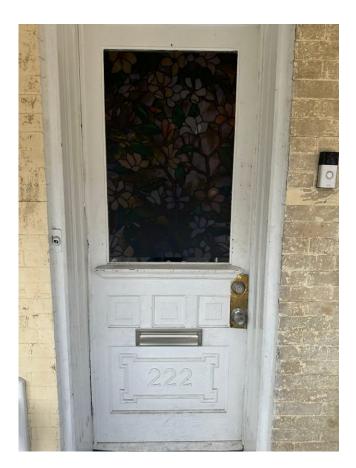
**Existing Door (Applicant)**

This application proposes to replace the front door of the residence, which is damaged and does not closed properly, with a smooth fiberglass surface door that is 36" x 80".

Observations & Comments: If the door is beyond feasible repair, replacement with the proposed fiberglass door is not historically appropriate. Ideally, the wood door with original, character defining detailing would be retained and repaired. This door contains an immense amount of character defining features, including the house number detailing. From the photographs, it does not appear that the door material is in poor condition, so perhaps upgrades to the hardware and/or weatherization is more appropriate, instead of replacement. There also appears to be a transom above the door. Given the proposed replacement door dimensions are 36" x 80", one would assume they plan on either removing the transom or framing down to accommodate the size differential, which is also not historically appropriate.

**Staff Recommendation:** It is recommended to retain the door if at all possible.
