**Historical Architectural Review Board
COA Final Review Sheet**

HDC-2023-00032

Address: 614 N. Law Street

Proposal: Legalize vinyl porch railings (violation correction)

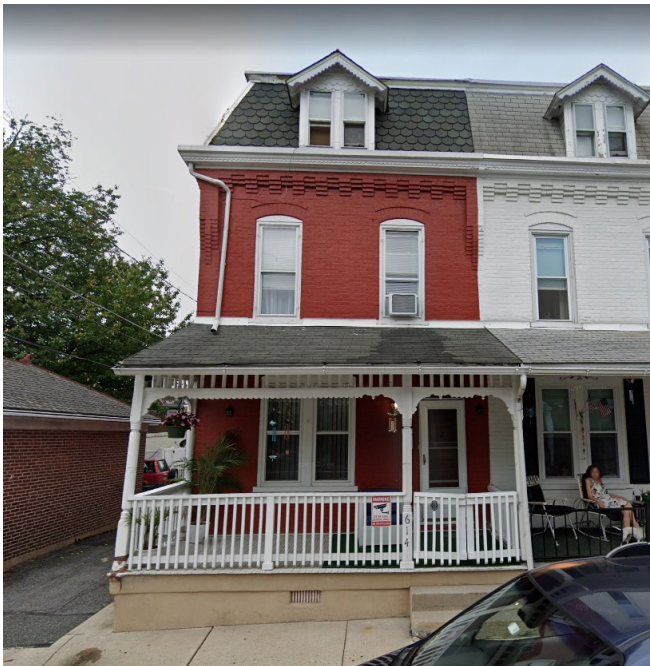
Front façade of 614 N. Law Street, 2019.
(Google StreetView)

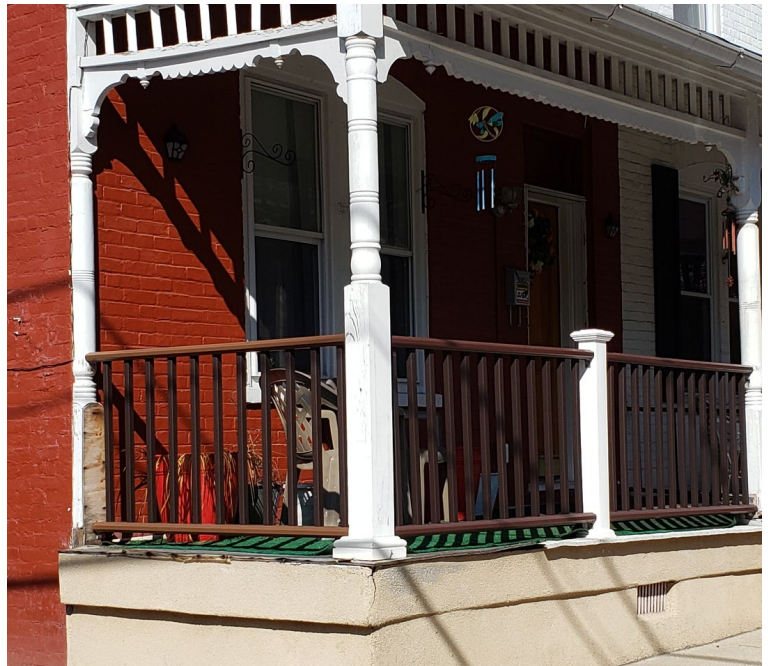
On May 12, 2023, staff issued a notice of violation for the installation of vinyl porch railings where non-original wood railings previously existed. This application seeks to legalize the vinyl railings. Staff notes that the corner porch post has also been recently replaced without a Certificate of Appropriateness.

Detail of vinyl railing, 2023.
(HARB files)

The previous railings consisted of a simple wood picket system and appeared to have replaced historic turned balusters, which are visible in the survey completed when the district was designated. The vinyl railings do not comply with Guideline 3.7.8, which notes that “vinyl railings and trim are not appropriate alternate materials for wood elements.” Staff suggests that painted turned wood balusters be installed in place of the vinyl railings, with some flexibility in design since the historic balusters were replaced several decades ago.

Mr. Huber noted that a portion of a bracket was also missing at the top of the replaced column. He suggested that it be restored as part of the scope to legalize the work, since it appears to have been broken during the replacement of the column. The HARB discussed returning the railings to wood to match the previous railings and commented that the porch column should match the historic column. Mr. Disla agreed to return the porch to its previous appearance and amended the scope of work.

Mr. Encelewski moved to approve the amended application presented on 6/5/2023 to replace the porch railings and column with appropriate wood railings and a wood column, with the staff to review details, pursuant to Chapter 3, Section 3.7 Porches & Steps. Mr. Lichtenwalner seconded the motion, which carried with unanimous support.
