# Historical Architectural Review Board COA Preliminary Review Sheet

**HDC-2024-001114**

**Address: 523 Allen Street**

**Proposal: Installation of second floor balcony railing and supports.**

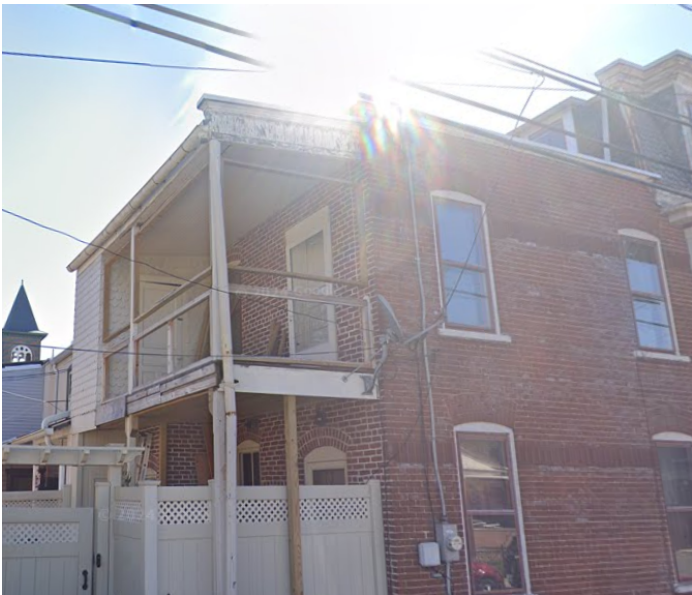
Current Condition at Rear (Applicant)

The current condition photo indicates additional posts supporting the balcony in addition to two original corner/intermediate posts. More information would be helpful to understand the intent of the proposed work; an appropriate approach would be to repair/replace posts in the original locations and remove intermediate posts that were later added as supplemental support.

- Railing assembly maintains similar proportions to the original railing at the front porch, and that the railings are constructed in a similar matter (2x framing is oriented horizontally at the top and bottom of the proposed spindles).
- Wood posts are repaired/replaced at the original post locations, and supplemental posts that were previously installed are removed.
- All wood elements are painted.

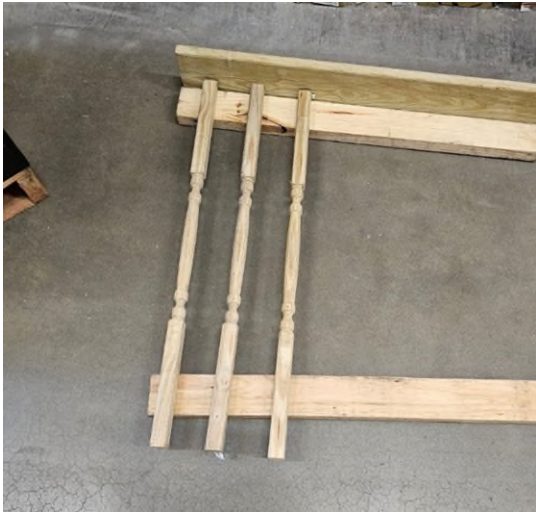
Proposed Railing (Applicant)

**Observations & Comments:** The proposed spindles for the railing are an appropriate replacement to the current condition. More information would be helpful to understand the configuration of the proposed railing system, including the orientation of the 2x4 framing shown in the photo "Proposed Railing." It would be appropriate if the construction of the railing maintains similar proportions to the original railing at the front porch, particularly that the framing is oriented horizontally at the top and bottom of the proposed spindles.

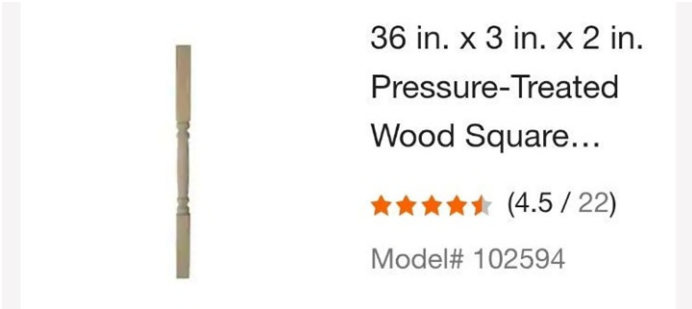
Proposed Spindle (Applicant)

All wood elements, including posts, railings, and spindles, are to be painted.
