Historical Architectural Review Board COA Preliminary Review Sheet

HDC-2025-00010 Address: 419 N 9th Street District: Old Allentown Historic District Owner: Archana Gujjari and Kiran Kumar Nalla Applicant: Owner Proposal: Window replacement at front and rear

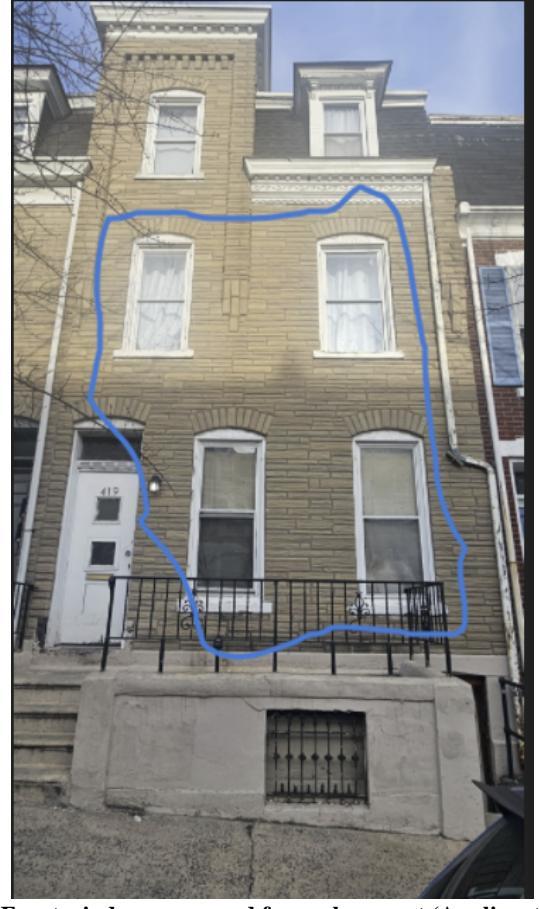
Front Elevation (Applicant)

Observations & Comments: The front windows facing 9th Street are previous replacement windows. The proposed 1/1 fiberglass windows appear to be an in-kind replacement of the existing windows. The decorative carved lintels should be protected and maintained.

- Front window lintels are protected and maintained.
- Applicant clarifies placement of windows in rear later addition, showing vertical and horizontal alignment. Final placement approved by Staff.
- Applicant submits window infill material, to be approved by Staff.

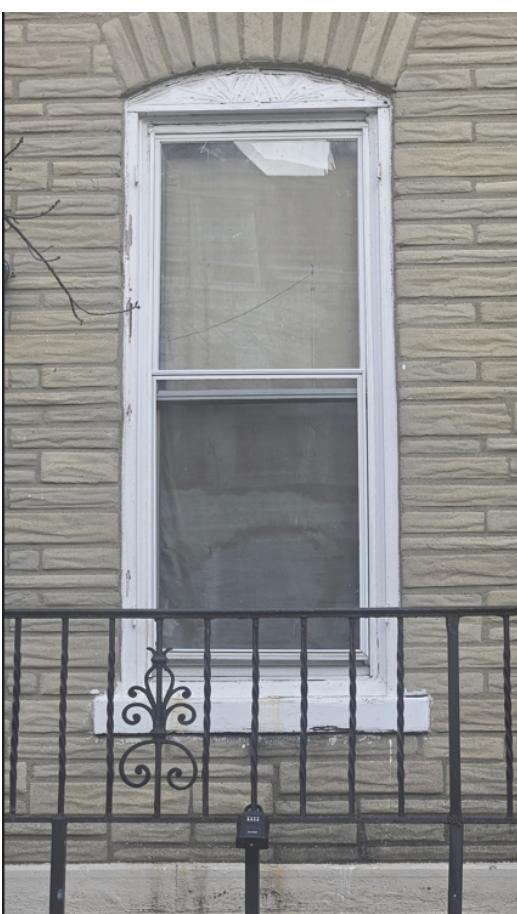
Current first floor, left-side window (Applicant)

Front windows proposed for replacement (Applicant)

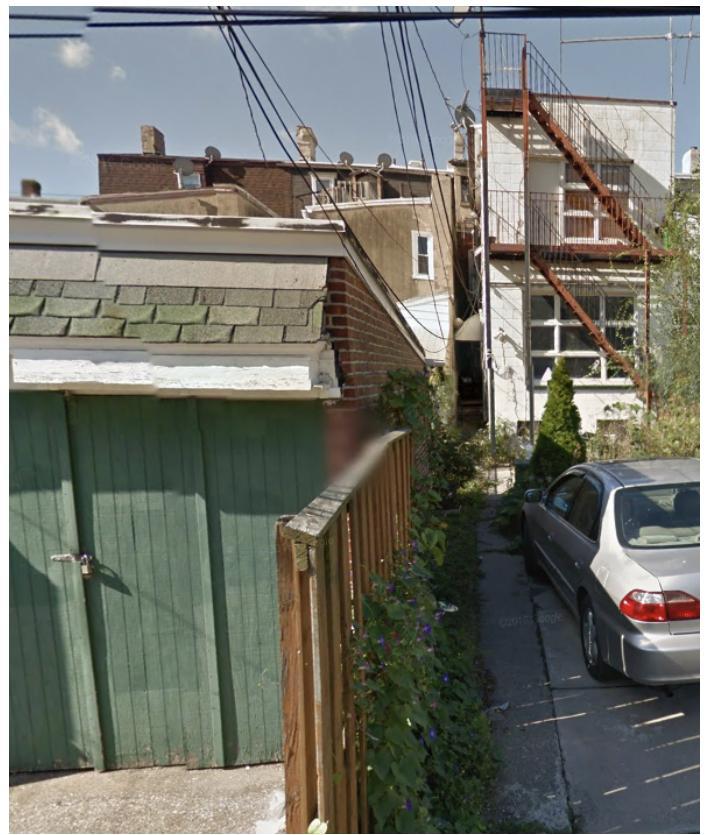
View from Right of Way to rear window, c.2014 (Google Maps)

The existing window openings on the rear CMU addition are visible from the public right-of-way, including all 6-lite and 9-lite windows. This rear addition was constructed after 1950, past the district's period of significance. Staff consider this addition to be comprised of non-contributing secondary facades, as the addition's features, materials, construction, and fenestration pattern are not consistent with the style of the original building or the historic district. Photos indicate deterioration of the windows, and the proposed replacement windows appear to create proportion and rhythm more compatible with the design of other buildings in the district.

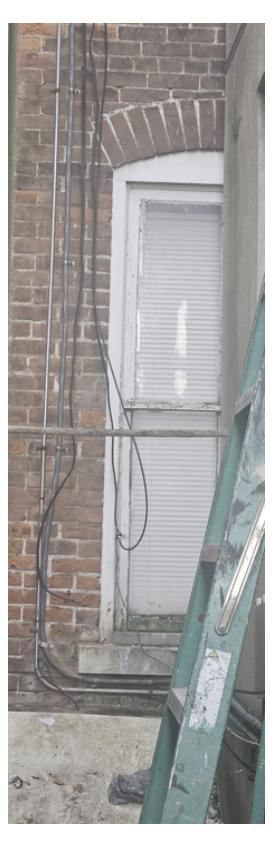
Rear first floor window

At the rear of the property, there are proposed alterations to windows on the original rear of the house as well as a later addition built in CMU block. Windows at the rear of the original building do not appear to be visible from the rear right-of-way (N. Nagle Street), as the CMU block addition blocks the view of those windows. While repairing and maintaining this original material is recommended, staff interpret this window as not being under HARB purview, as they are not visible.

The HARB were in consensus that the first floor rear windows within the original brick wall are not visible from a rightof-way and are not under HARB purview. The applicant clarified the placement of windows, indicated vertical and horizontal alignment.

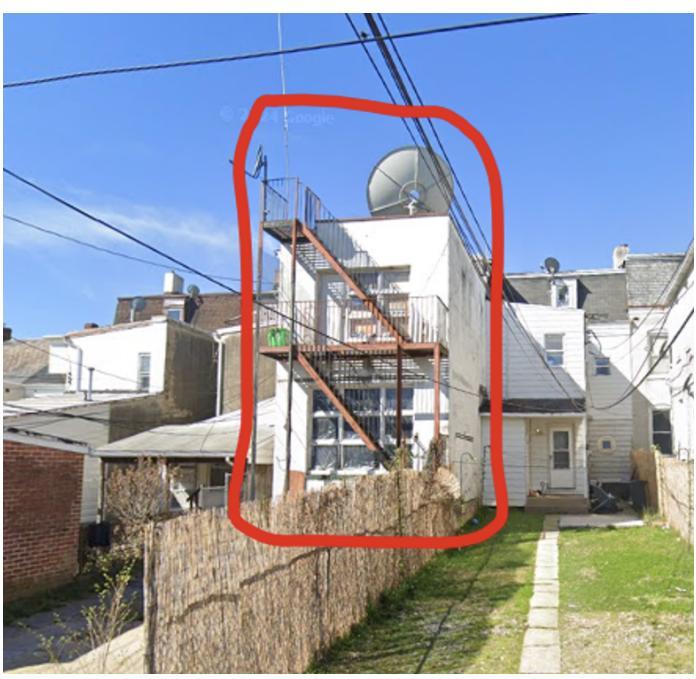
Rear Elevation (Applicant)

The applicant provided sketches that indicate proposed window sizes within the original openings. More information would be helpful to understand the alignments of the new windows relative to each other – will the new windows align vertically and horizontally? Overall building elevations would be helpful to clarify this. Product data for the proposed exterior material of the window infill around the proposed window would be needed for review. Per the Guidelines, vinyl materials and plastics are not appropriate.
