**Historical Architectural Review Board  
COA Final Review Sheet**

**HDC-2023-00060**

**Address: 141 N. 10<sup>th</sup> Street**

**Proposal: Legalize removal of rear porch (violation correction)**

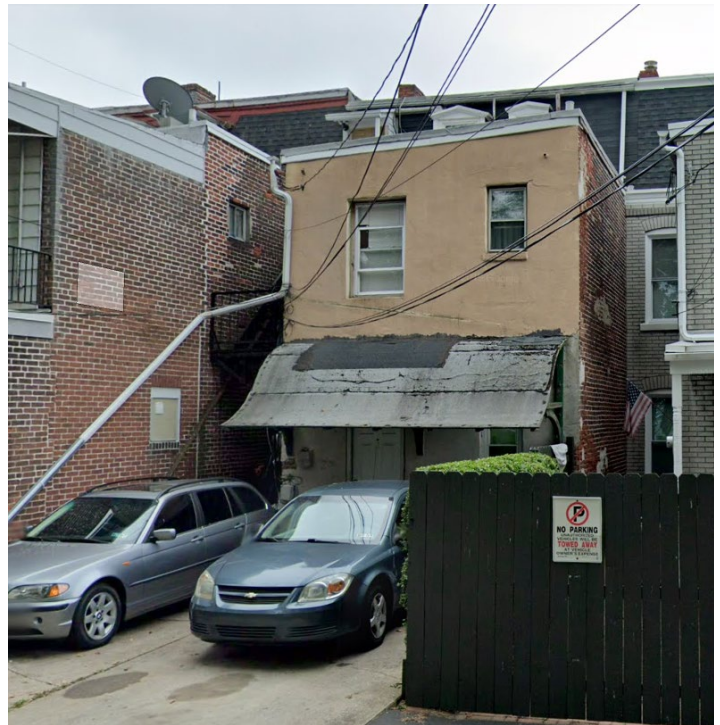
**Rear porch roof of 141 N. 10<sup>th</sup> Street prior to removal, 2019.  
(Google StreetView)**

Though located at the rear of the building, the one-story porch was highly visible from the public right-of-way because of its proximity to the Allentown Cemetery, which is located immediately across Hazel Street. The porch also had the distinctive form of the Allentown porch roof, which is the curved projecting roof installed on brackets. The owner contends that the porch roof was in poor condition and beyond repair, and that it had to be removed to comply with insurance requirements.

Staff finds that, because the porch was visible from the public right-of-way and was of the distinctive Allentown porch roof design, the porch should be replicated and reinstalled to match the original. The 1932 Sanborn map shows that the porch had a “composition roof,” and staff suggests that asphalt shingles or a similar material be used, and recommends that the roof be secured on wood brackets to match the original.

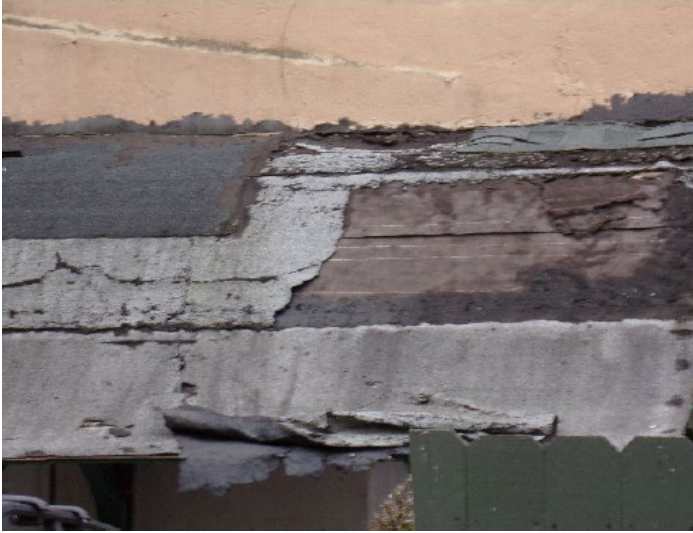
Detail of porch roof prior to removal.  
(Applicant)

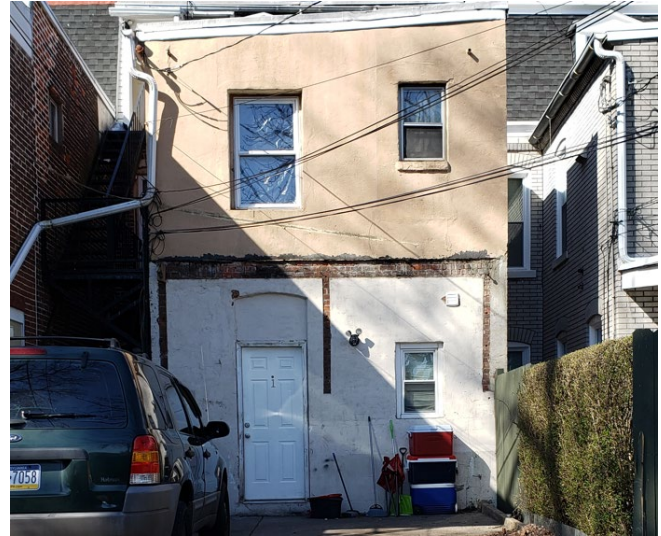
Rear of 141 N. 10<sup>th</sup> Street following removal of the porch roof, 2023.  
(HARB files)

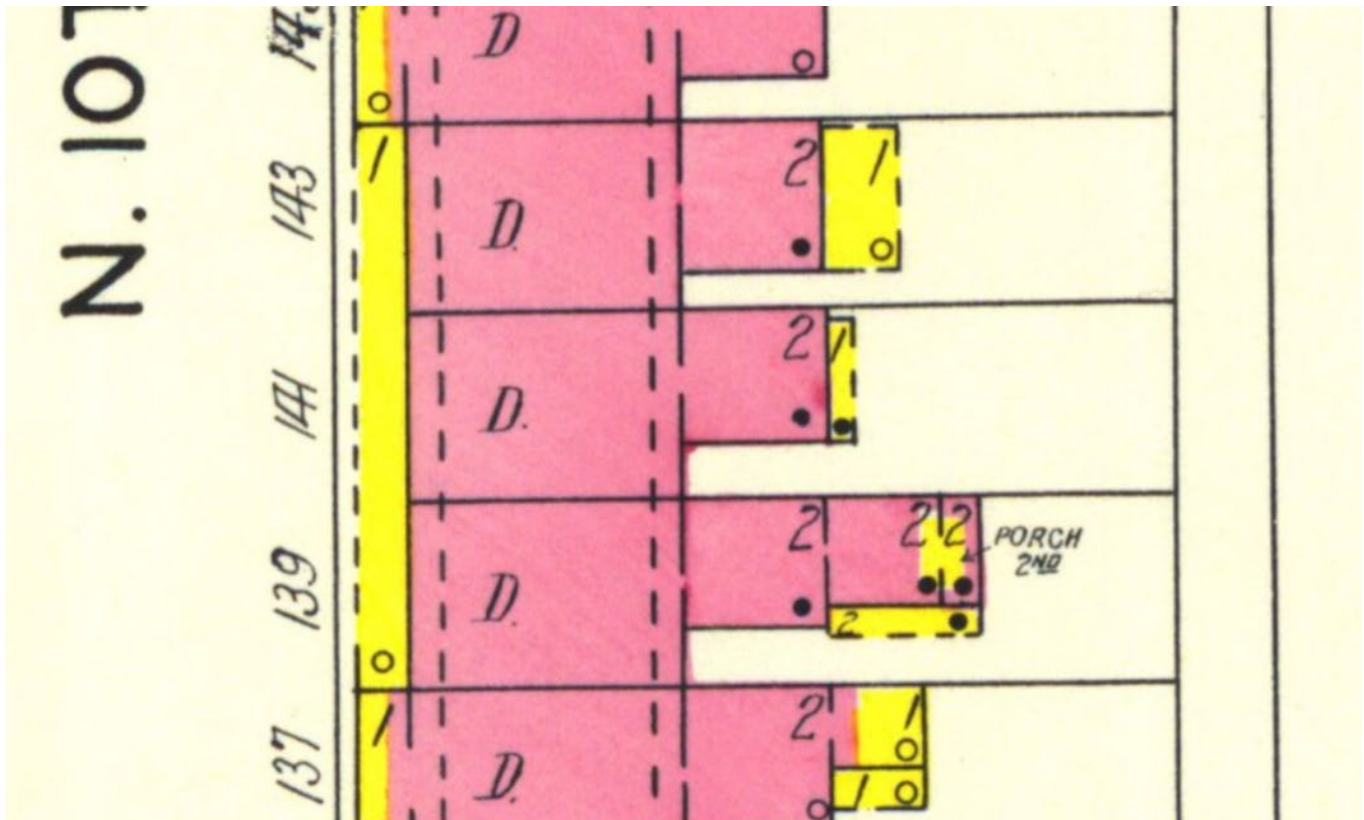
1932 Sanborn map showing rear one-story porch.  
(Pennsylvania State University Library)
