**CITY OF ALLENTOWN  
HISTORIC ARCHITECTURAL REVIEW BOARD  
FINAL REVIEW SHEET  
February 5, 2018**

**Case # HDC-2018-00004** Proposal to maintain the aluminum first floor windows and aluminum wrapped wood. Remove brickote and expose original brick. Front door will be replaced to resemble original. Replace windows on second and third floor.

**Property located at:** 1147 W. Turner St.

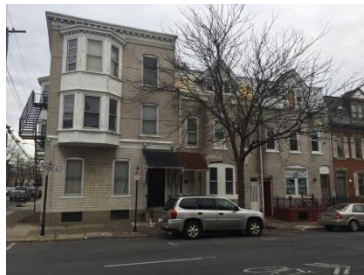
**Building description, period, style, defining features:** This structure is a 3 story, 3 bay, brickoted brick dwelling with a mansard roof with gabled roofed dormer, paired first floor windows joined with a segmental arch, a shed roof over the entry door, and an original grocer alley door. The house dates from c. 1870 and is Eastlake Queen Anne in style. All windows are 1/1 double hung. The original wood windows on the first floor have been replaced with new vinyl windows smaller than the original. The trim and brick between the windows have been covered with coil stock aluminum.

**Violations:** December 15, 2017: Replaced two original wood first floor windows with vinyl windows. Capped windows with aluminum.

**Evaluation, effect on historic district, recommendations:** The vinyl windows and aluminum wrapping of woodwork do not meet the historic district design guidelines and are not historically appropriate. Aluminum-clad wood windows would be an acceptable replacement window and should be sized to more appropriately fit the opening. Though the brickoted dividing post was not original, it was historically appropriate and should be uncovered (most likely was one larger window with transom above). The sill should be left exposed; it should be repaired as needed, sanded and repainted. Any additional windows should be reviewed for restoration; if they cannot be salvaged, new wood windows or aluminum-clad wood double hung windows that fit the existing opening would be appropriate.

1. The proposal to maintain the aluminum first floor windows and undertake other renovations at 1147 W Turner Street was presented by Frank Bickel.
2. The living room vinyl windows will be replaced with larger aluminum clad wood or fiberglass windows per sketch. There will be a 6"-8" mullion between the new windows and the trim will be 2"-3" on either side. The trim may be a no-rot material such as Azek. No aluminum capping is permitted.

3. The second floor windows will be replaced with new aluminum clad wood or fiberglass windows to match the size of the existing. The center window will be returned to full size. No aluminum capping of the trim is permitted.

4. The existing Mansard roof siding material will be replaced with Certainteed Carriage House shingles in a slate gray color.
5. The existing modern style entry door will be replaced with a new wood or smooth fiberglass ½ light door with 2 lower panels, a 4 panel door, or an historic door.

6. The entry roof may be replaced to match the neighboring roof.
7. The existing failing brickote will be removed and the historic brick repointed according to Preservation Brief #2 guidelines. Soft lime-based mortar must be used.
