**Historical Architectural Review Board  
COA Preliminary Review Sheet**

**HDC-2024-00028**

**Address: 825 W Gordon Street**

**Proposal: Replace front door**

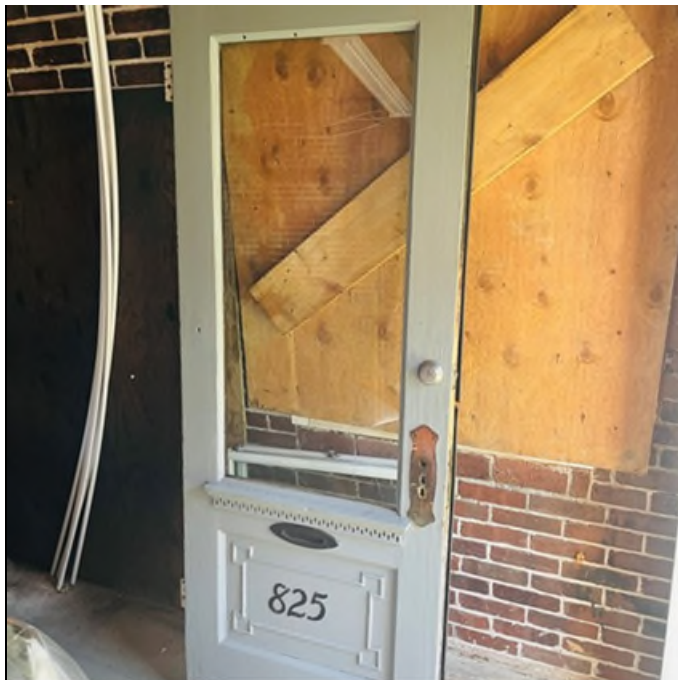
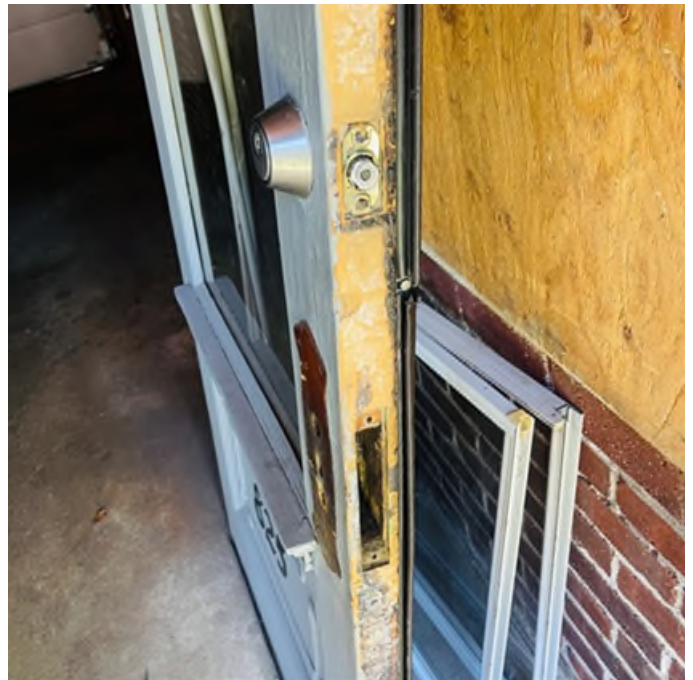
This application proposes to replace the front door of the residence, which is broken, not working, and had rotting wood, with a new metal door. Rotted wood trim will be replaced with new wood.

**Existing Door (Applicant)**

**Observations & Comments:** If the door is beyond feasible repair, replacement with the proposed metal door is not historically appropriate. Ideally, the wood door with original, character defining detailing would be retained and repaired. This door contains an immense amount of character defining features, including the bottom panel detailing. From the photographs, it does not appear that the door material is in poor condition, so perhaps upgrades to the hardware and/or weatherization is more appropriate, instead of replacement.

**Staff Recommendation:** It is recommended to deny the application. The original door should be retained if at all possible.

**Action:** Mr. Huber made a motion to deny the application presented on May 6, 2024, for the door replacement at 825 W Gordon Street because it did not comply with the Guidelines for Historic Districts: Chapter 3, Section 3.6 – Doors and there were no known unique circumstances that would apply. It was recommended that the original door and jamb be replaced to their original condition and that a full view storm door would be acceptable if the applicant chooses.

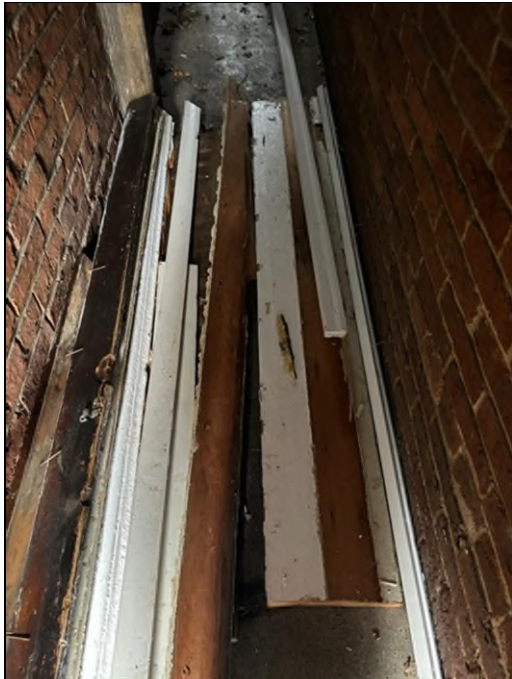
**Existing Trim (Applicant)**
