**Historical Architectural Review Board  
COA Preliminary Review Sheet**

**HDC-2025-00102**

**Address: 521 N 6<sup>th</sup> Street**

**Proposal: Remove and install new decorative paneling around second floor bay window (Violation Correction)**

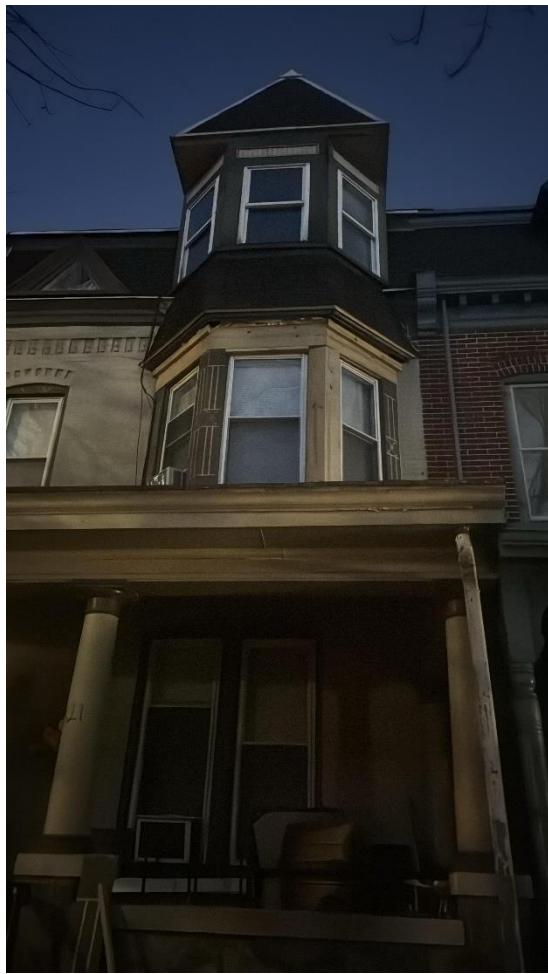
From application: The existing exterior window panels and surrounding wood components exhibit deterioration, including rot in multiple locations. In addition, sections of the soffit board are missing, leaving the assembly exposed and vulnerable to further damage.

Current Condition (Applicant)

The scope of work includes the careful removal of all deteriorated and damaged wood elements around the affected window areas and soffits. Any unsound material will be replaced with new pressure-treated lumber where structural integrity or moisture exposure is a concern.

On top of the pressure-treated substrate, new exterior trim boards will be custom carved and installed to match the existing architectural pattern and profile, ensuring visual continuity with the original design. All replacement components will be securely fastened, properly aligned, and prepared for exterior finishing.

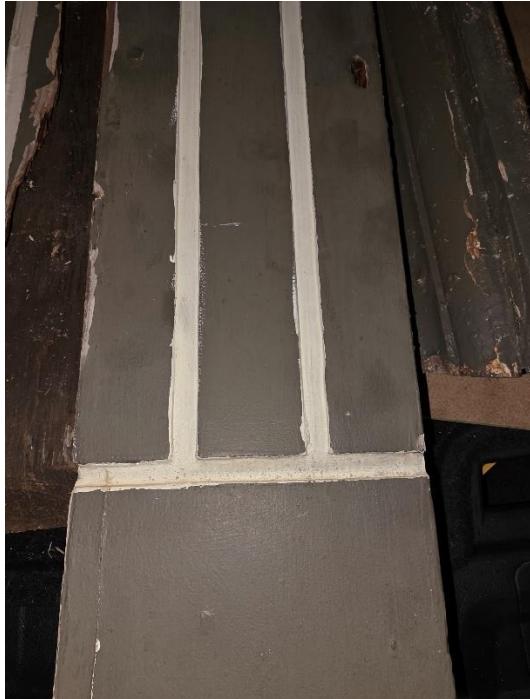
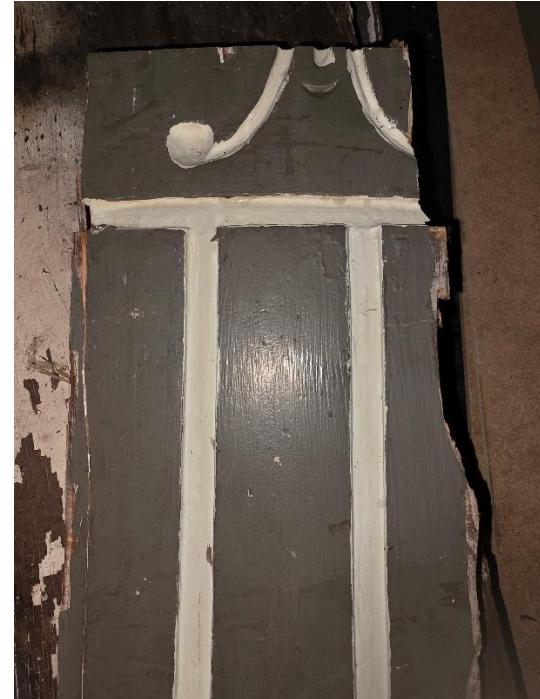
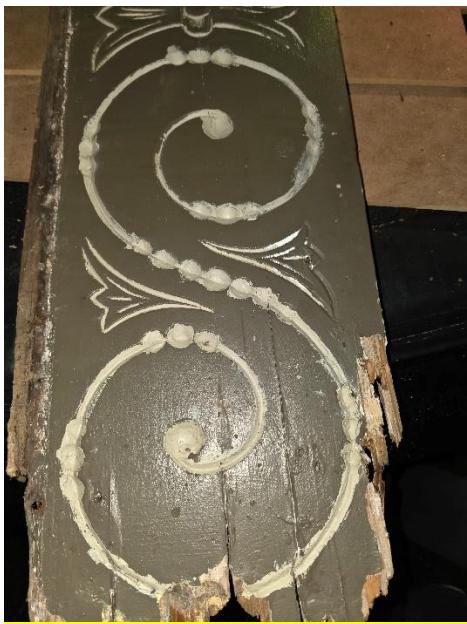
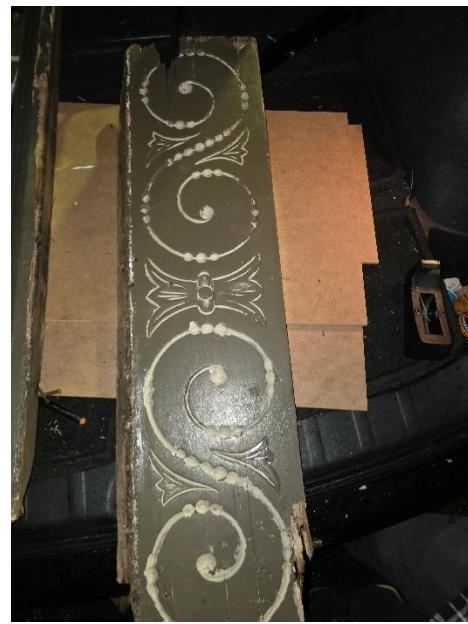
Original Panel Design (Applicant)

The applicant stated that his company was hired to replace the deteriorated wood panels; many were severely rotted and in poor condition. The rotted wood was removed and replacement wood added to create a sound, weathertight condition. The applicant proposed taking a physical tracing of the original panels as a basis for recreating the trim. The Board discussed a few options for how that could be achieved, such as using a router, a CNC machine, or handcarving. Mr. Hart suggested that the means of creating the panels is up to the contractor; the goal is for the panels to be visually similar to the original ones.

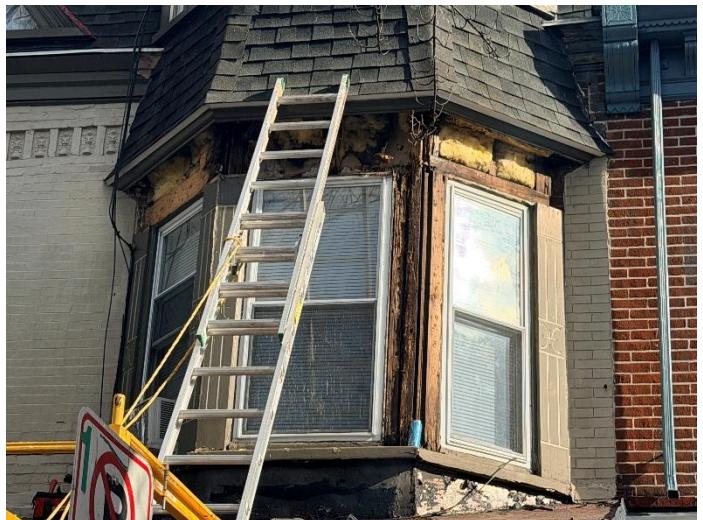
Wood Removal (Applicant)

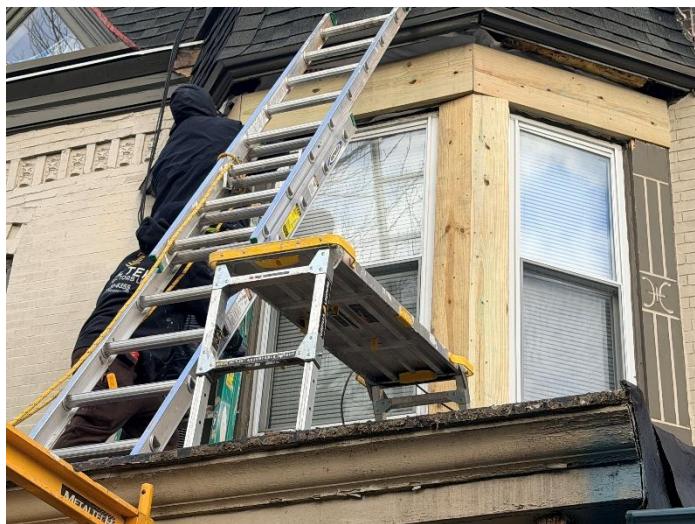
Wood Replacement/Current Condition (Applicant)

The proposed scope calls for adding new scribed trim onto replaced substrate. Based on the submitted photos, it appears that replacement wood is in plane with original scribed trim. More information would be helpful to understand how a consistent finished plane will be achieved; ensuring that edges align appropriately to adjacent elements, such as other trim and window sills.

**Staff Recommendation:** Staff request more information on the extent of the work area and the approach for achieving a consistent plane of the trim's surface. Generally, the proposed approach to replacing the wood trim is appropriate. All exposed wood surfaces should be painted.
