**Historical Architectural Review Board
COA Preliminary Review Sheet**

HDC-2026-00012

Address: 334 N. 9th Street

Proposal: Repair deteriorating brick facade

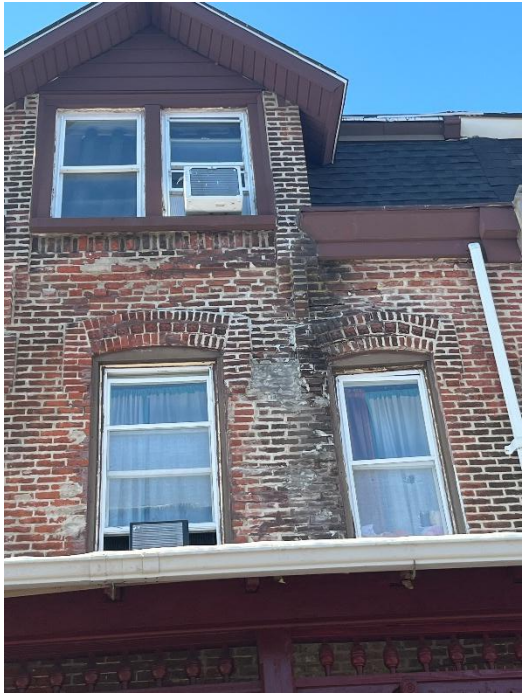
Existing Upper Floor Condition (Applicant)

Overview
334 North 9th Street Allentown PA, contractor upon sight visit noticed the following. Severe water and structural damage on the right side of the building above the window arch. Upon further assessment it was noted that water damage and wrong use of mortar was the main cause of damage. Damage is way too far

Key Repairs:
Due to severe structural damage, shoring will need to be installed before any of the construction process begins. Once permits are pulled and in place the first thing to be done is the installation of the helibeam system. This system is a shoring method in masonry restoration to prevent further structural damage by installing stainless steel heli beam bars all through the masonry structure to distribute the load bearing weight. Once these bars are installed they require 24-48 hours of cure time before any demo will take place. While these bars are being installed the roof underneath will be shored up to withstand the weight of bricks materials, workers, and demo process. The protection of the building's roof is also a concern and 3/4 plywood will be installed as a "protection board" during the construction process. After all shoring and safety measures are taken the main repairs will take place, demo of failed brick, relay to historical guidelines, install proper flashing and wall ties. After these repairs take place a permanent solution to the water damage will be resolved.

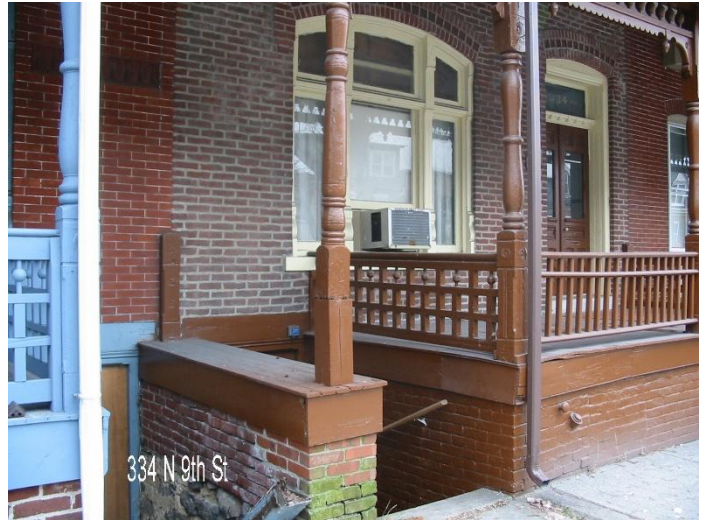
Existing First Floor Condition (Applicant)

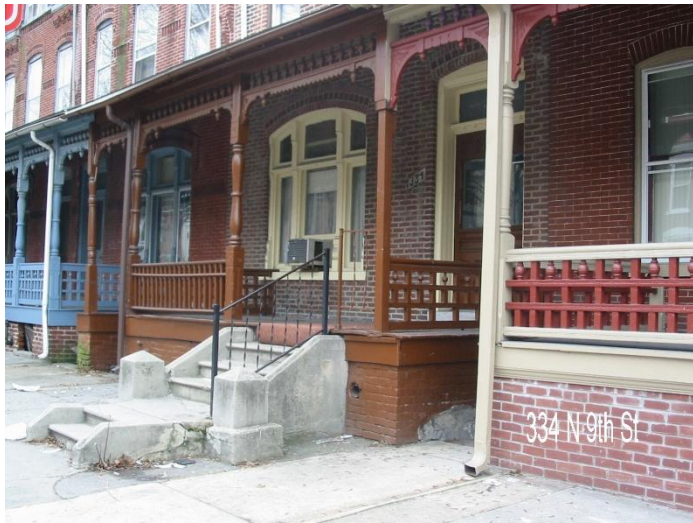
Existing First Floor Condition (Applicant)

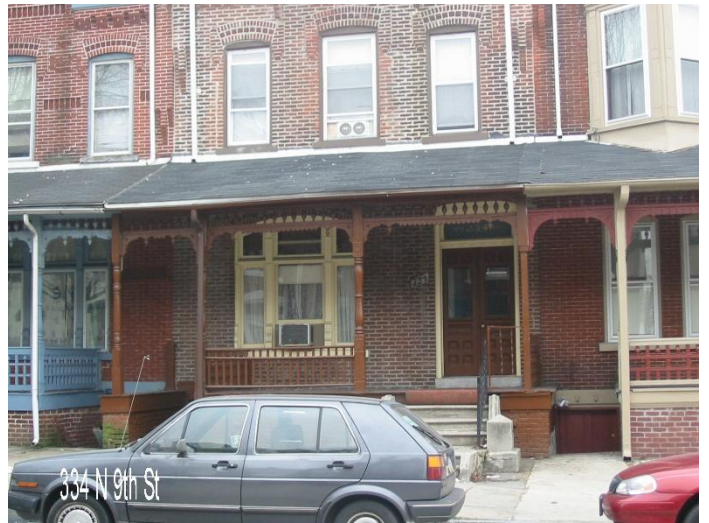
Existing Condition (Applicant)
