**HISTORIC ARCHITECTURAL REVIEW BOARD
CITY OF ALLENTOWN, PENNSYLVANIA**

**May 3, 2021
FINAL REVIEW**

Case # HDC-2021-00015

Property Address: 1507W. Turner St

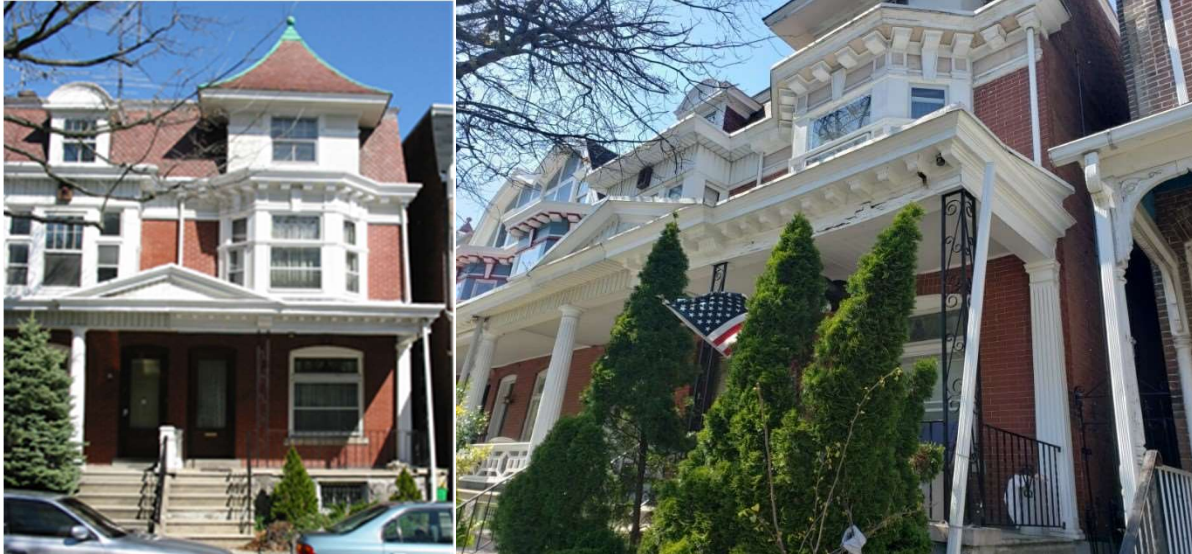
This brick 3-story end of row house, ca 1911 is a Colonial Revival. The mansard roof has red slate shingles, a large dormer with 8/2 sash window, projecting cornice and spire roof with a finial. The 2nd floor has a projecting cornice with brackets and a bay window with 1/1 sash windows, glass transom and a wooden keystone over the windows. The 1st floor has a picture windows with beveled glass transom and brick lintels. The wooden porch has a single beveled glass door, transom, and projecting moldings as well as wrought iron columns and railing and bull-nosed concrete steps and wrought iron railings. There is a visible basement window grille. The rear of the property has a wooden fence and gate with porches; the 1st floor is enclosed with siding and the 2nd porch has square columns, wrought iron railing and a door.

The proposed scope of work at the porch support columns is not appropriate as proposed. There is insufficient information in the application to fully evaluate the proposed alterations and materials.

As proposed, one non-historic metal support (at center) will remain; one non-historic metal support (at corner) will be replaced with a 6x6 post; and the one wood half pillar (at the shared entrance) will be removed and replaced with a full-height 6x6 post. The 6x6 posts will be “padded out to receive new PVC material to finish off the posts.” PVC cladding is not an appropriate material. There is no information about the finished appearance, shape, or size of the new columns. Removal of the existing wood half column is not justified. Removal of historic material should be avoided whenever possible. Installation of a new (half) column at the shared entrance will change the appearance of the building. There is precedent for a shared column within this block of houses. A shared column may have existed originally. However, the shared columns are *all* half columns supported by a base integrated with the shared railing.

It is not appropriate or recommended to cover the new exterior beam or the fascia with PVC product. As proposed, the “existing dentil pieces will be removed and recapped.” The dentil modillions should be retained and repaired or replaced like-for-like with wood to match existing. Dentil modillions should not be capped.

The recommended scope of work is full replacement of all inappropriate metal elements with new supports to match the extant tapered round columns at the adjoining buildings should the determination by a structural engineer determine the need for additional support. Porch details—including the fascia and dentil modillions—should be repaired or replaced like-for-like and no elements shall be capped with PVC. It is recommended that the applicant submit drawings, graphic representations of the scope of work, and product data for proposed materials. The recommendation is to advise applicant on the appropriate scope of work and not approve the application as submitted.
