**Historical Architectural Review Board**  
**COA Preliminary Review Sheet**

**HDC-2025-00091**

**Address:** 231 N Fulton Street

**Proposal:** Legalize the installation of a Multi-Zone Mini split system slim duct and units along Emmett Street.

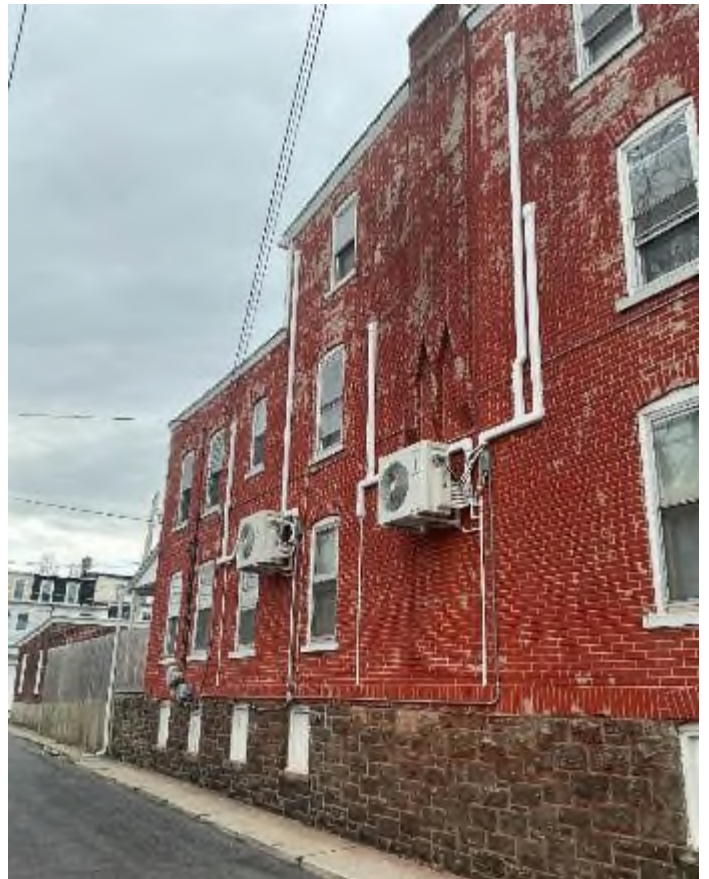
**Current Condition, after installation (Applicant)**

**Observations & Comments:** This application follows the denial of the legalization of the mini-split installation at the October 6, 2025, HARB meeting. The current HVAC system is installed on the exterior wall of a corner building, along Emmett Street. Two units are mounted on the wall near the top of first floor windows and various equipment lines are routed across the wall surface.

The current Slimduct lines are white and highly visible on the exterior. The applicant's proposal to paint the Slimduct to match the exterior brick is appropriate to make these elements more inconspicuous and blend in. The proposed work includes brick repair. More information would be helpful to understand the intent, location, and materials used in brick repair.

**Staff Recommendation:** More information would be helpful to understand the scope of the brick repair. Regarding the mechanical system reconfiguration, staff recommend approving the application with the following conditions:

- The roof-mounted mechanical units are set back from the roof edge so that they are not visible from a public right-of-way.
- Brick repair is performed so that any units and mortar match the existing in dimension, materiality, texture, pattern, and color.
