**Historical Architectural Review Board
COA Final Review Sheet**

HDC-2024-00008

Address: 433 N. 8th Street

Proposal: replace 7 windows

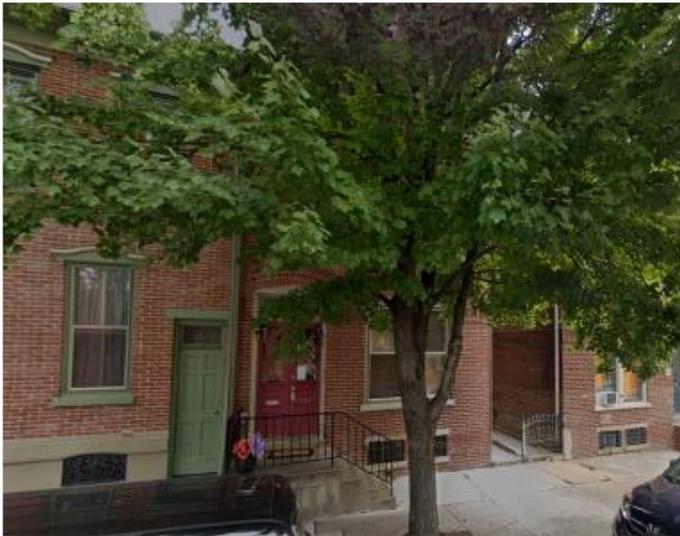
**Front façade of 433 N. 8th Street, 2023.
(Google StreetView)**

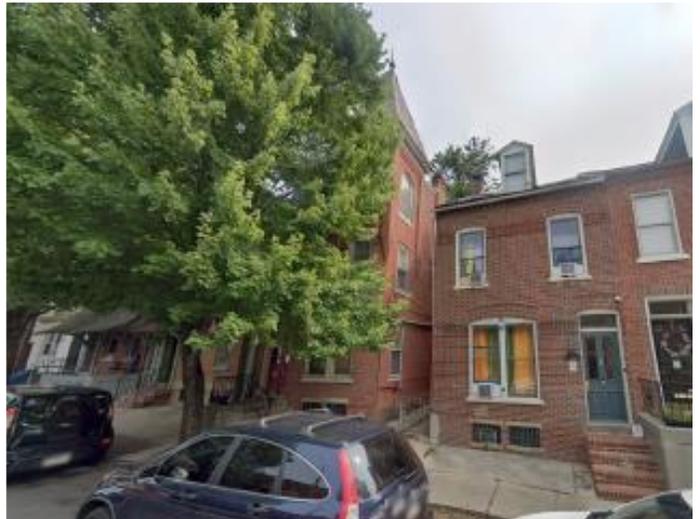
**Side of 433 N. 8th Street, 2023.
(Google StreetView)**

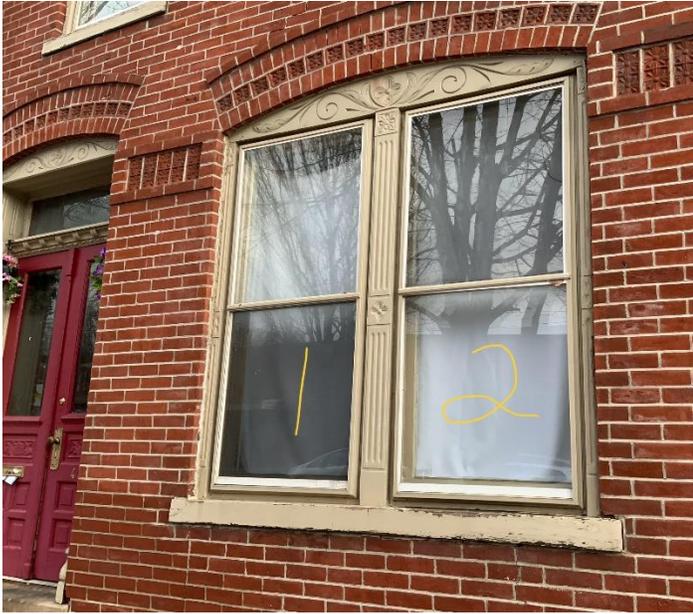
**Front windows of 433 N. 8th Street
(Applicant)**

Observations & Comments: The reason for replacing the historic window sashes is not evident or stated. The wood window sashes appear to be in good condition. The aluminum storm windows appear to be old. Ideally the windows, front and front corner in particular (windows 1, 2, and 3), should be retained, repaired as needed, weights and ropes repaired if needed, perimeter of frames caulked, and new energy efficient storm windows installed. The energy efficiency of a restored historic wood window with new storm window is roughly equivalent to a new insulated glass window.

Staff Recommendation: It is recommended to not approve the window sash replacement at the front and front corner of the building. It is recommended to approve the repair of the existing wood windows at the front and front corner of the

building and the installation of new aluminum storm windows in a color that matches or blends with the trim; or the installation of interior storm windows.

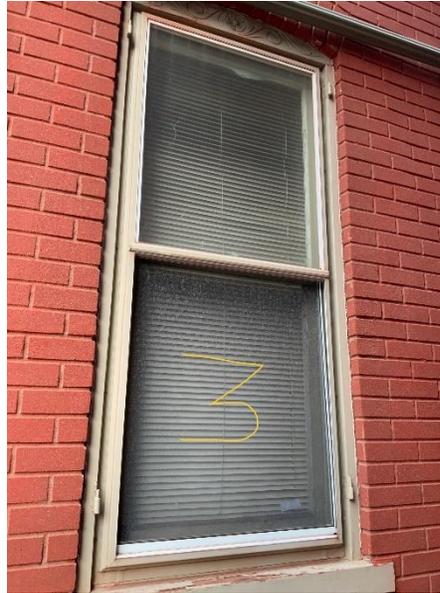
**Side window of 443 N 8th Street
(Applicant)**
