**HDC-2022-00045****Address: 814 W. Liberty Street****District: Old Allentown Historic District****Applicant: Juan Mendez, Mendez Diaz, LLC, Owner****Proposal: Legalize infill at Rewal Street opening (Violation Correction)****Building Description:**

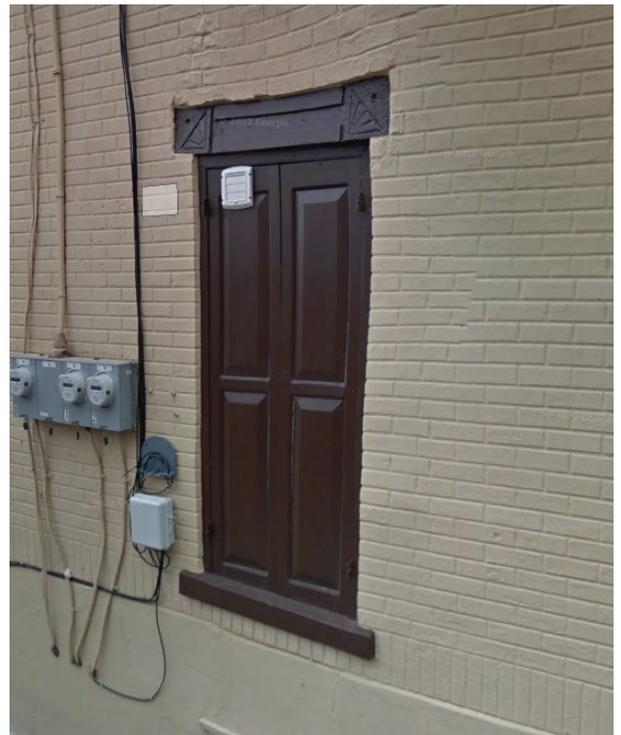
First-story window on Refwal Street façade prior to being infilled. (Google StreetView)

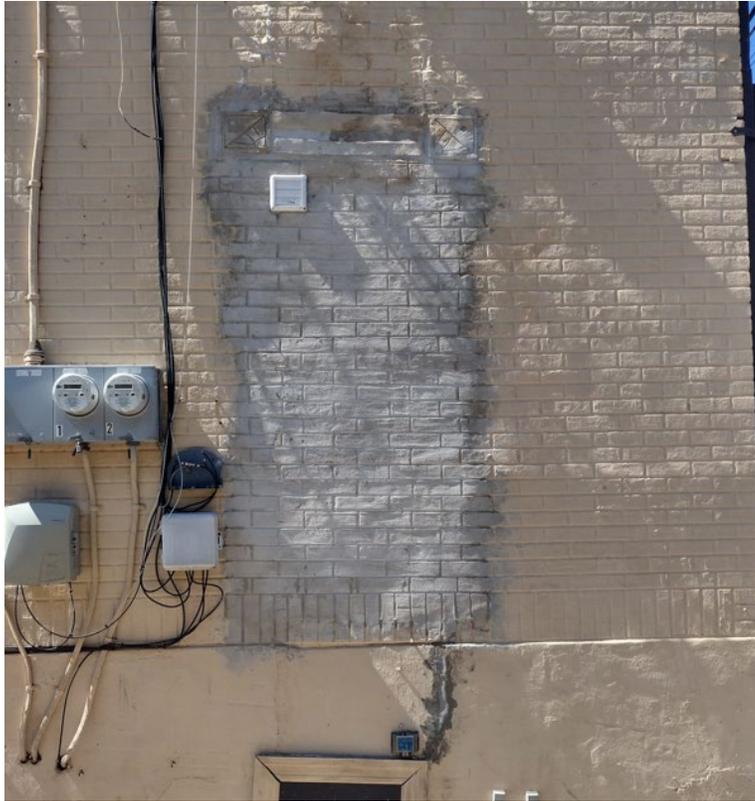
On August 18, 2022, a Notice of Violation was issued by staff to the property owner of 814 W. Liberty Street for infilling a first-story window on the Refwal Street façade. The window opening was infilled with insulation and brick, the lintel and brick were coated with a waterproof cement finish, and the wood window frame and sill were removed. This application seeks to legalize the work, and the applicant proposes to paint the infilled area to match the surrounding masonry.

Refwal Street window after being infilled.  
(Applicant)

The staff finds that eliminating the opening as proposed does not meet the Design Guidelines, because it alters the ratio of window openings to solid wall surfaces (3.5.10) and disrupts the rhythm of openings on the façade (3.5.11). Removing the wood sill and coating the decorative wood lintel does not meet Guideline 3.5.1, because it alters original window components. The submitted documentation of the work does not show that adequate waterproofing was installed around the opening or infill materials. This indicates a risk that moisture will be trapped in the masonry wall and cause future deterioration. The staff recommends that the new infill be removed, the opening be properly waterproofed, and that the window be infilled in a more appropriate manner by reinstalling the wood sill, removing the coating from the lintel, reinstating the reveal in the brick, and reinstalling a wood frame with shutters in a fixed closed position.

HARB member Glenn Lichtenwalner moved to approve w/conditions, the application presented on 11/7/2022 for the legalization of the infilling of the Refwal Street opening to correct a violation at 814 W. Liberty Street with the following conditions: infill the full opening left from the removal of the non-original window, sill and lintel with materials to replicate the existing brick and brickote, agreed to by the applicant, and finds compliance with the following sections of the Guidelines for Historic Districts: Chapter 3, Section 3.5 Windows, and finds that there are circumstances unique to the property: this is not an original window, it is a c. 1994 replacement window and the leaking condition surrounding this window was causing irreparable damage to the existing and adjacent historic masonry fabric. HARB Vice Chair AJ Jordan seconded the motion, which passed unanimously.
