**Historical Architectural Review Board
COA Final Review Sheet**

HDC-2023-00063

Address: 619 N. Park Street

Proposal: Legalize installation of porch header, posts, and railings

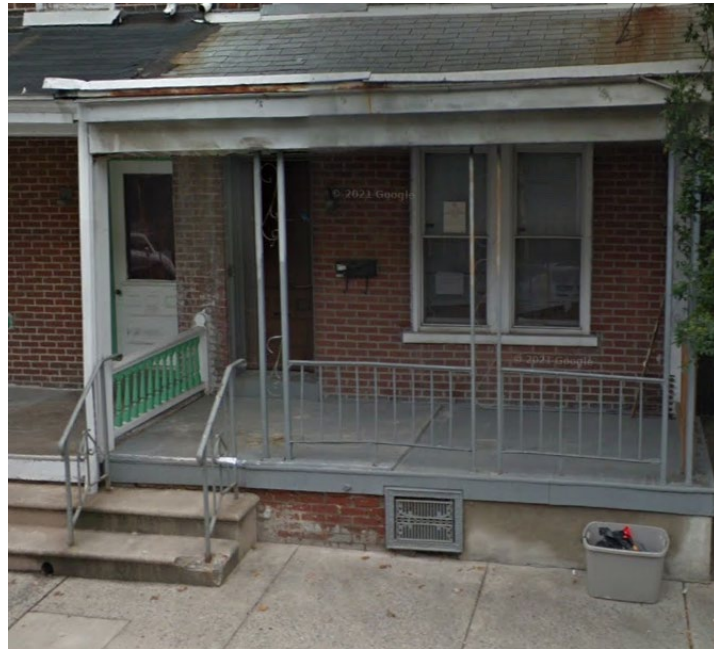
**Metal posts and railings prior to replacement, 2018.
(Google StreetView)**

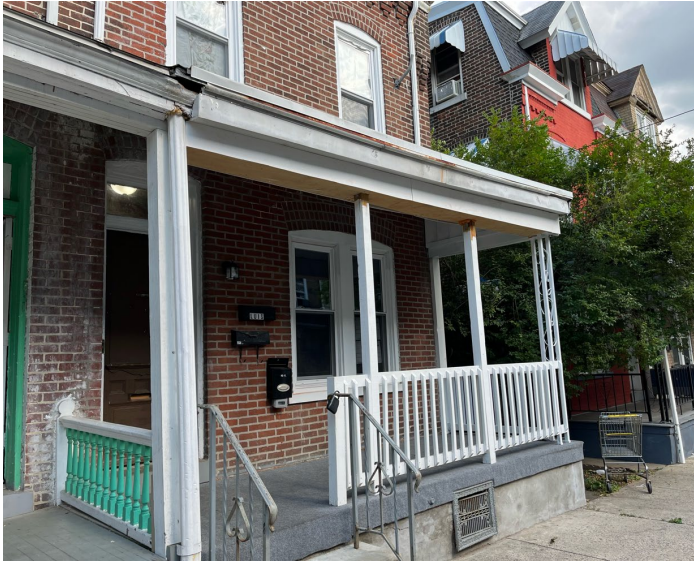
**Porch following replacement of the posts and railings, 2023.
(Applicant)**

The applicant purchased the property in June 2023 and contends that the work was done prior to the sale. The historic wood porch had been altered at some point in the past and metal posts and railings were installed, and the porch floor was changed from wood to concrete. The current alteration removed the inappropriate metal railings and posts. Three of the metal posts were replaced with wood, and one metal post remains. The railings were replaced with wood pickets. While the work does not replicate the historic appearance of the porch, the guidelines recommend but do not require a full

The carpet does not comply with Guideline 3.7.8 and should be removed.

- The corner metal porch post is replaced with a solid wood post;
- The existing spindles are reused and inserted into the top and bottom rails;
- The top rail is of an appropriate size and form to fit the spindles as presented in the application;
- All wood elements are painted; and
- The carpeting is removed to expose the concrete porch floor.

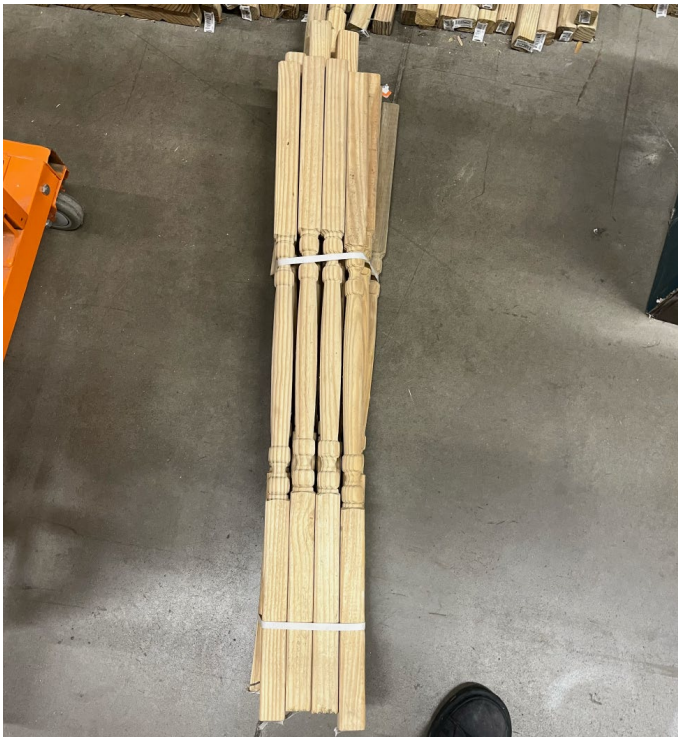
Proposed spindles for the porch railings.
(Applicant)

Mr. Lichtenwalner stated that this issue with the railings is similar to another property where that property owner installed similar railings that caused the violation. In that case, he continued, the HARB allowed the owner to turn the railings around to create a different look. He asked that the existing spindles be inserted into the top rail. He then suggested that the applicant replace the metal post with a wood post to match the others that were installed. He also added that the carpet would need to be removed to correct the violation. Mr. Huber agreed with Mr. Lichtenwalner's suggestion, adding that the applicant would need to purchase a top and bottom rail, and then insert the existing spindles into them.

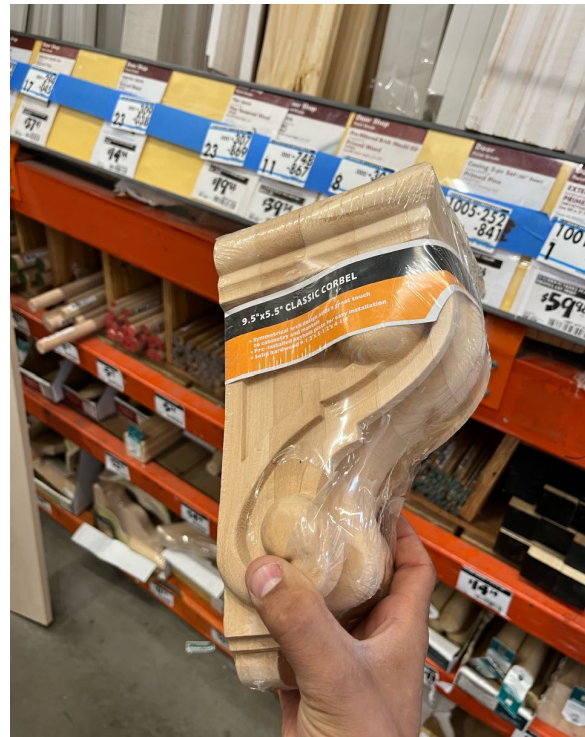
Staff contends that because the porch posts do not currently match, installing two more appropriate posts would not improve the overall appearance of the porch and would result in three different types of posts. Staff recommends installing only the proposed wood railings to legalize the work. Staff further suggests that the brackets and decorative elements proposed to be installed at the existing posts be left out of the scope, since those details are intended for turned wood columns and not the existing utilitarian posts.

Proposed brackets for the porch posts.
(Applicant)
