**CITY OF ALLENTOWN**

**Certificate of Appropriateness for work in the Historic Districts: 820 Liberty St.**

**Historical Architectural Review Board  
COA Preliminary Review Sheet**

**HDC-2024-00053**

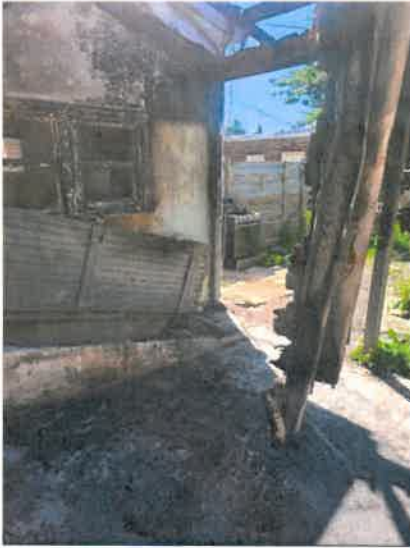
**Current Condition at Rear (Applicant)**

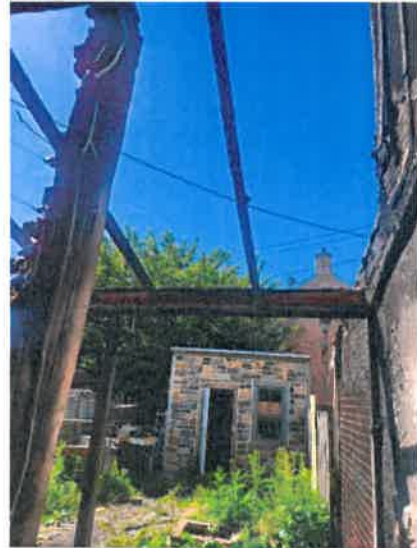
**Fire Damage at Rear (Applicant)**

- Conditions that all materials are replaced in kind with their condition prior to the fire.

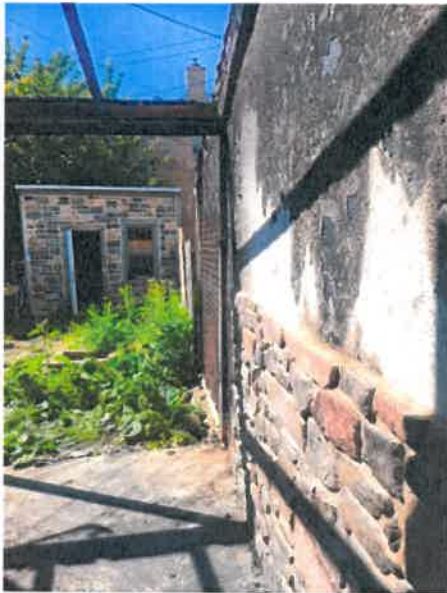
**Fire Damage at Building Rear (Applicant)**
