**HISTORIC ARCHITECTURAL REVIEW BOARD
CITY OF ALLENTOWN, PENNSYLVANIA**

FINAL REVIEW

Case # HDC-2021-00014

Property Address: 23 N. West St.

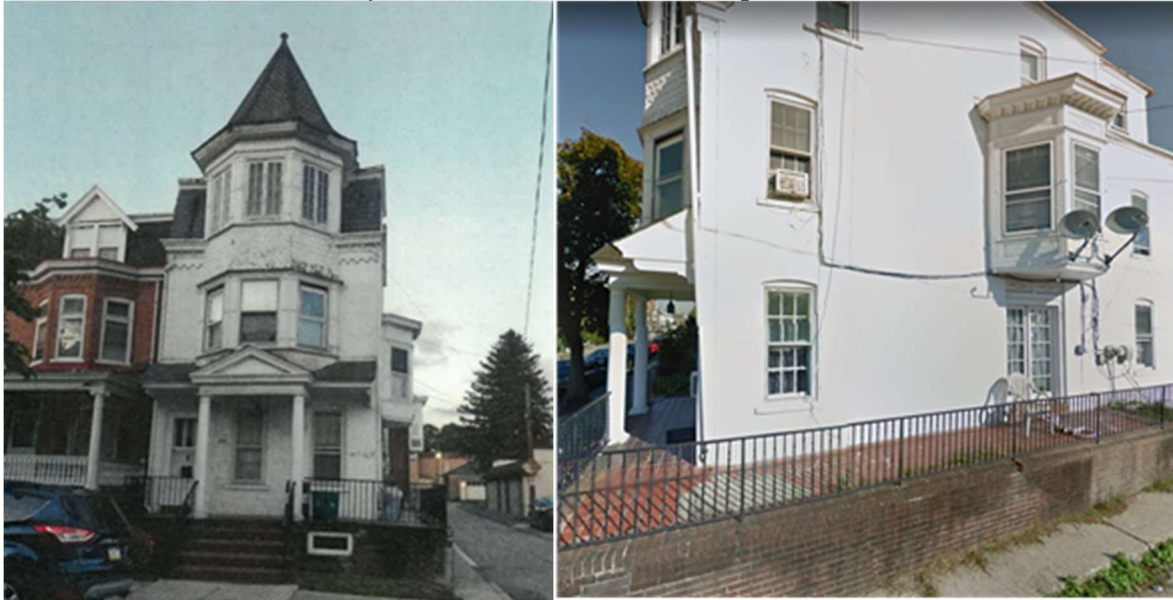
This three-story brick end of the row This 3-story brick/stucco single house, ca 1900 is a Colonial style. The flat roof has turret with slate shingles and a single chimney. There is an iron fence along the length of the brick porch which wraps around the west (front) and south (side) facades of the building. The windows are seventeen 6/6 sash, brick lintels and a bay window with transom. The main entry is a double door on a brick porch.
