R83 - 2018

### Certificates of Appropriateness for work in the Historic Districts: 25 N. 15<sup>th</sup> Street, 26 N. 11<sup>th</sup> Street, 726 W. Gordon Street

# CITY OF ALLENTOWN HISTORIC ARCHITECTURAL REVIEW BOARD FINAL REVIEW SHEET June 4, 2018

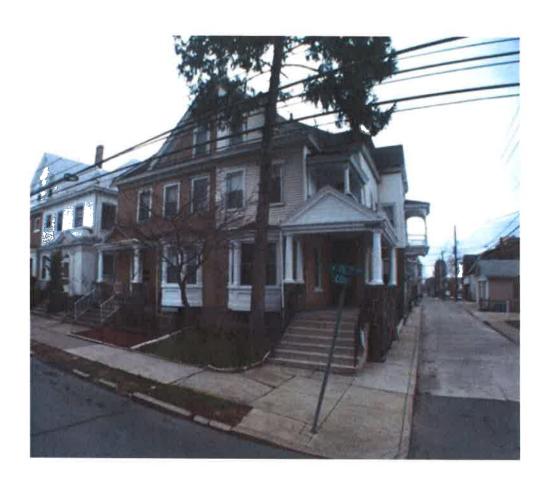
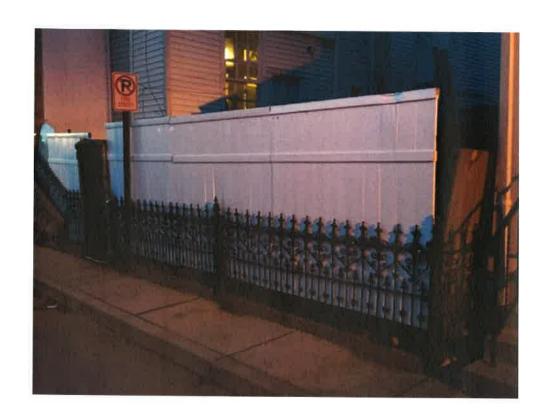
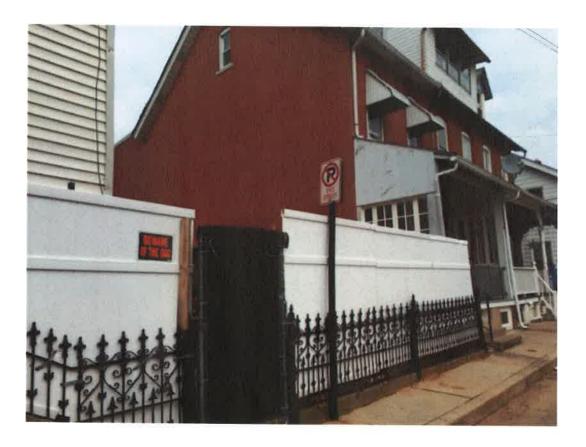
**Proposed alterations:** It is proposed to continue the installation of vinyl fence on side of property. The vinyl fence has been installed by attaching to the historic wrought iron fence and installing a chain link fence gate in place of the wrought iron gate.

**Violations**: February 15, 2018 - Installed vinyl fence along side yard in rear of property. **Guideline Citation: SIS 9**. New additions, exterior alterations, or related new construction shall not destroy historic materials that characterize the property. The new work shall be compatible with the massing, size, scale, and architectural features to protect the historic integrity of the property and its environment. **Allentown Guidelines for Historic Districts:** 5. Guidelines for Existing Buildings and Structures, 1. Repairs, Replacement and Alternate Materials: 10. Streetscapes and Outdoor Features

**Evaluation, effect on historic district, recommendations:** The installed fence is not historically appropriate, nor does it appear to be safely erected. Vinyl fencing is not permitted in the historic district nor is the chain-link gate. As noted in the guidelines:

A wood vertical board fence, professionally installed with proper wood gate would be historically

appropriate. Proper concrete footings and foundations would be necessary to support the fence. It is suggested that the fence be set back from the historic fence by approximately 3' (or more) so that it would meet with the neighboring building without a return, or perhaps be placed inward of the basement bilco type door. This set back might also allow the wrought iron fence gate to be reinstalled. The wood fence would also have a gate so there would be added distance and protection for the dog and passersby. A new fence should be stained and finished to better resist weather. The existing concrete paving would be visible between the two fences. Discussion: The applicant said he did not realize he was in an historic district and after discussions with Mr. Kimmerly he understood that the vinyl fence was not acceptable. The type of wood fence that would be acceptable was addressed when Mr. Kimmerly pointed out that the design guidelines do not permit solid wood fences on a primary street. It was decided that a solid wood fence would be acceptable in this side street location due to its relatively low visibility and because the guidelines do allow solid board fences in rear or side yard situations. The HARB agreed with the Historic Consultant's suggested placement of the fence 3' or so behind the ornamental iron fence, and a sketch was created for the applicant to address the Bilco-type basement entrance. The applicant said he still had the ornamental fence gate, and Ms. Jackson informed the applicant that it would need to be reinstalled. The details of the wood fence, the height, and time to replace the vinyl fence were reviewed.

- 1. The proposal to continue the installation of vinyl fence on side of property at 125 N 15th Street was presented by Wilfredo Paniagua.
- 2. The vinyl fence must be replaced with a dog-eared wood fence no more than 6' high with proper foundations. It is recommended that the fence be stained to resist weather.
- 3. The fence will be set back approximately 3' from the existing historic ornamental iron fence. A site visit will be done by Mr. Kimmerly and Historic Consultant (if needed) to determine the exact placement of the fence around the basement door.
- 4. The original gate must be reinstalled.
- 5. The vinyl fence must be replaced within 3 months of the date of the HARB meeting or September 4, 2018.

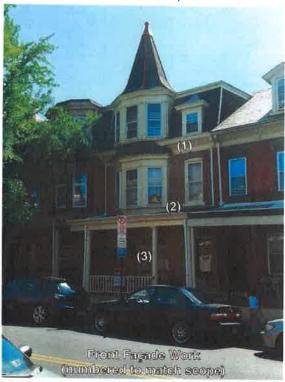
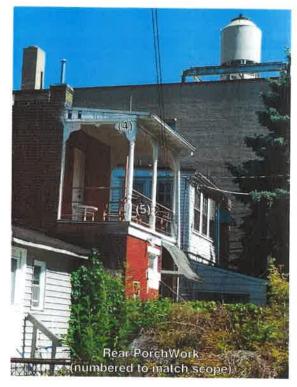
**Building description, period, style, defining features:** This structure is a 3 story attached brick row home with a Mansard roof with double story oriel window and tower roof, a hipped roof dormer windows, mostly 1 over 1 double hung windows or windows with larger, lower sashes with fixed transoms (in oriel windows), angled cornice with cut-out details, segmentally arched masonry openings, a full front porch with Doric columns, and historic wood door. The house dates from the late 1th century (c. 1888) and is Queen Anne in style. The second floor level of the oriel window has lost its paired Ionic column trim features still seen on the third floor.

Evaluation, effect on historic district, recommendations: The proposed rehabilitation work is historically appropriate. As noted, great care should be taken to preserve the historic elements of this house, as it has many. The storm windows at the oriels should be addressed to better reflect the existing sash configuration which appears to be transoms above larger lower sashes. Past work indicates the transoms were, and hopefully still are, stained glass, but the lower sashes may have been replaced with vinyl. In either case it appears the historical transom configuration is still in place and thus storm windows should match this if possible.

- 1. The proposal to make repairs to box gutter and front porch roof, recoat flat roofs and repair rear balcony at 26 N 11th Street was presented by Mike Handzu and Lynne Holden.
- 2. The existing box gutters at second floor on the front of the home will be relined with new EPDM rubber roofing membrane. All carpentry detail at the cornice and brackets will be retained with no alteration.
- 3. Front porch roof flashing will be inspected and repaired as necessary to prevent further water damage as proposed. Areas of roof needing repair will be recoated to match existing roofing material in design, color, material and texture. Roof maintenance will be performed in accordance with National Park Service Preservation Brief #4.

- 4. Porch columns and brackets will be retained without alteration.
- 5. Existing windows will be chemically stripped of lead-based paint and repainted to match existing color. NPS Preservation Brief #37 & #10 will be followed.
- 6. The existing storm windows will be removed.
- 7. The columns, brackets and trim of the second floor rear porch will be stripped of lead-based paint and repainted following above National Park Service guidance.
- 8. The existing second floor rear porch metal railing will be removed and replaced with a new wood railing system with square or turned spindles and painted. The balusters will be appropriately scaled with historically appropriate top and bottom rails. The final design of the rail porch railing must be reviewed by Staff.

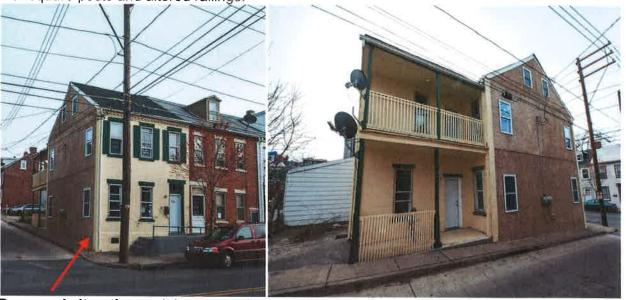
**Building description, period, style, defining features:** This 2½-story painted brick end-of-row house, ca 1870 is Federal in style. The gable roof has asphalt shingles and the cornice has brick dentils. The windows are 1/1 double hung with stone lintels and paneled shutters on 2<sup>nd</sup> floor windows only. The main entry is a six panel door with a transom and concrete stoop with pipe railing. The east façade wall was structurally unsound and was recently rebuilt with CMU with rough stucco finish. There is a two-story wood porch at the south end of the east façade with square posts and altered railings.

**Evaluation, effect on historic district, recommendations:** The proposed work is historically appropriate although additional details or drawings may be needed for the front stoop and rear porch railing. This renovation, as proposed, is an outstanding outcome for this home that was threatened with demolition only two years ago. Some recommendations and clarifications:

- 1. The proposal to restore the facade at 726 Gordon Street was presented by Shelby Ek and Peter Lewnes.
- 2. The existing paint will be removed from the front façade and sections at the rear of the building if budget allows. The historic brick will be spot repointed with appropriate soft mortar and brick repaired where needed. If necessary, the brick will be fully re-pointed. Preservation Brief #2 should be followed for all brick repair and repointing.

- 3. The side of the building that was replaced with concrete block and finished with textured stucco will be stained or finished with silica paint that bonds with the masonry materials. The color of the paint finish will blend with the natural brick to unify the front and side facades. The applicants will attempt to smooth the rough stucco texture if possible.

- 4. The existing water table will be repaired and repainted per new color scheme.
- 5. The existing concrete front steps will be removed and replaced with new brick and flagstone steps reoriented towards the street instead of parallel to the street.

- 6. The inappropriate balusters on rear porch will be replaced with historically appropriate turned balusters with traditional top and bottom rails.
- 7. The existing satellite dishes will be removed.
