CITY OF ALLENTOWN

**Certificates of Appropriateness for work in the Historic Districts:  
224 N 9<sup>th</sup> Street and 1501 Linden Street**

**Case #HDC-2018-00041**– Proposal to continue installation of vinyl siding

**Case #HDC-2018-00042**– Proposal to continue installation of the vinyl composite porch flooring

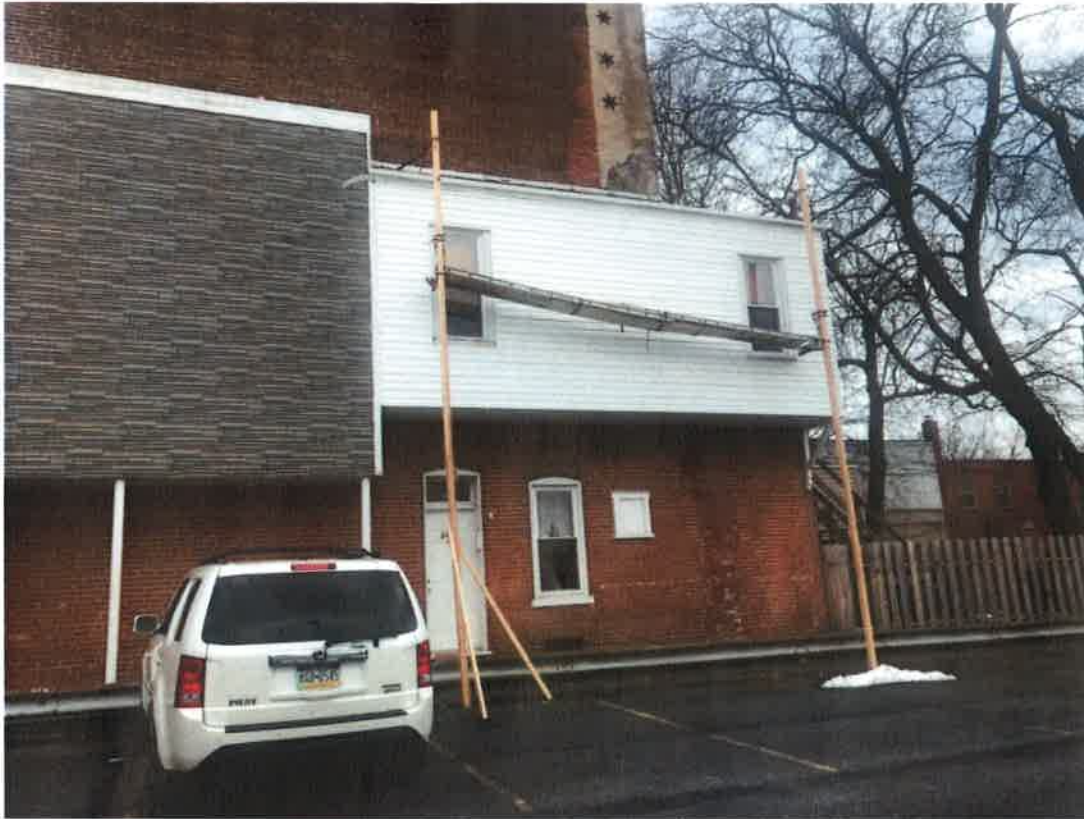
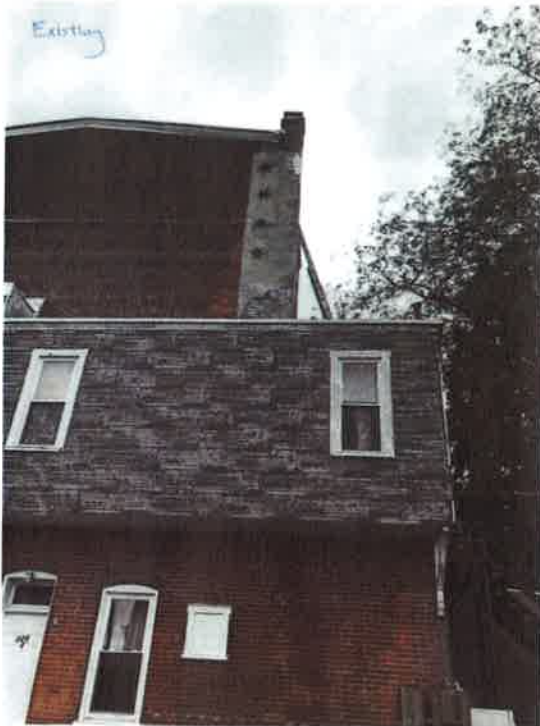
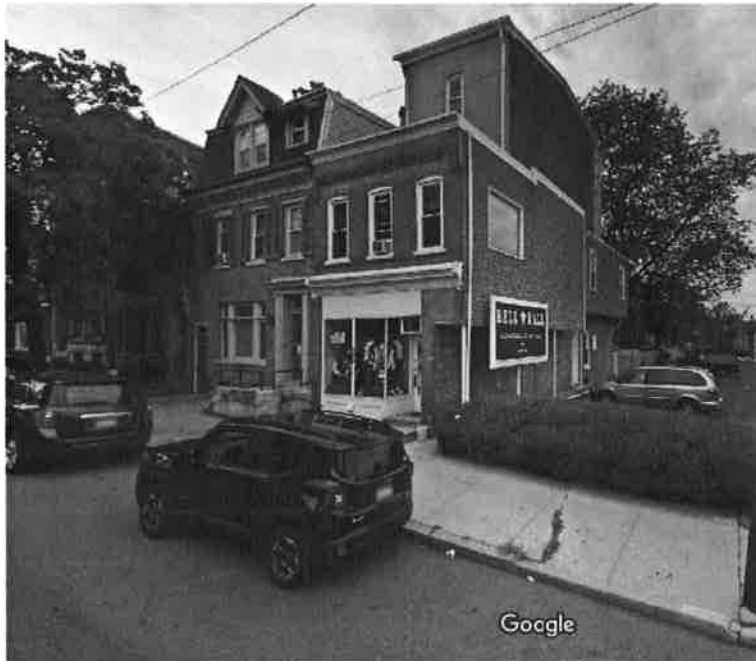
**Building description, period, style, defining features:** This structure is a 3 bay, 3 story, tan brick, semi-detached mixed-use building with flat roof, corbelled roof cornice, 1 over 1 double hung windows and first floor storefront with wood and metal projecting cornice. The building is altered with a 3<sup>rd</sup> floor brick and stucco addition set back from the front façade in the range of 15'. The building was also likely attached to another building that was removed leaving the former grocer alley open and second floor side wall exposed. The building dates from c.1897-1911 and is Italianate in style. The second-floor side wall of the building has been covered with asphalt (Insul-Brick) siding above the recessed grocer alley wall of red brick. The rear cantilevered portion of the building, formerly covered with the same Insul-Brick siding has been covered with white vinyl siding without HARB review.

**Violations:** 8/21/2013 Window sign was changed. Sign was removed. Violation resolved. 11/29/2018 - Installed white vinyl siding on the side near the back of the building.

**Evaluation, effect on historic district, recommendations:** Vinyl is not an appropriate material for this highly visible side façade. Alternative historically appropriate options are smooth, fiber cement siding, such as HardiPlank or smooth cement-based stucco since the building is a masonry structure and there is stucco at the rooftop addition. Existing trim should not be covered with new siding as done with the vinyl siding installation.

1. The proposal to continue installation of vinyl siding at 224 N 9<sup>th</sup> Street was presented by Gus Giapoutzis.
2. The white vinyl siding installed without approval will be removed.

3. Fiber cement siding in a tan or grayish color will be installed on both the side towards the front and the cantilevered section towards the rear.
4. Existing window trim will not be covered with siding.

5. Window trim and sills may be retained and repaired or replaced with white Azek or similar composite material matching existing trim and sills in size.

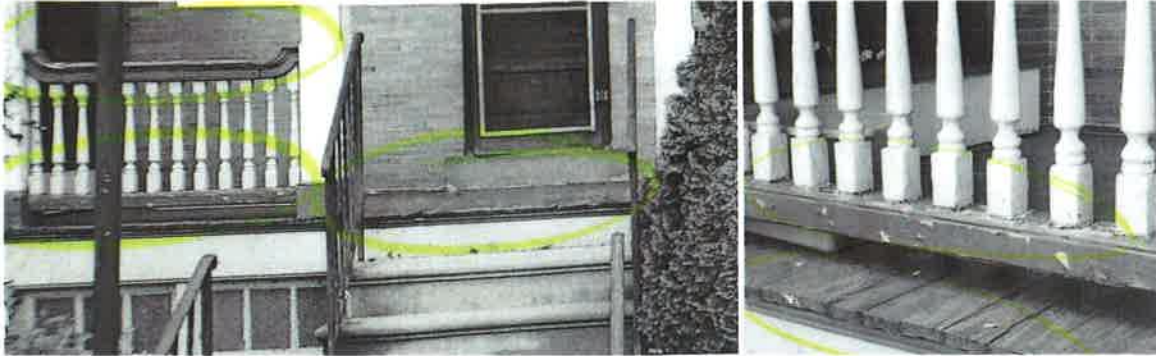
**Before:**

**Building description, period, style, defining features:** This twin house, c.1897-1911 is constructed of yellow brick and is Eastlake in style. The shared cross-gable roof has asphalt shingles, dormers and a single chimney. The front facing gables are covered with scalloped wood shingles. The windows are a combination of 1/1 sash, arched windows with brick lintels, casement, bay, stained glass transoms and ornamental frames with flat lintels. Windows in the bay contain unique curved glass. The main entry is a single glazed door with transom and stone lintel. The porch roof is supported by ionic posts; the floor is wood and there are turned balusters.

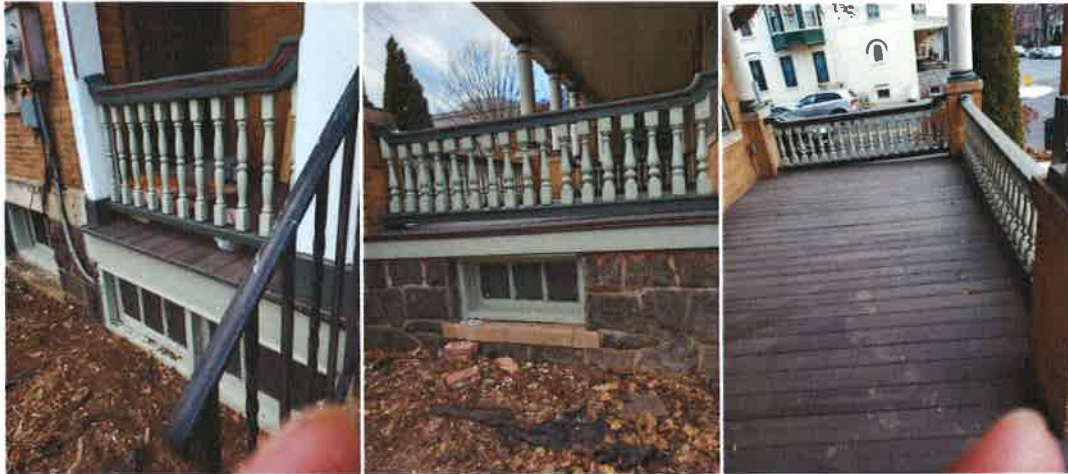
**After:**

**Violations:** 10/25/2018 – Removed porch railing. Removed porch floor boards and replaced with vinyl composite material. Porch railings were repaired and replaced, violation for railings resolved.

**Evaluation, effect on historic district, recommendations:** The installed flooring isn't technically appropriate according to guidelines, which stress the replacement of historic materials be in-kind. A tongue and groove wood floor should have been installed, and properly stained and sealed, which should hold up to weather over time if maintained. Understanding that maintenance tends to be neglected, the Trex product reduces maintenance requirements, and in this case, appears to closely resemble a stained wood floor. Samples should have been

provided, and in the future, this alternative material could be considered on a case by case basis. The other mitigating factor in this case is the elevated level of the porch which makes the porch floor surface hard to see from street level. The edge is the most visible and resembles the historic appearance.

1. The proposal to continue the installation of the vinyl composite porch flooring at 1501 W Linden Street was presented by Henri Desrosiers.
2. The vinyl composite (Trex) porch flooring installed without HARB review and approval must be removed. The material does not have appropriate dimensions or edge treatment and is installed on the very visible primary/front façade of the building.
3. The porch flooring will be replaced with historically appropriate fir, tongue and groove 2 ½" – 3" wood decking or solid PVC composite (Aeratis or equal) tongue and groove 3" decking with factory finish or painted.
4. The porch floor replacement must be completed by May 15, 2019.
5. The existing concrete side steps will be retained and repaired in-kind. The concrete steps must keep the bullnose feature to match the original.
