**HISTORIC ARCHITECTURAL REVIEW BOARD  
CITY OF ALLENTOWN, PENNSYLVANIA  
August 31, 2020**

**FINAL REVIEW**

**Address:** 1444 W Linden Street –

**Case #** HDC-2020-00027 - Proposal to repair the porch columns, header and wall

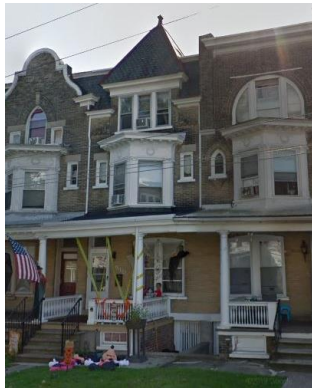
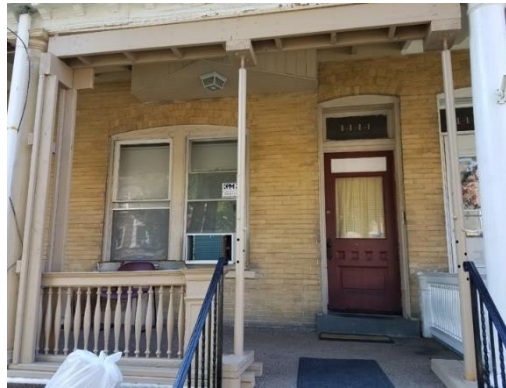
**Building description, period, style defining features:** This structure is a 3 story, attached tan brick dwelling with Mansard roof, front facing Flemish gable, a triple window on the third floor featuring center pointed arch, second floor double-angled oriel window, full front porch with Doric columns and original turned balustrade. The building dates form c 1900 and is Edwardian in style.

*The porch is in need of repair. The header needs to be replaced likely due to a leaking box gutter. The box gutter must be repaired and repainted. A new header should be sized by a structural engineer and it should be wrapped in 1 x wood and painted. The new Column must match the old as closely as possible, The new post could be fiberglass. Fiberglass is hard to distinguish from wood and would be historically appropriate.*

**Evaluation, effect on historic district, recommendations:** The proposal as amended to be the repair of the porch header, posts, and wall near the posts is historically appropriate. The new work must match the old in appearance and materials. The location and description of the wall repair should be discussed. It is not clear where that is occurring.
