**HISTORIC ARCHITECTURAL REVIEW BOARD
CITY OF ALLENTOWN, PENNSYLVANIA
April 5, 2021**

FINAL REVIEW

Case # HDC-2021-00012

Property Address: 1012 W Turner St.

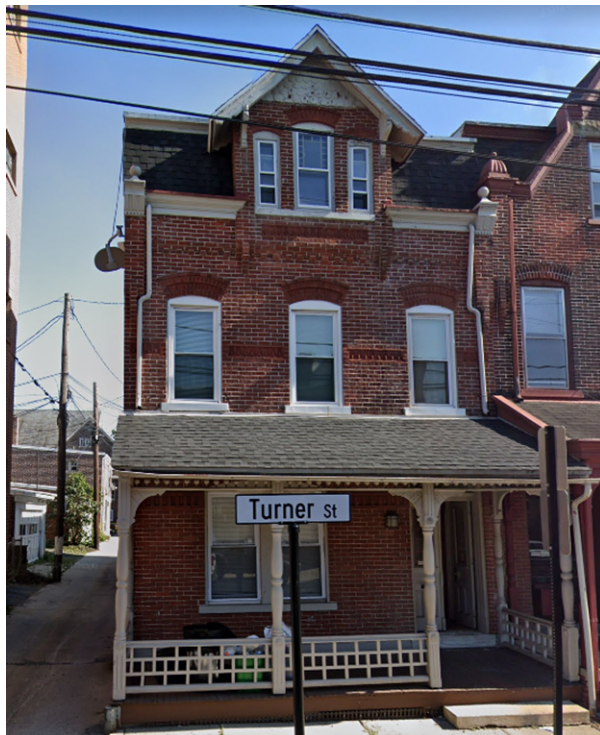
This three-story brick end of the row Porch House, ca 1885, has a Mansard roof with a large dormer, fishscale slate, and a chimney. The former has a bracketed gable roof, fishscale shingles in the gable peak and three windows - the center window having a Queen Anne style upper pane. The second-floor roof edge has brick corbelling, panels on both edges of the house, both edges of the former as well as across the width of the house. Louvered shutters (removed) flank the second-floor windows which are 1/2 double hung sash. The windows are set in curved top frames which are topped with segmental arched lintels. There is a row of decorative tiles across the front façade. The first floor has two windows set into a large curved top frame and a glazed double door entry. There is a wooden porch with turned columns, fan brackets and a wooden balustrade.

The porch structure and corner post has suffered significant repeated damage from car traffic due to its location on a narrow alley. Reconstruction of the corner post and replacement of the rotted header and structural components to address life safety concerns and comply with current building code is reasonable and appropriate. The proposed new materials are in-kind replacements and all new elements will match existing. Wood beadboard and wood tongue and groove decking are historically appropriate materials and are consistent with the Design Guidelines. The porch roof is currently clad with asphalt architectural shingles and will be replaced in-kind. Asphalt architectural shingles to resemble natural slate roofing are an acceptable alternate roofing material per the Guidelines.

- Replace rotted and damaged wood when repair is not possible with new wood members including one corner column, header beam, alley-side handrail, 2x8 ledger board, bead board ceiling, 1x4 tongue and groove wood floor. All new components to match existing in dimensions, size, profile, appearance, and material. If structurally sound, salvage and reuse the upper and middle sections of the corner column, replace the base portion in kind to match the existing.
- Replace existing porch roof rafter with 2x6 rafters (with dove tails) to meet building code requirements.
- Provide new asphalt, architectural shingles and flashing at porch roof.
- Provide new round gutter with acceptable profile per Guidelines.
- Salvage and reuse all existing decorative materials including but not limited to posts, ball and dowel spandrels, brackets, balustrades and handrails.
