HISTORIC ARCHITECTURAL REVIEW BOARD
CITY OF ALLENTOWN
November 12, 2021
FINAL REVIEW

Property located at: 231 N 8th St.

Case: HDC-2021-00030

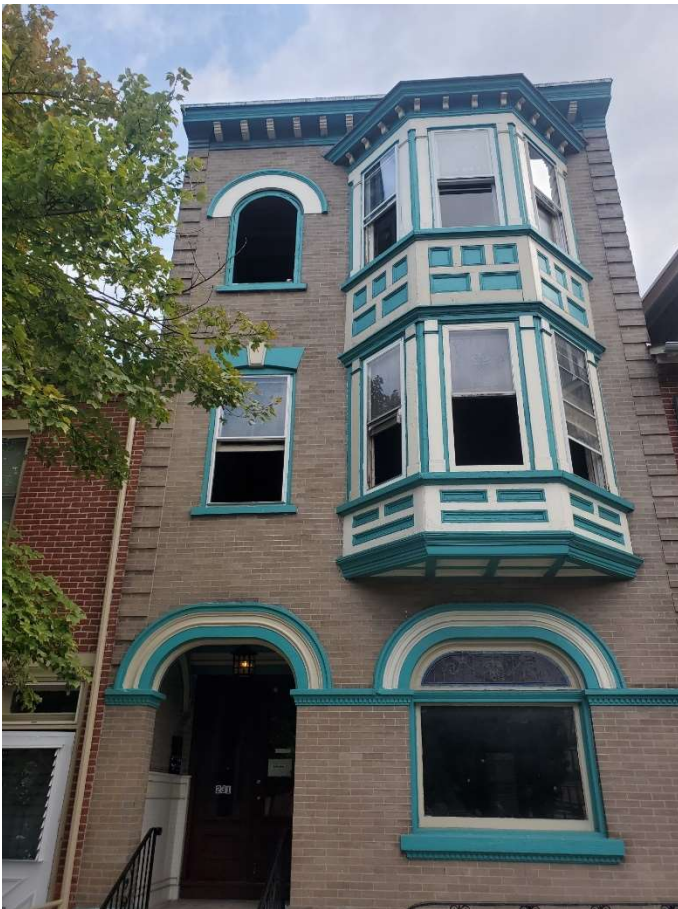
This 3-story brick building, ca. 1904, shows Romanesque Revival styling. The flat roof has bracketed projecting eaves, dentilated cornice on 1st floor between the picture window and transom. The lintels on the 1st and 3rd floor are full arches made of wood. There are single windows to the left of the projecting bay windows on the 2nd and 3rd floors, all windows have 1/1 sashes. The lintel on the 2nd floor single window has a keystone. There are quoins along the edges of the building.

The main entrance double door is recessed. The foyer has tile walls and marble floors with wood arched moldings to match the 1st floor moldings. There is fan shaped wrought iron grill work on street to protect the basement entrance. There are two basement window grilles visible.

The proposal does not conform to the guidance within the Historic District Design Guidelines or the SIS. As stated in the 2020 preliminary report the existing stained-glass windows are a unique feature of the building and removal would have a negative impact on the historic district. The windows are in deteriorated condition, but a high amount of original historic material remains intact.

The appropriate treatment is for the existing stained-glass windows to be repaired, restored, and reused. Additional professional assessments and quotes should be completed to determine the feasibility of restoration of the existing stained-glass windows and/or support the finding of irreparable damage and required replacement. Windows that are irreparably damaged should be replaced in-kind.
